CAMAS MUNICIPAL POOL
City of
Camas
WASHINGTON

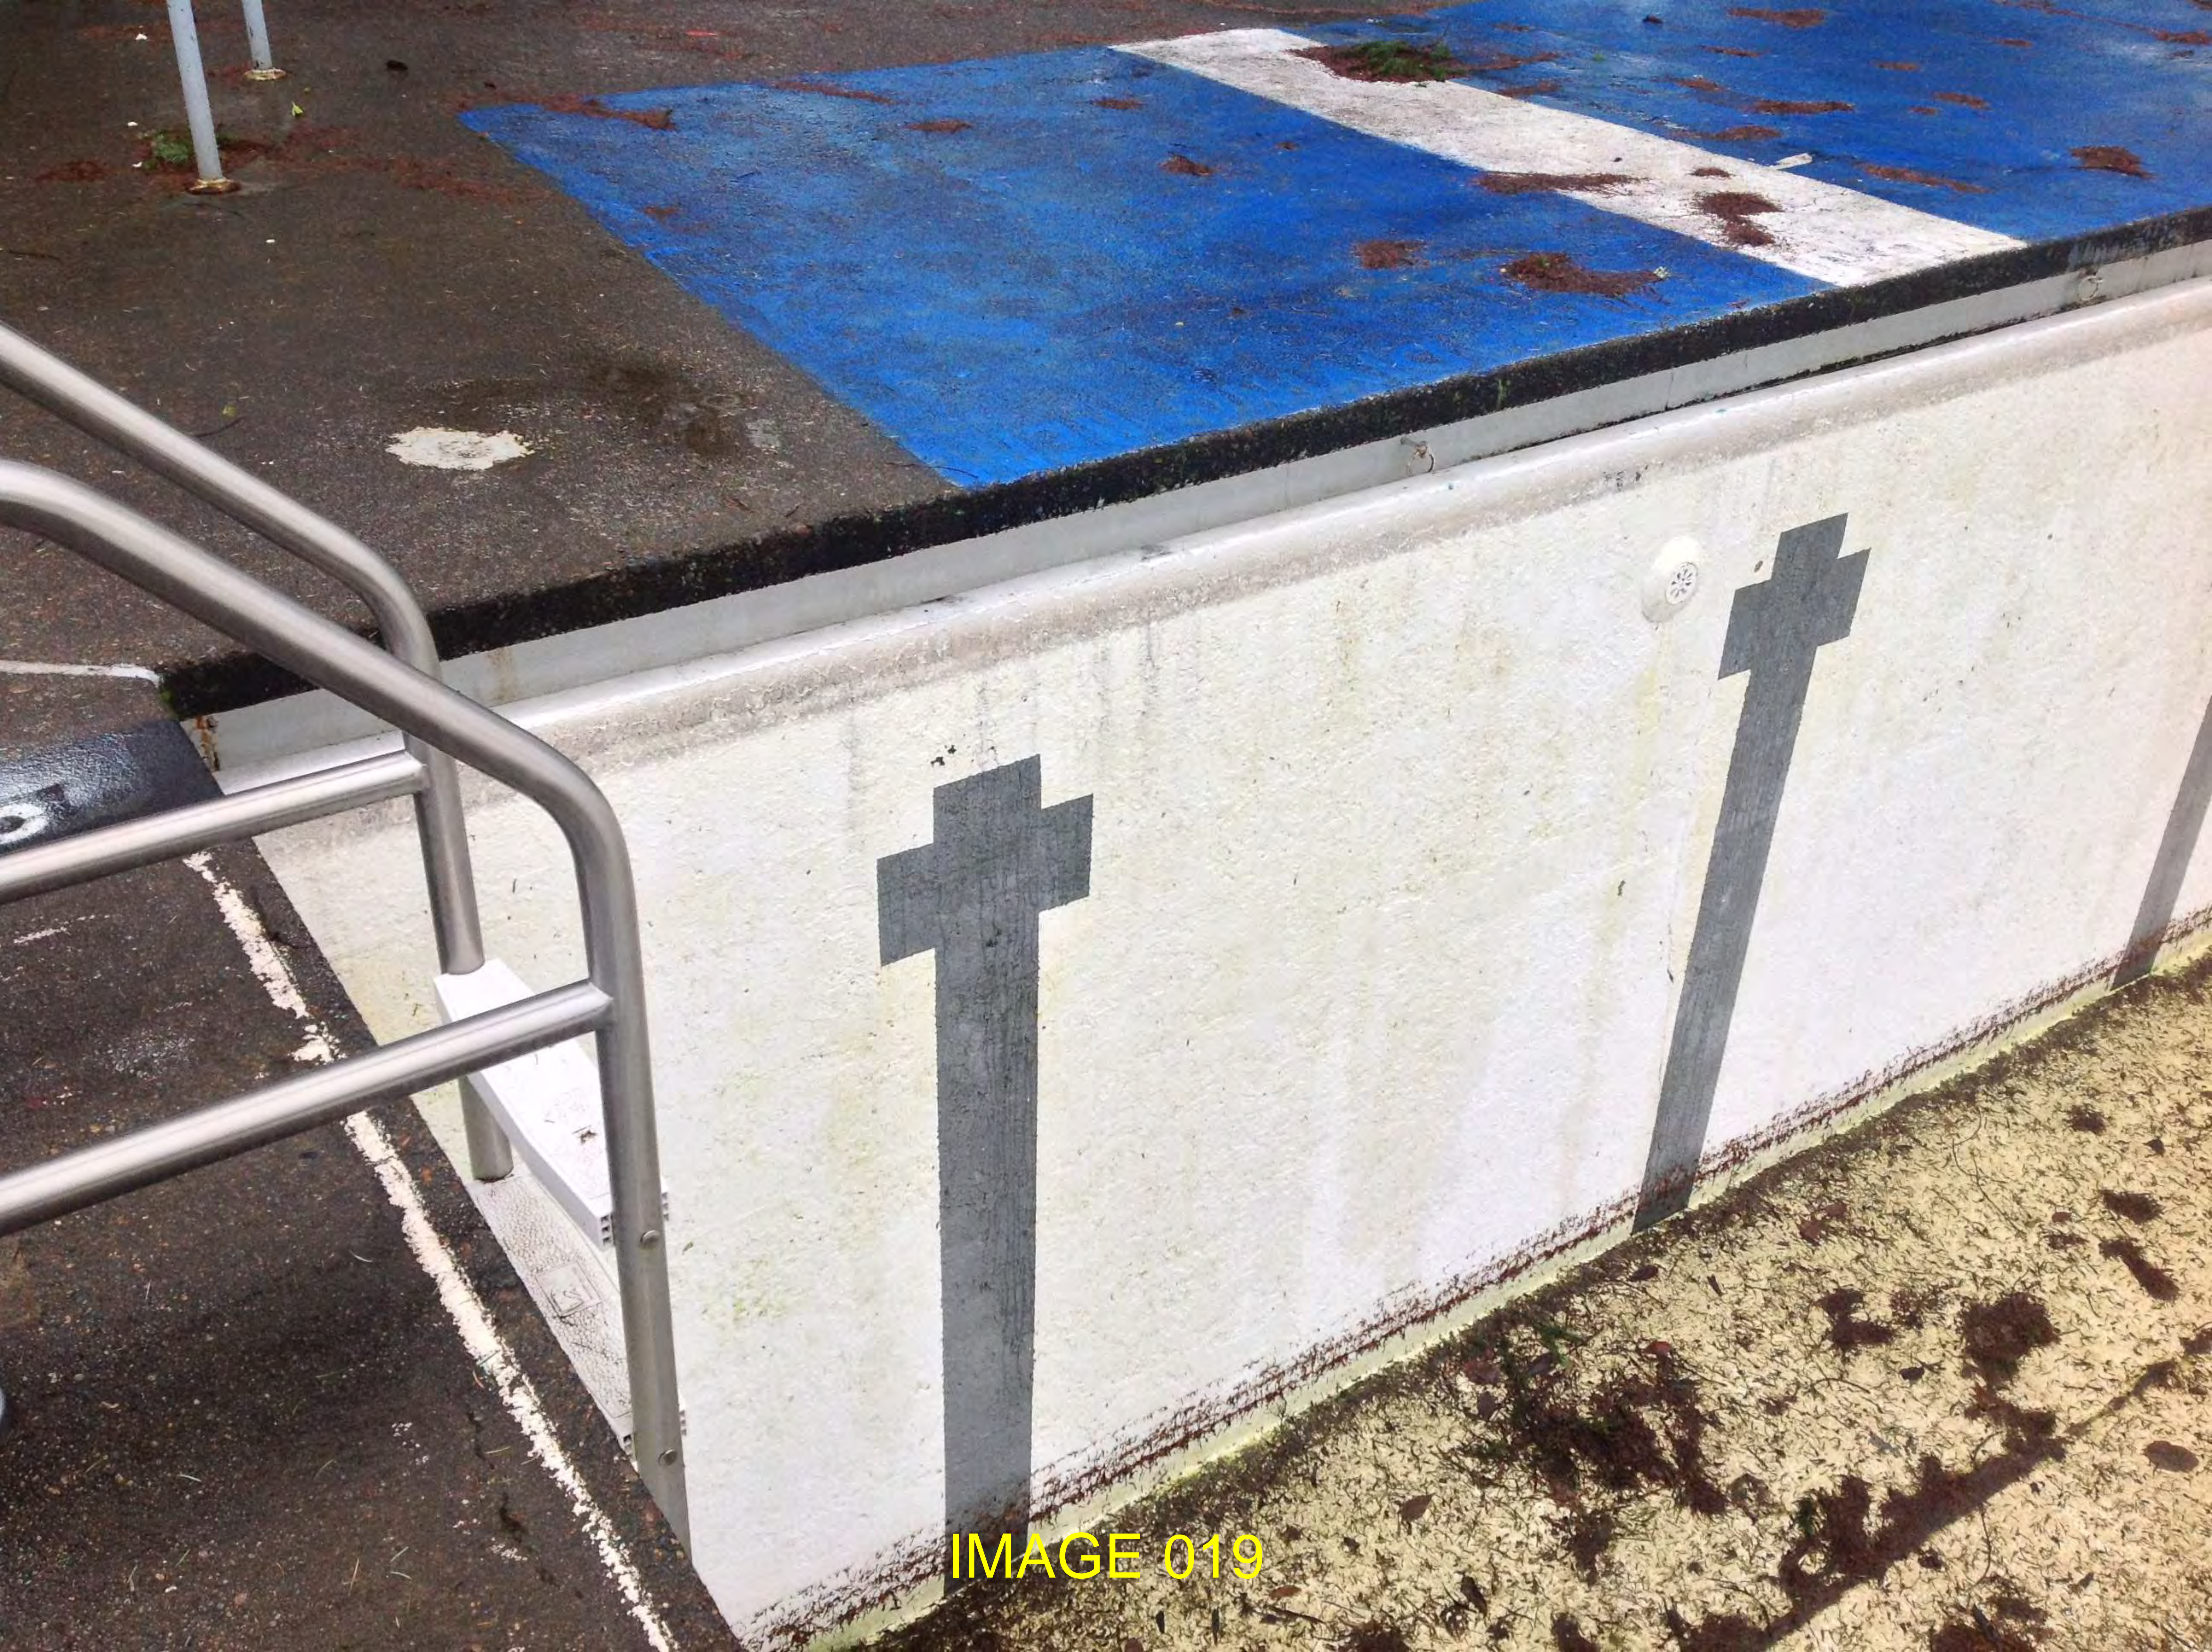
IMAGE 019

Paint Chipping, Peeling,
and Flaking Away

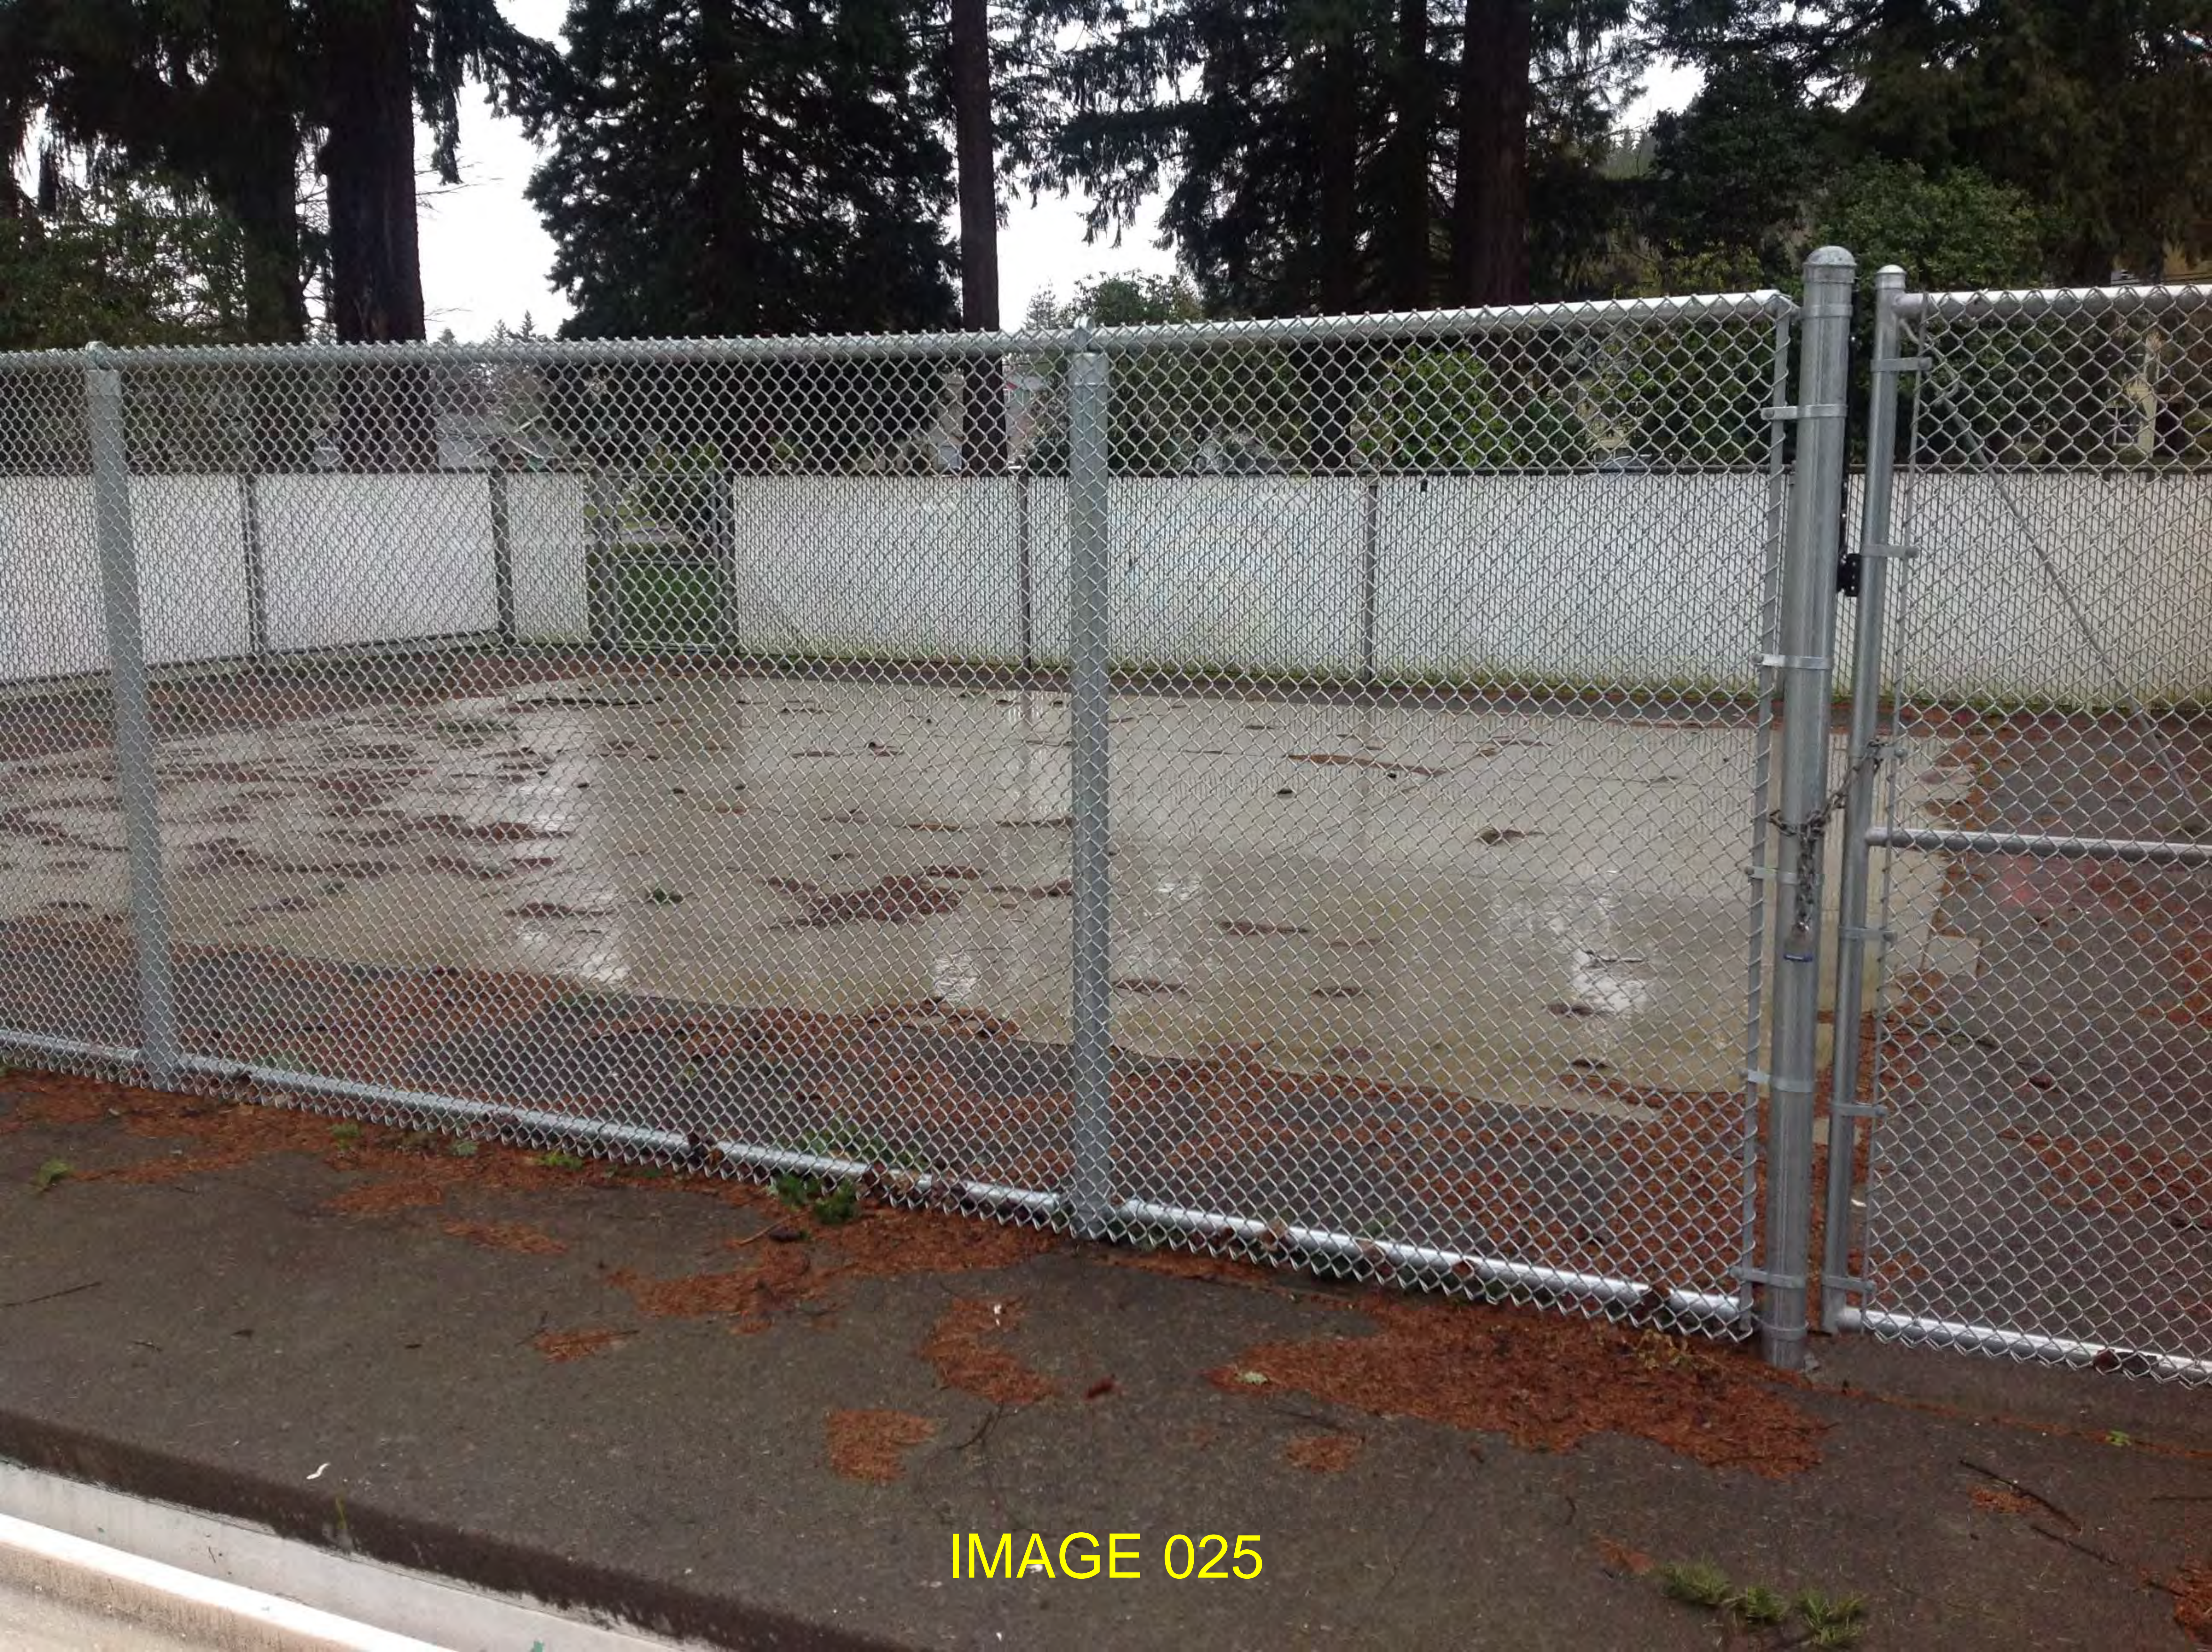
IMAGE 025

Insufficient Gutter
Drop-Out

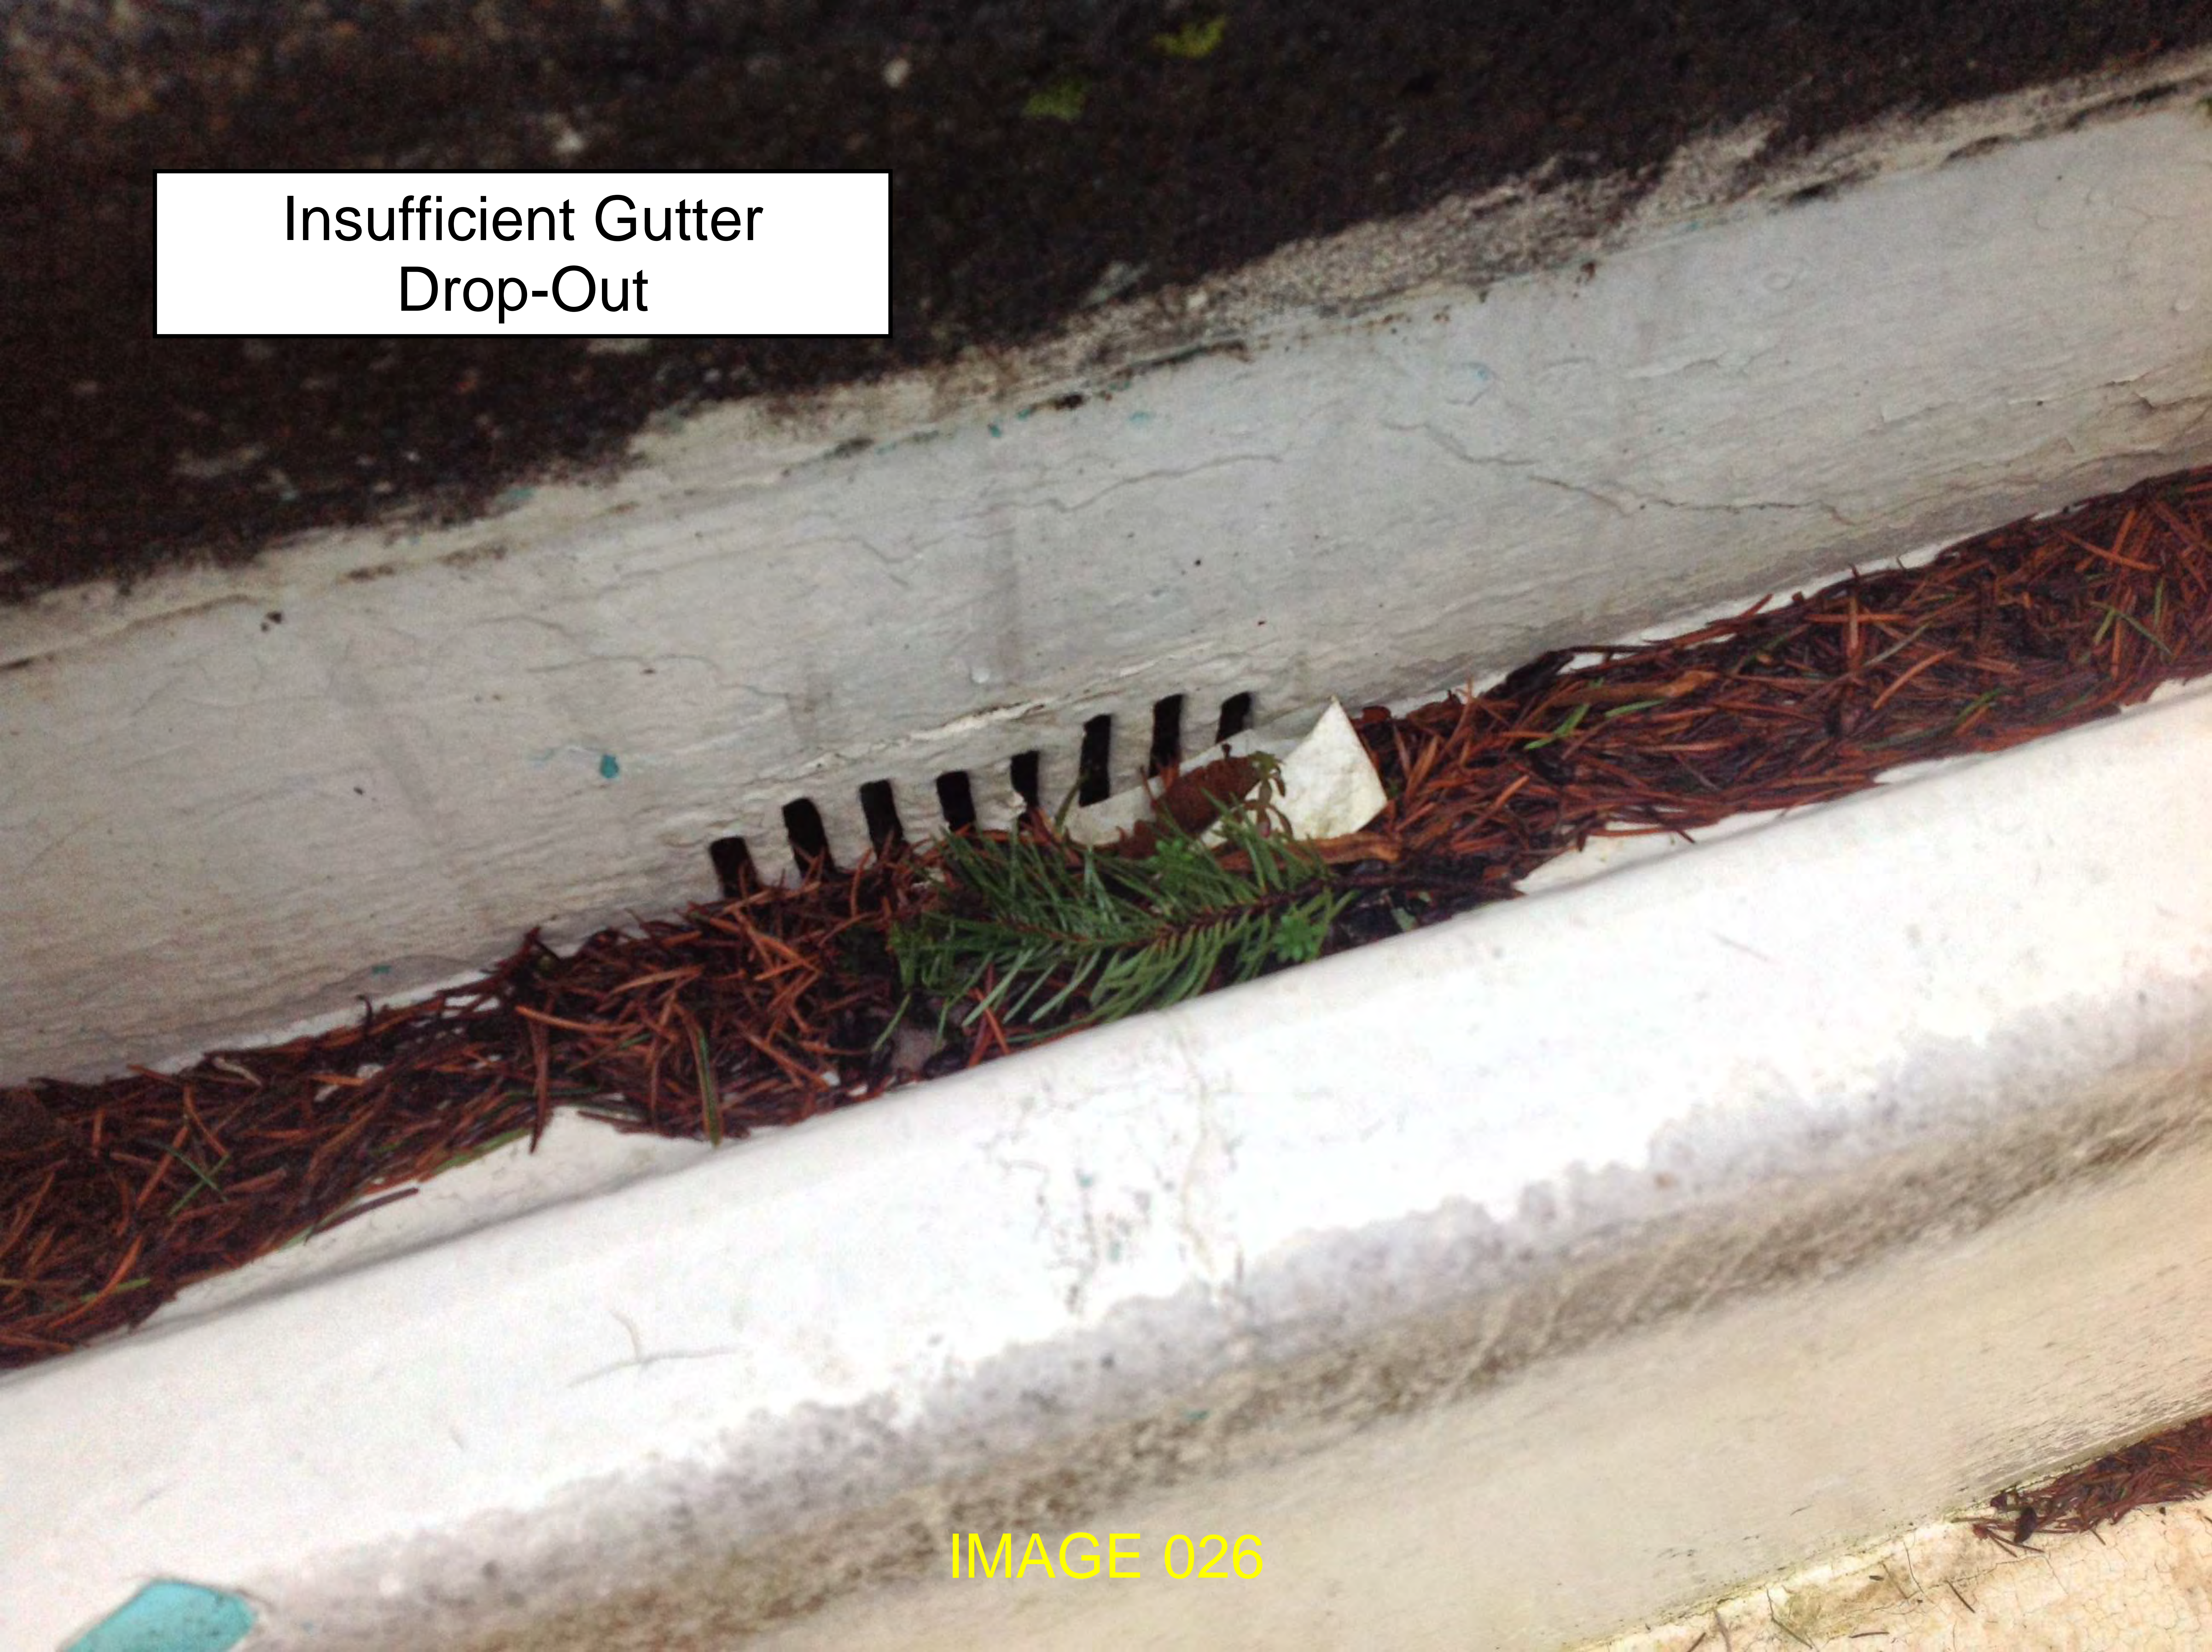
IMAGE 026

Return Fitting
Not Adjustable

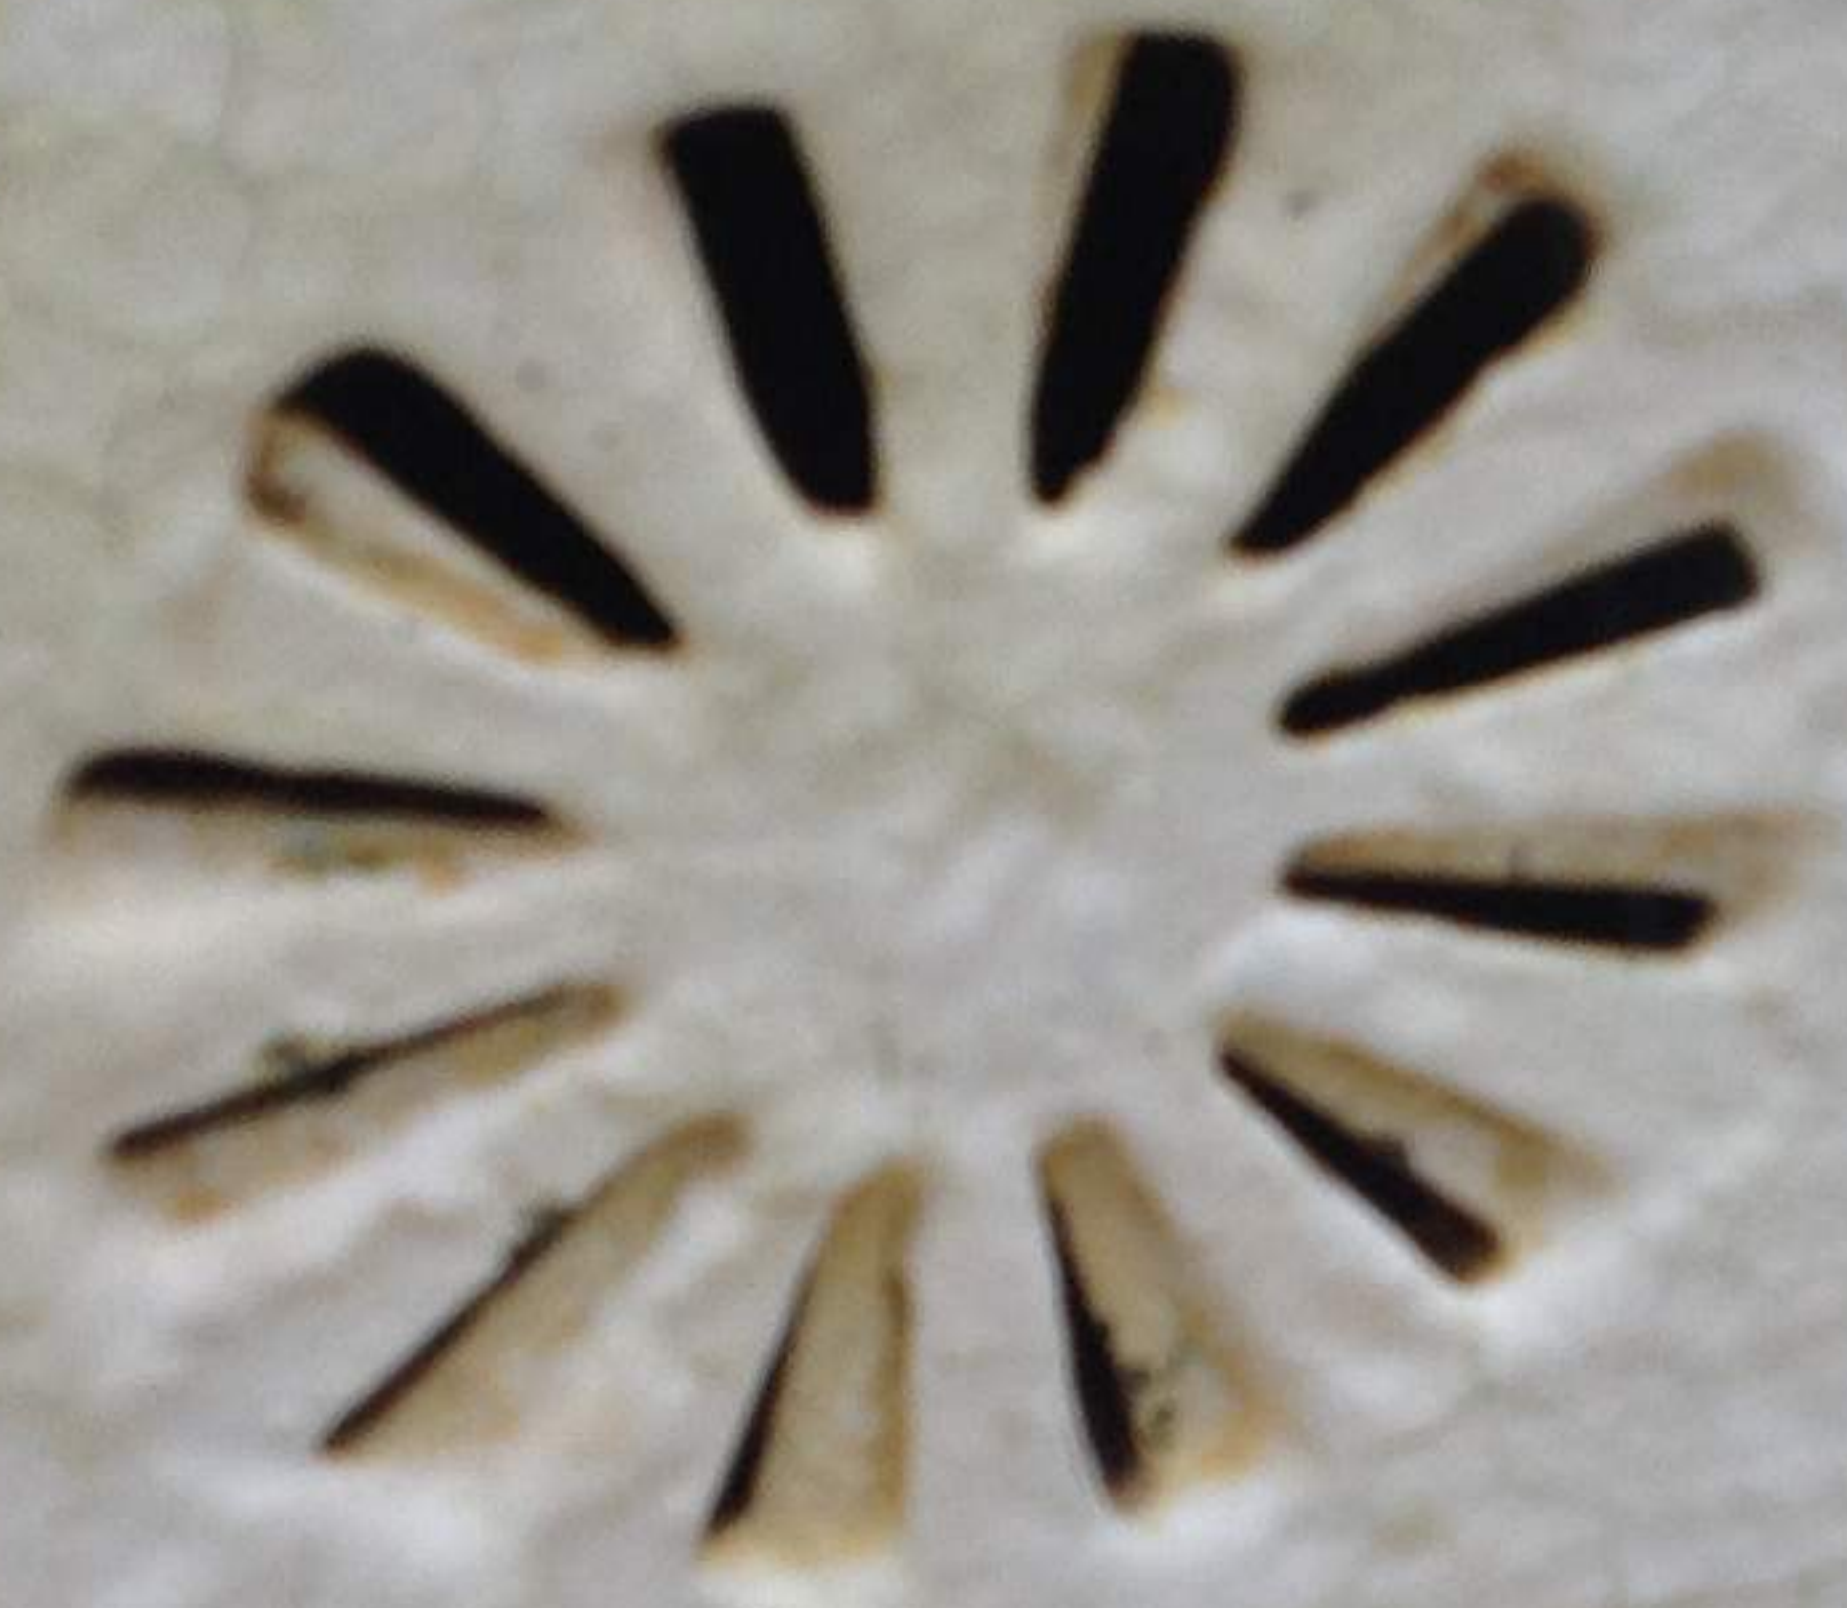
IMAGE 027

Return Fitting
Not Adjustable

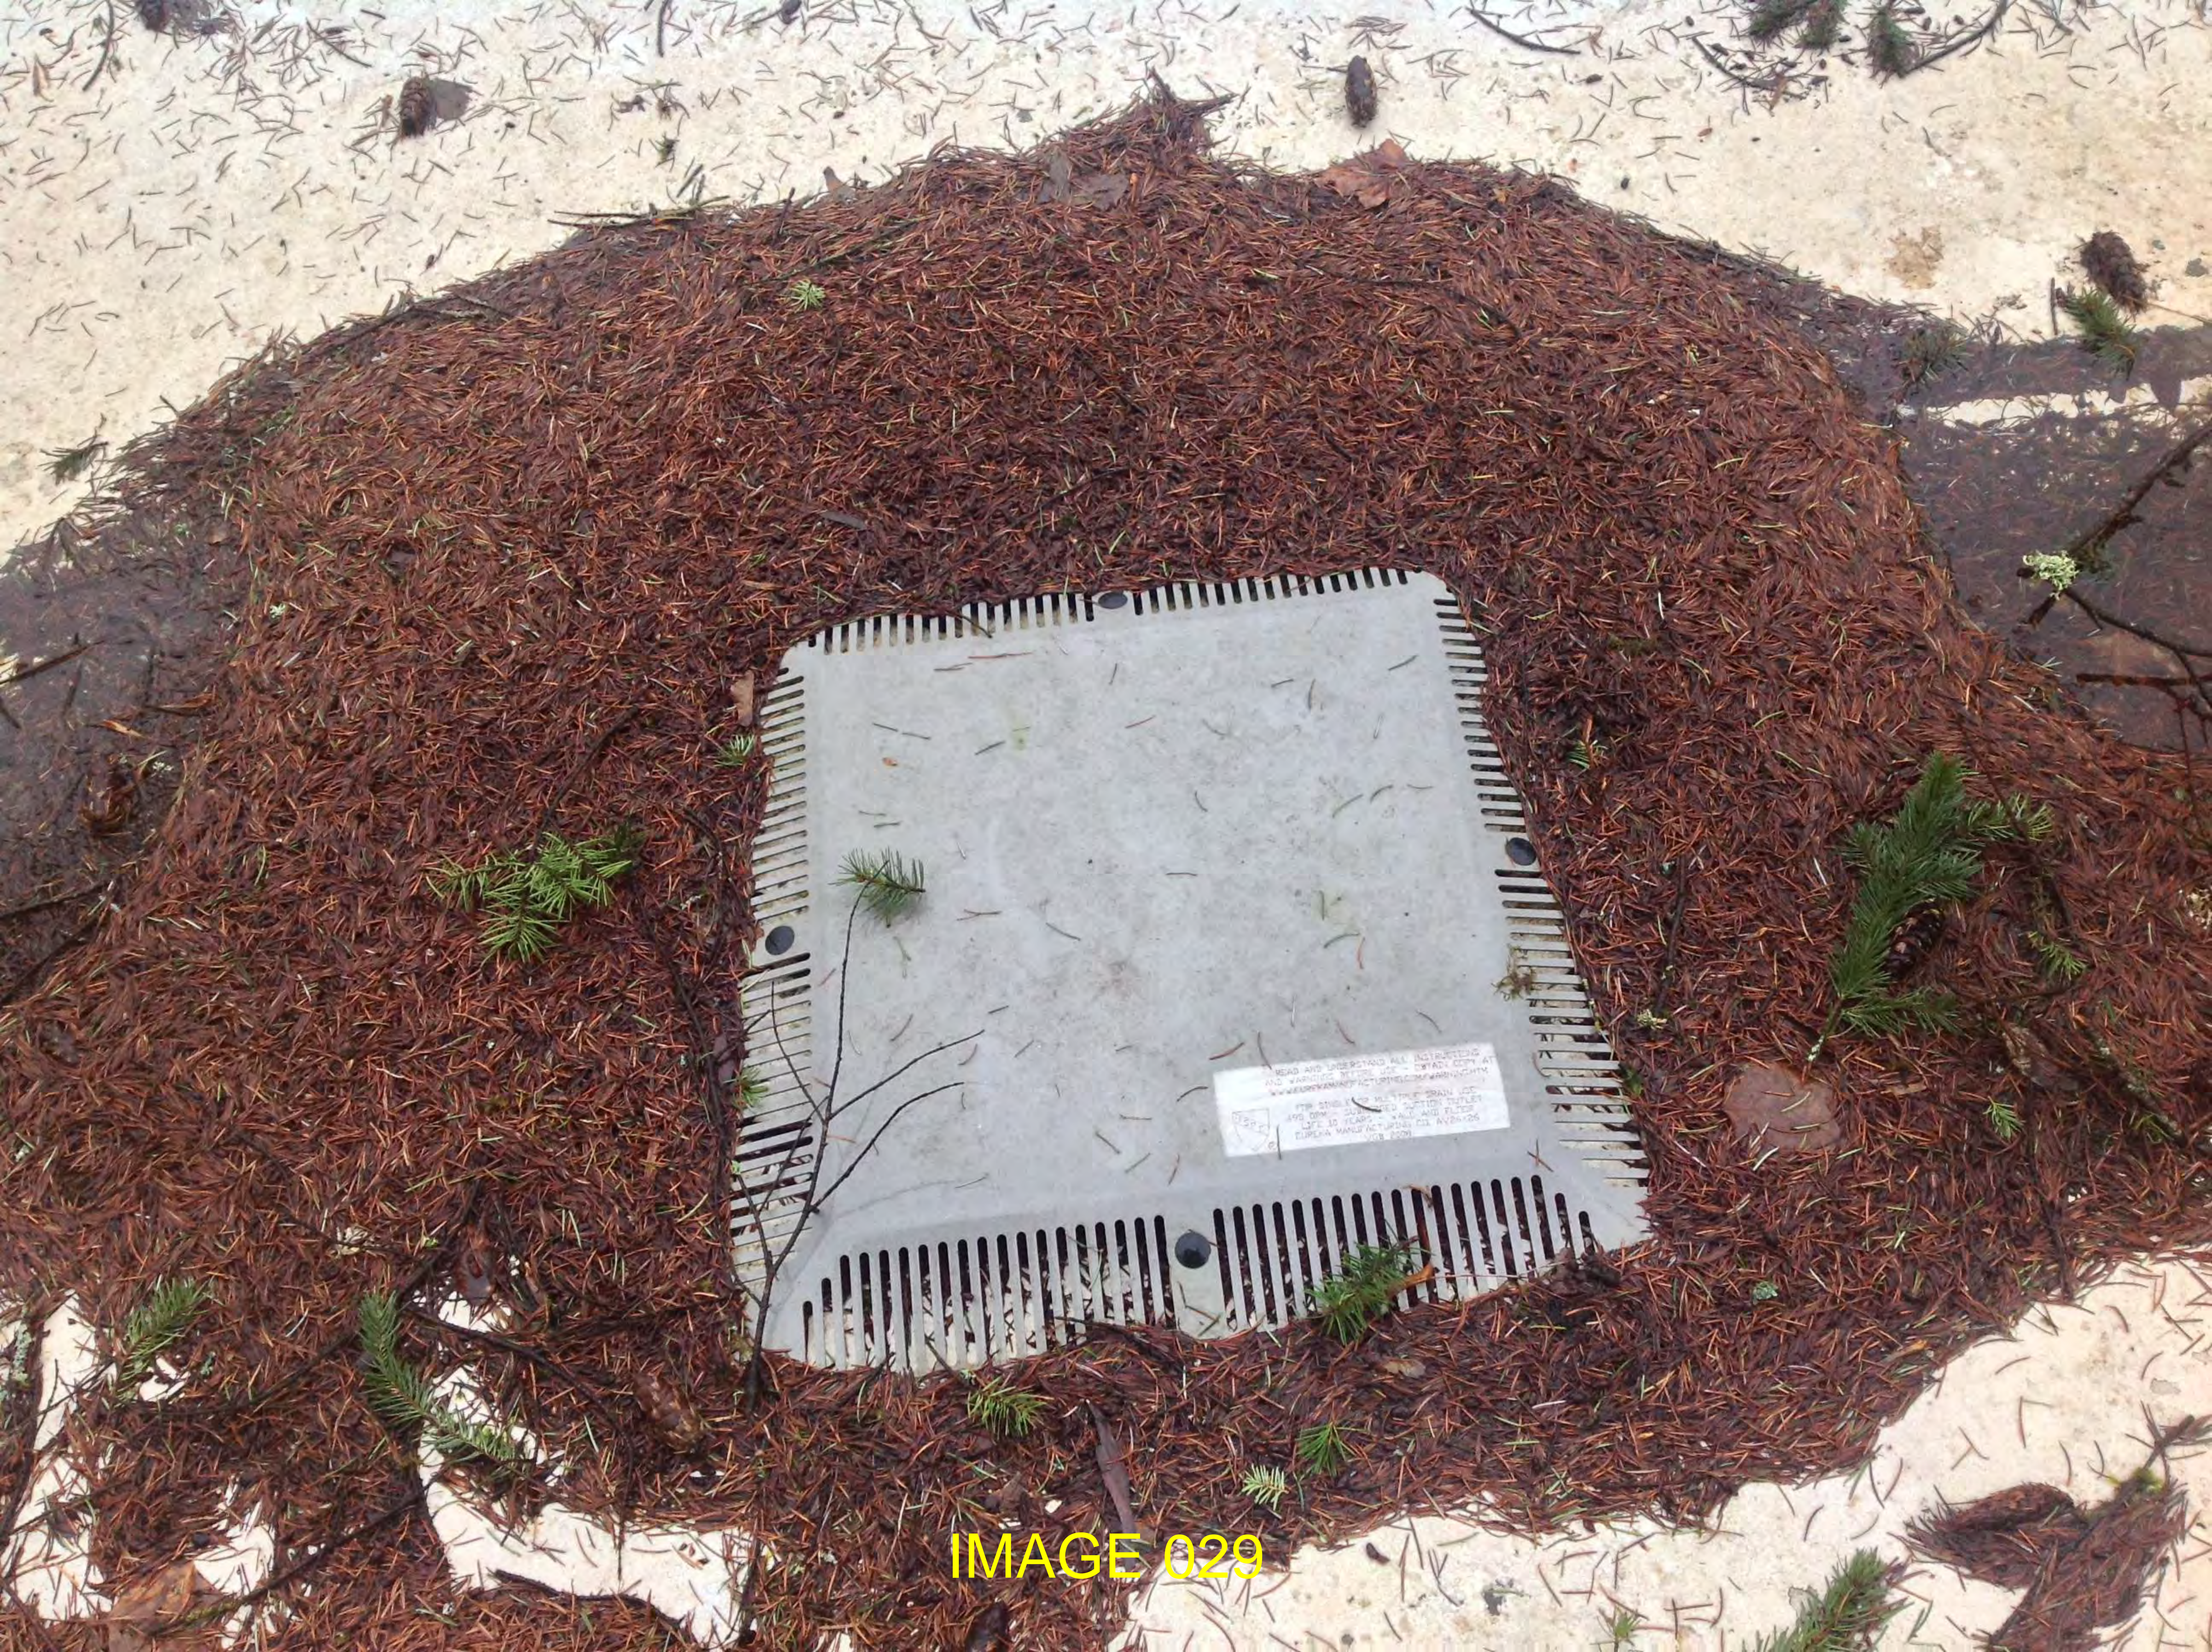
IMAGE 029

Junior Pool
Vessel Cracking

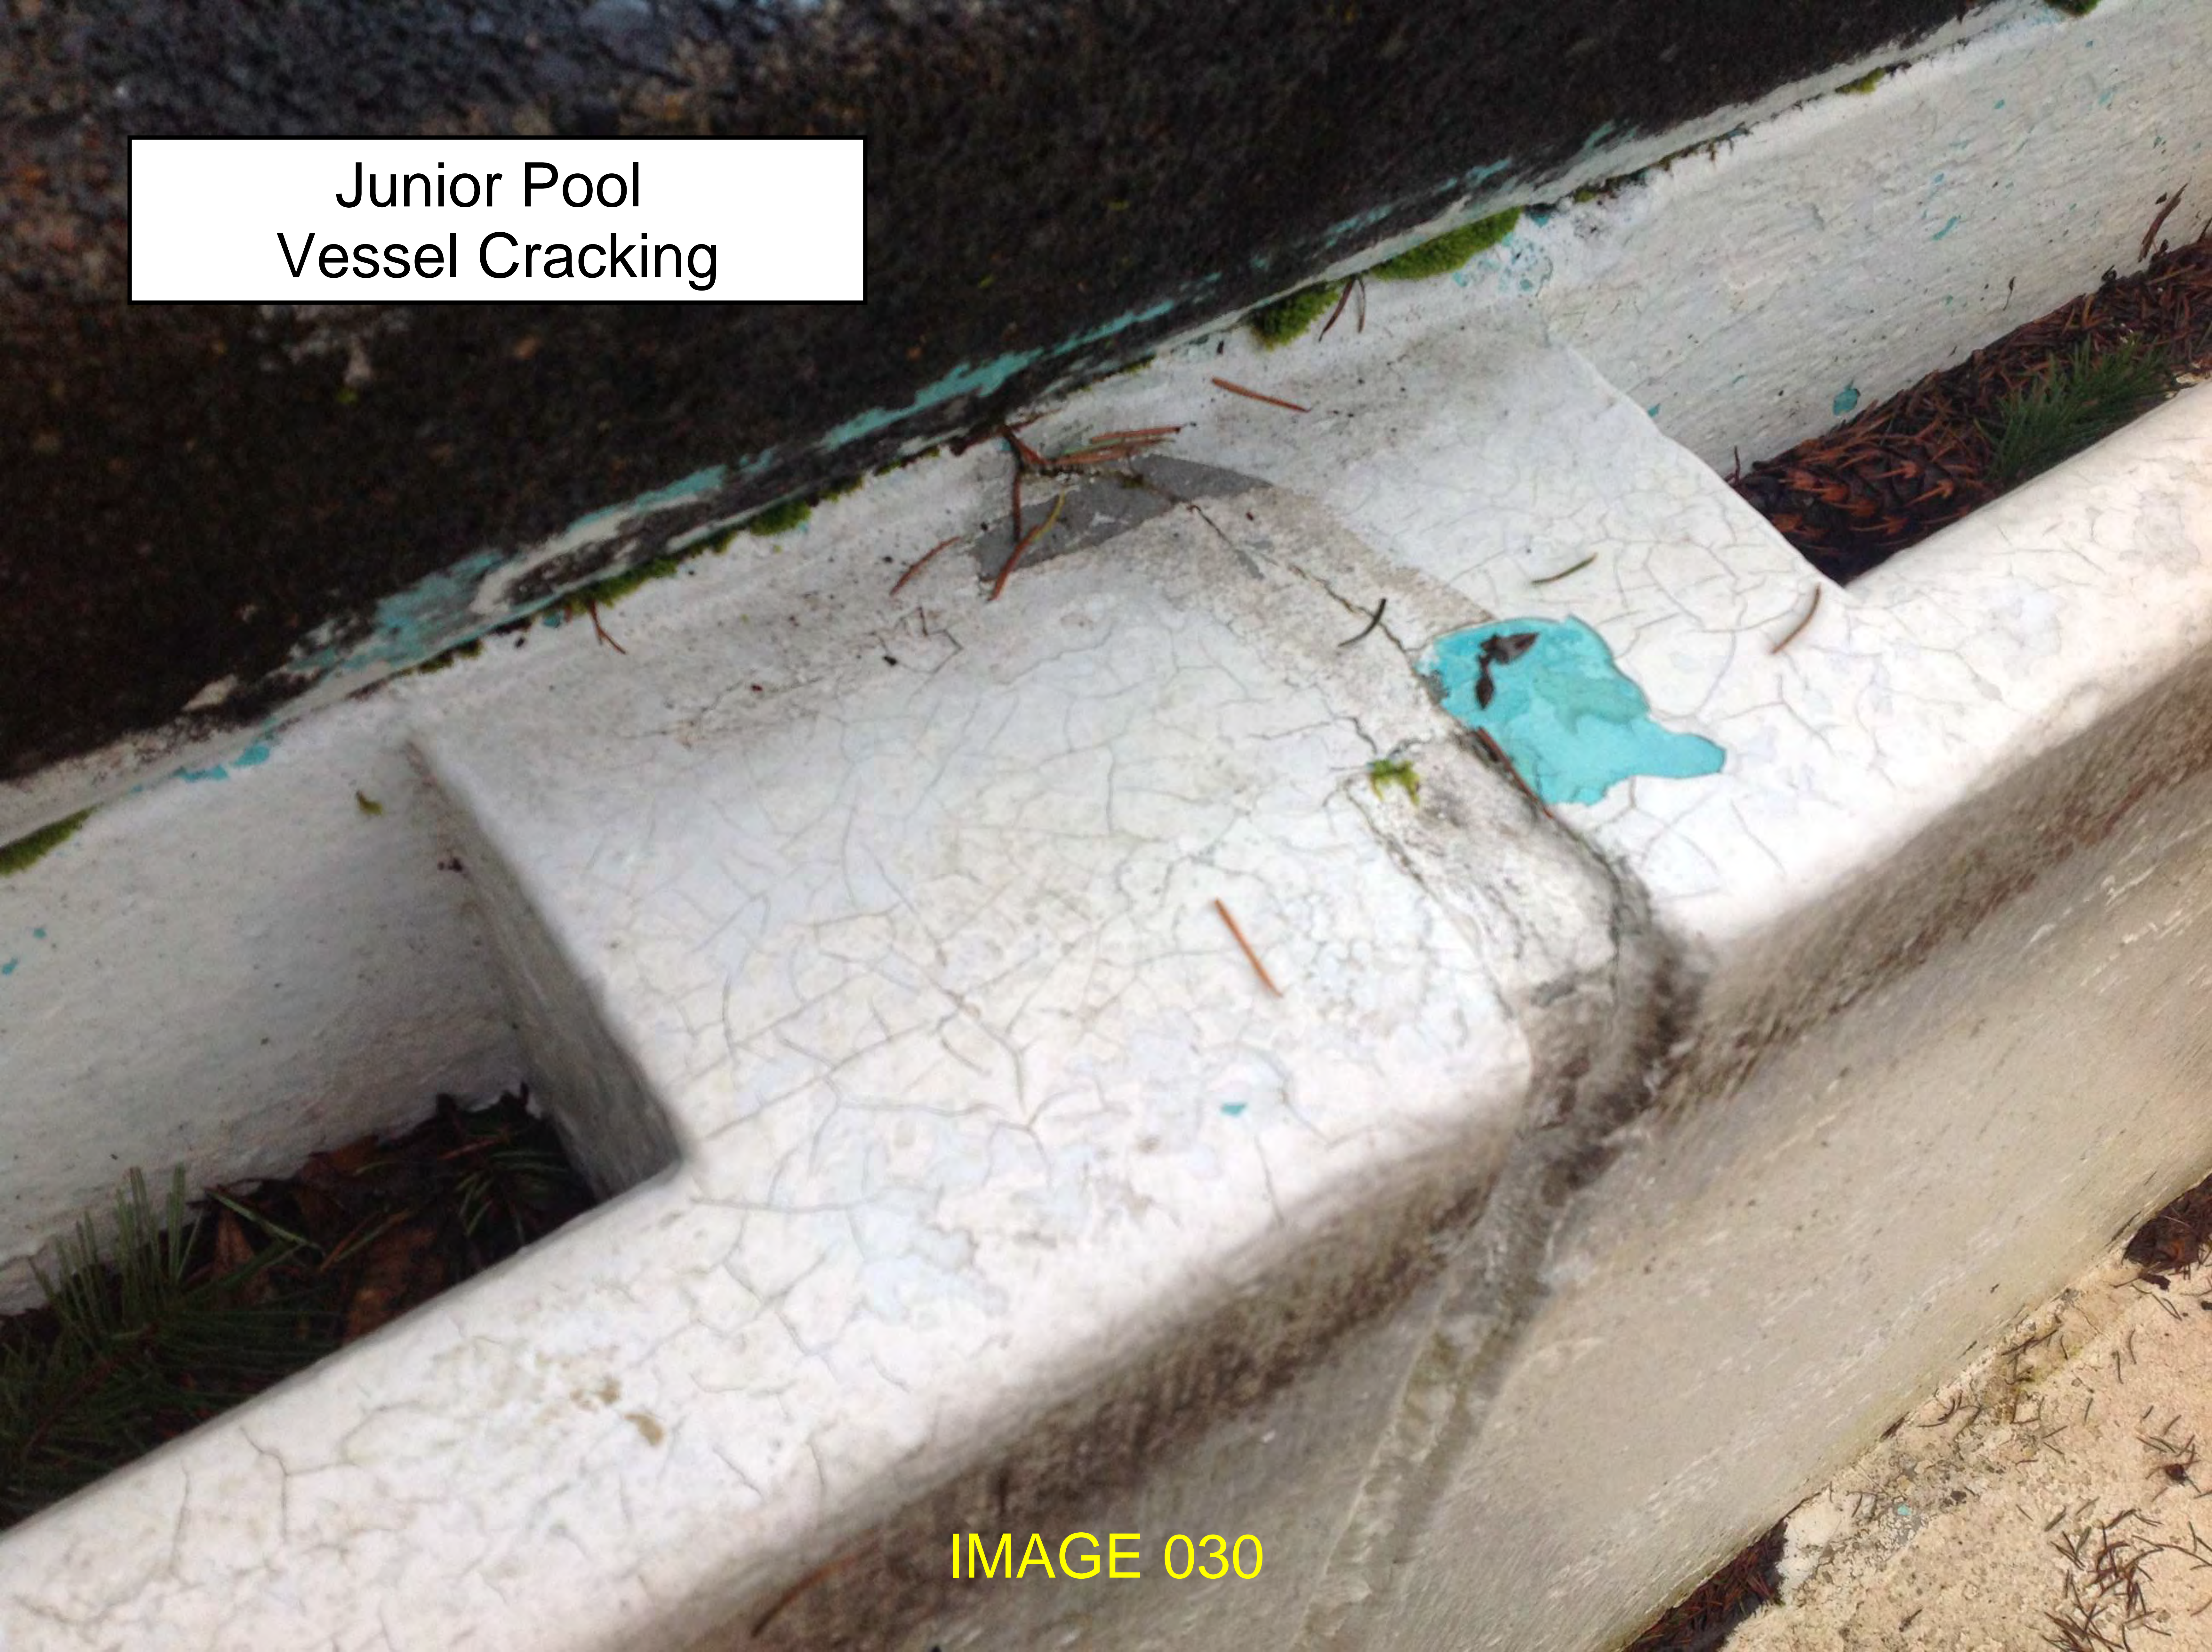
IMAGE 030

Insufficient Gutter
Drop-Out
