CAMAS MUNICIPAL POOL
City of
Camas
WASHINGTON

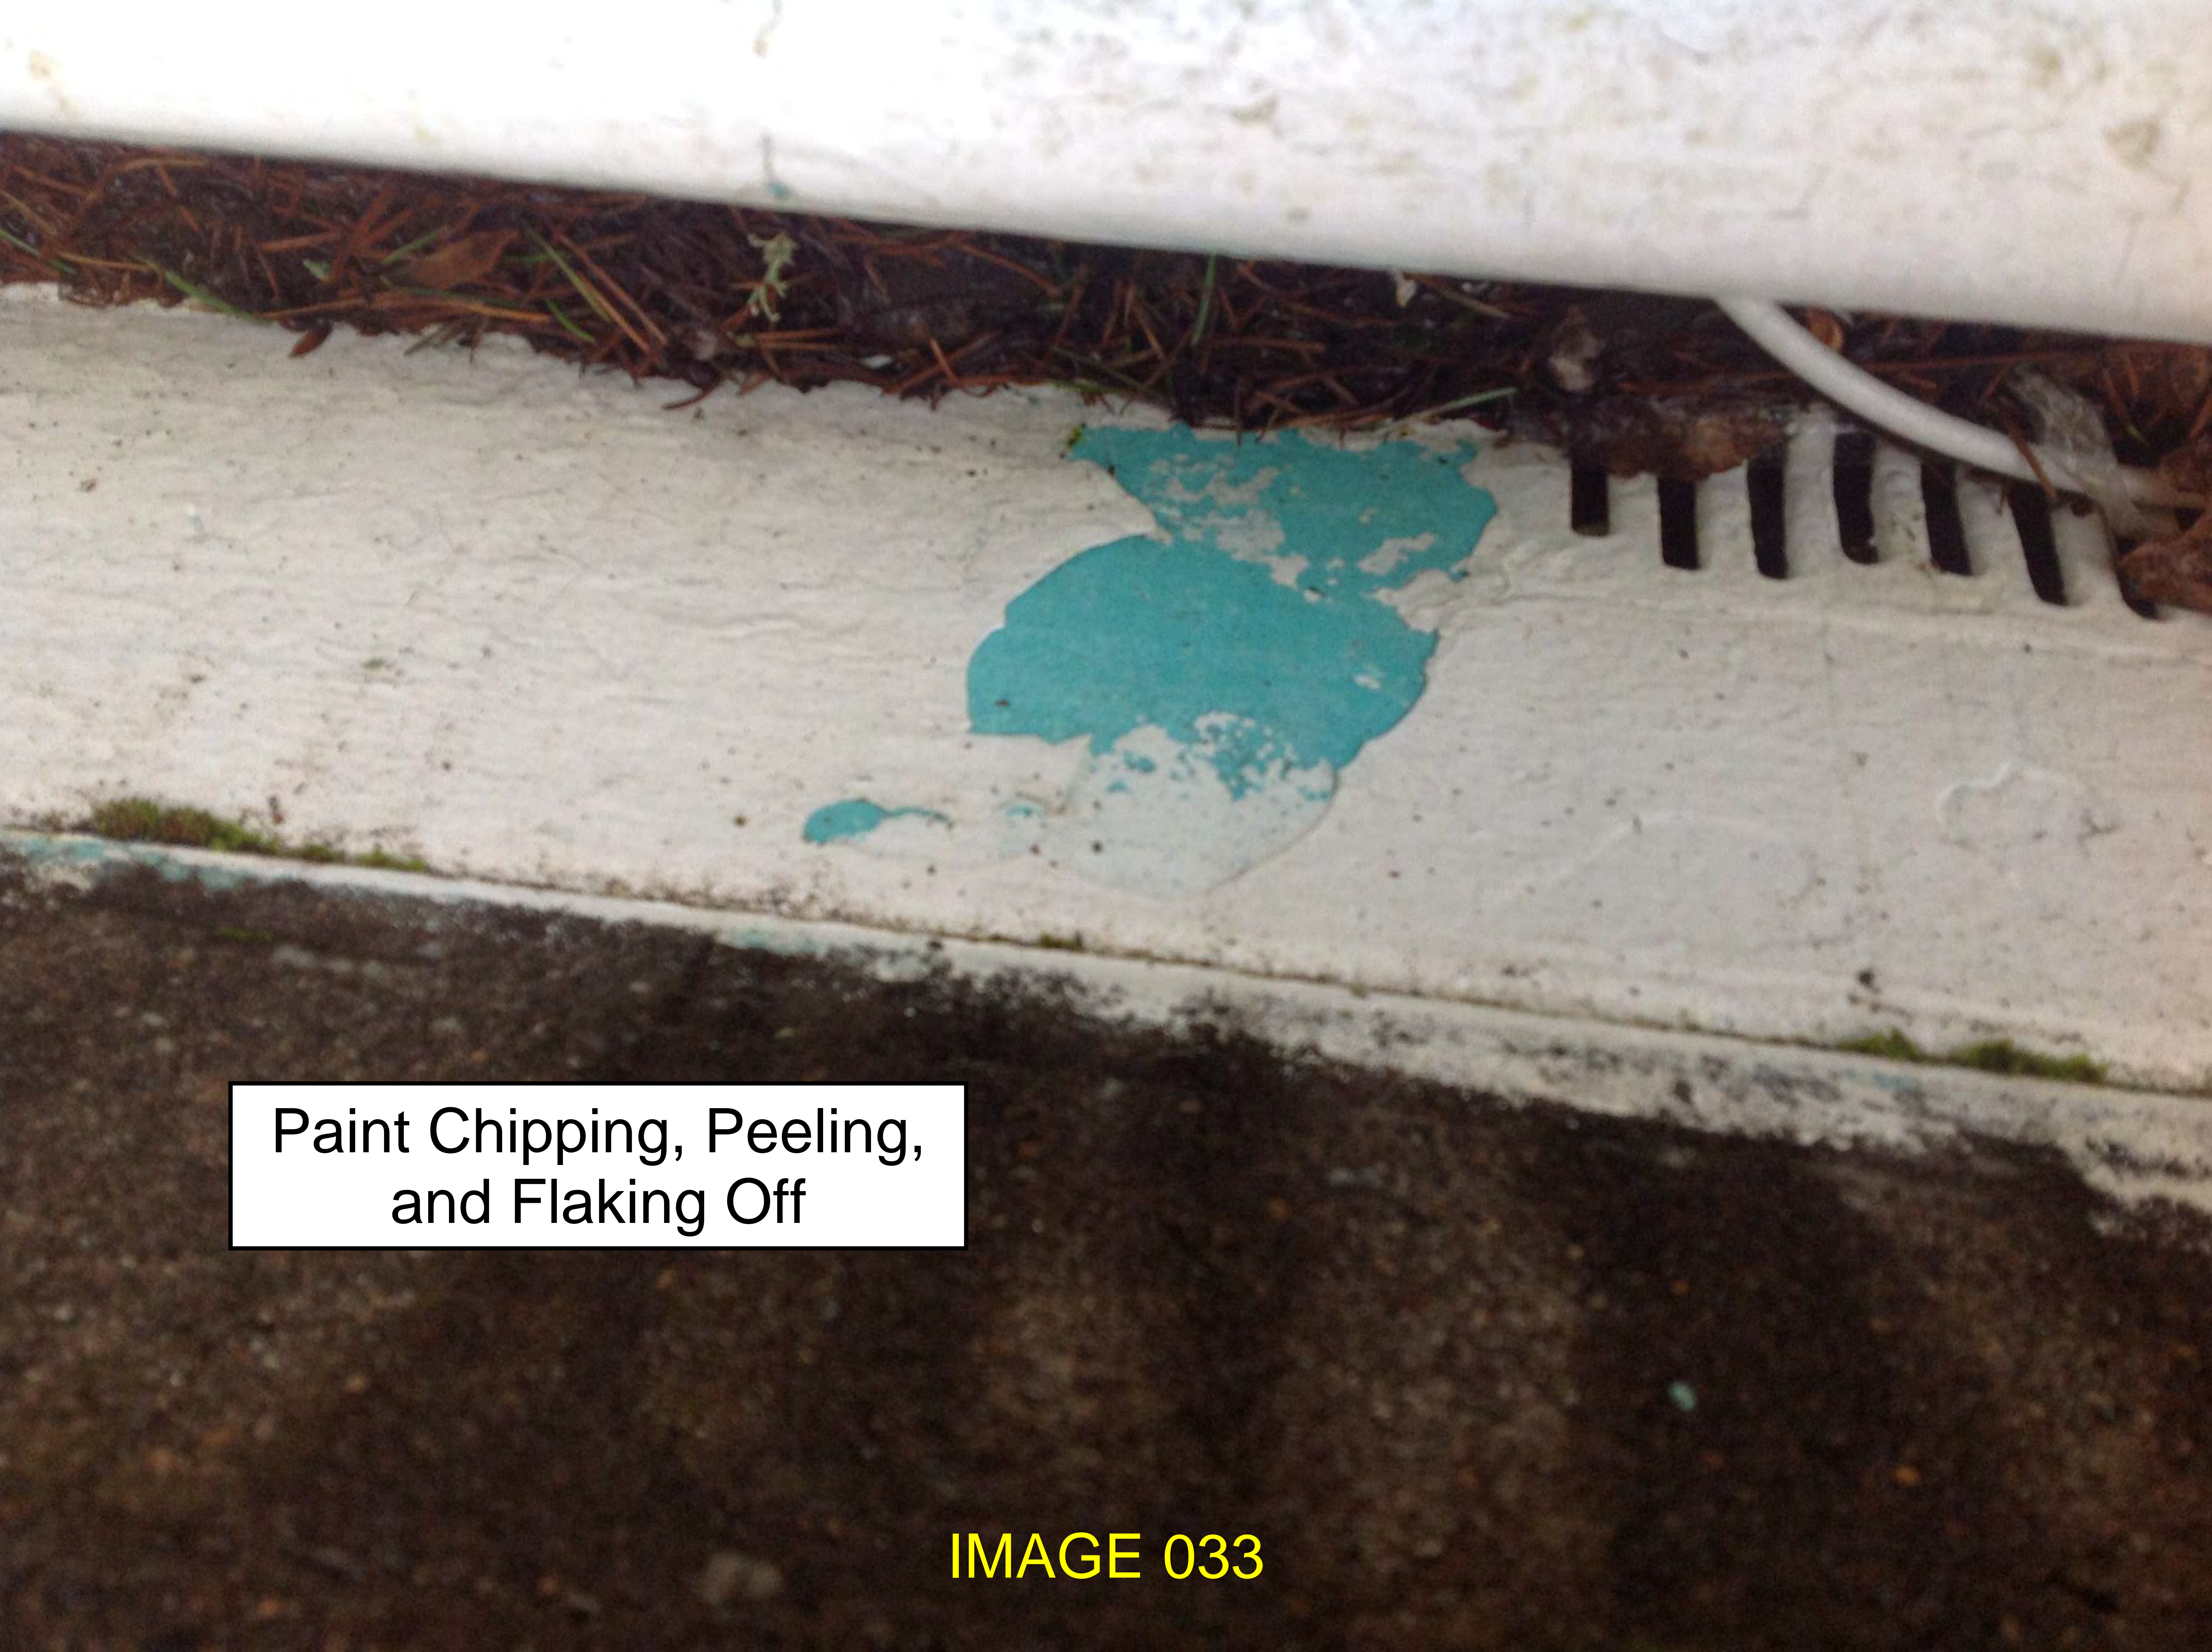
IMAGE 033

Paint Chipping, Peeling,
and Flaking Off

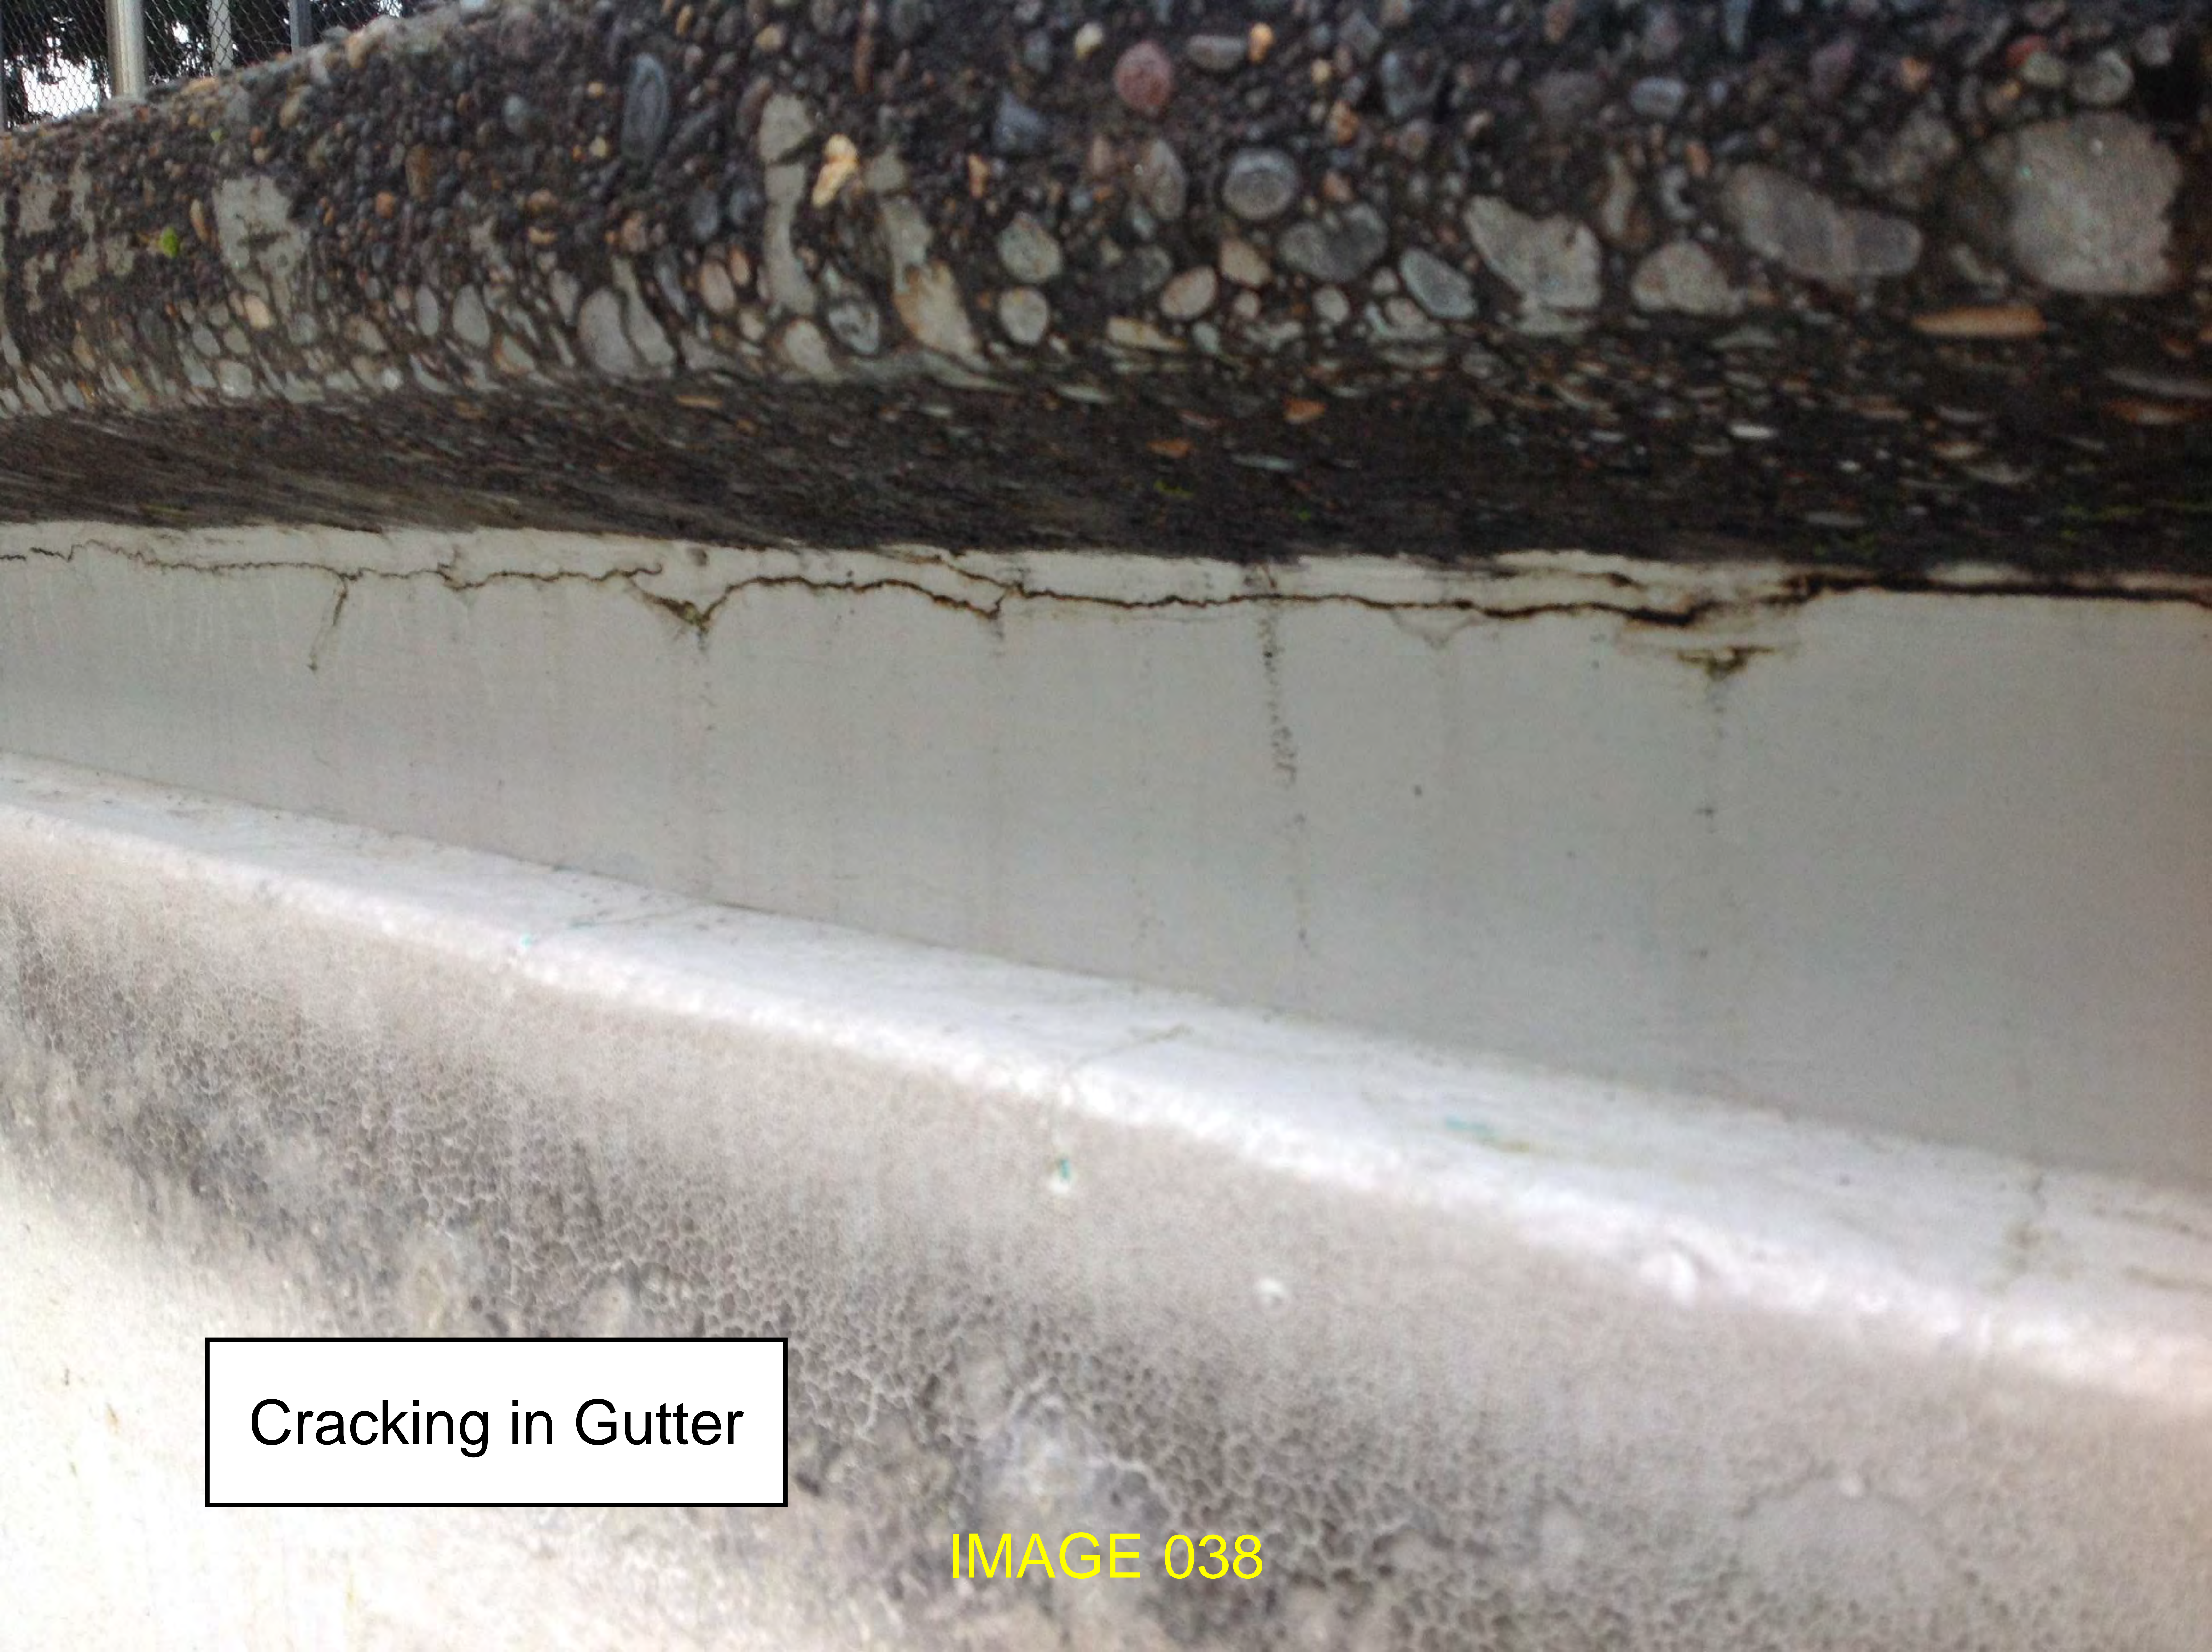
IMAGE 038

Cracking in Gutter

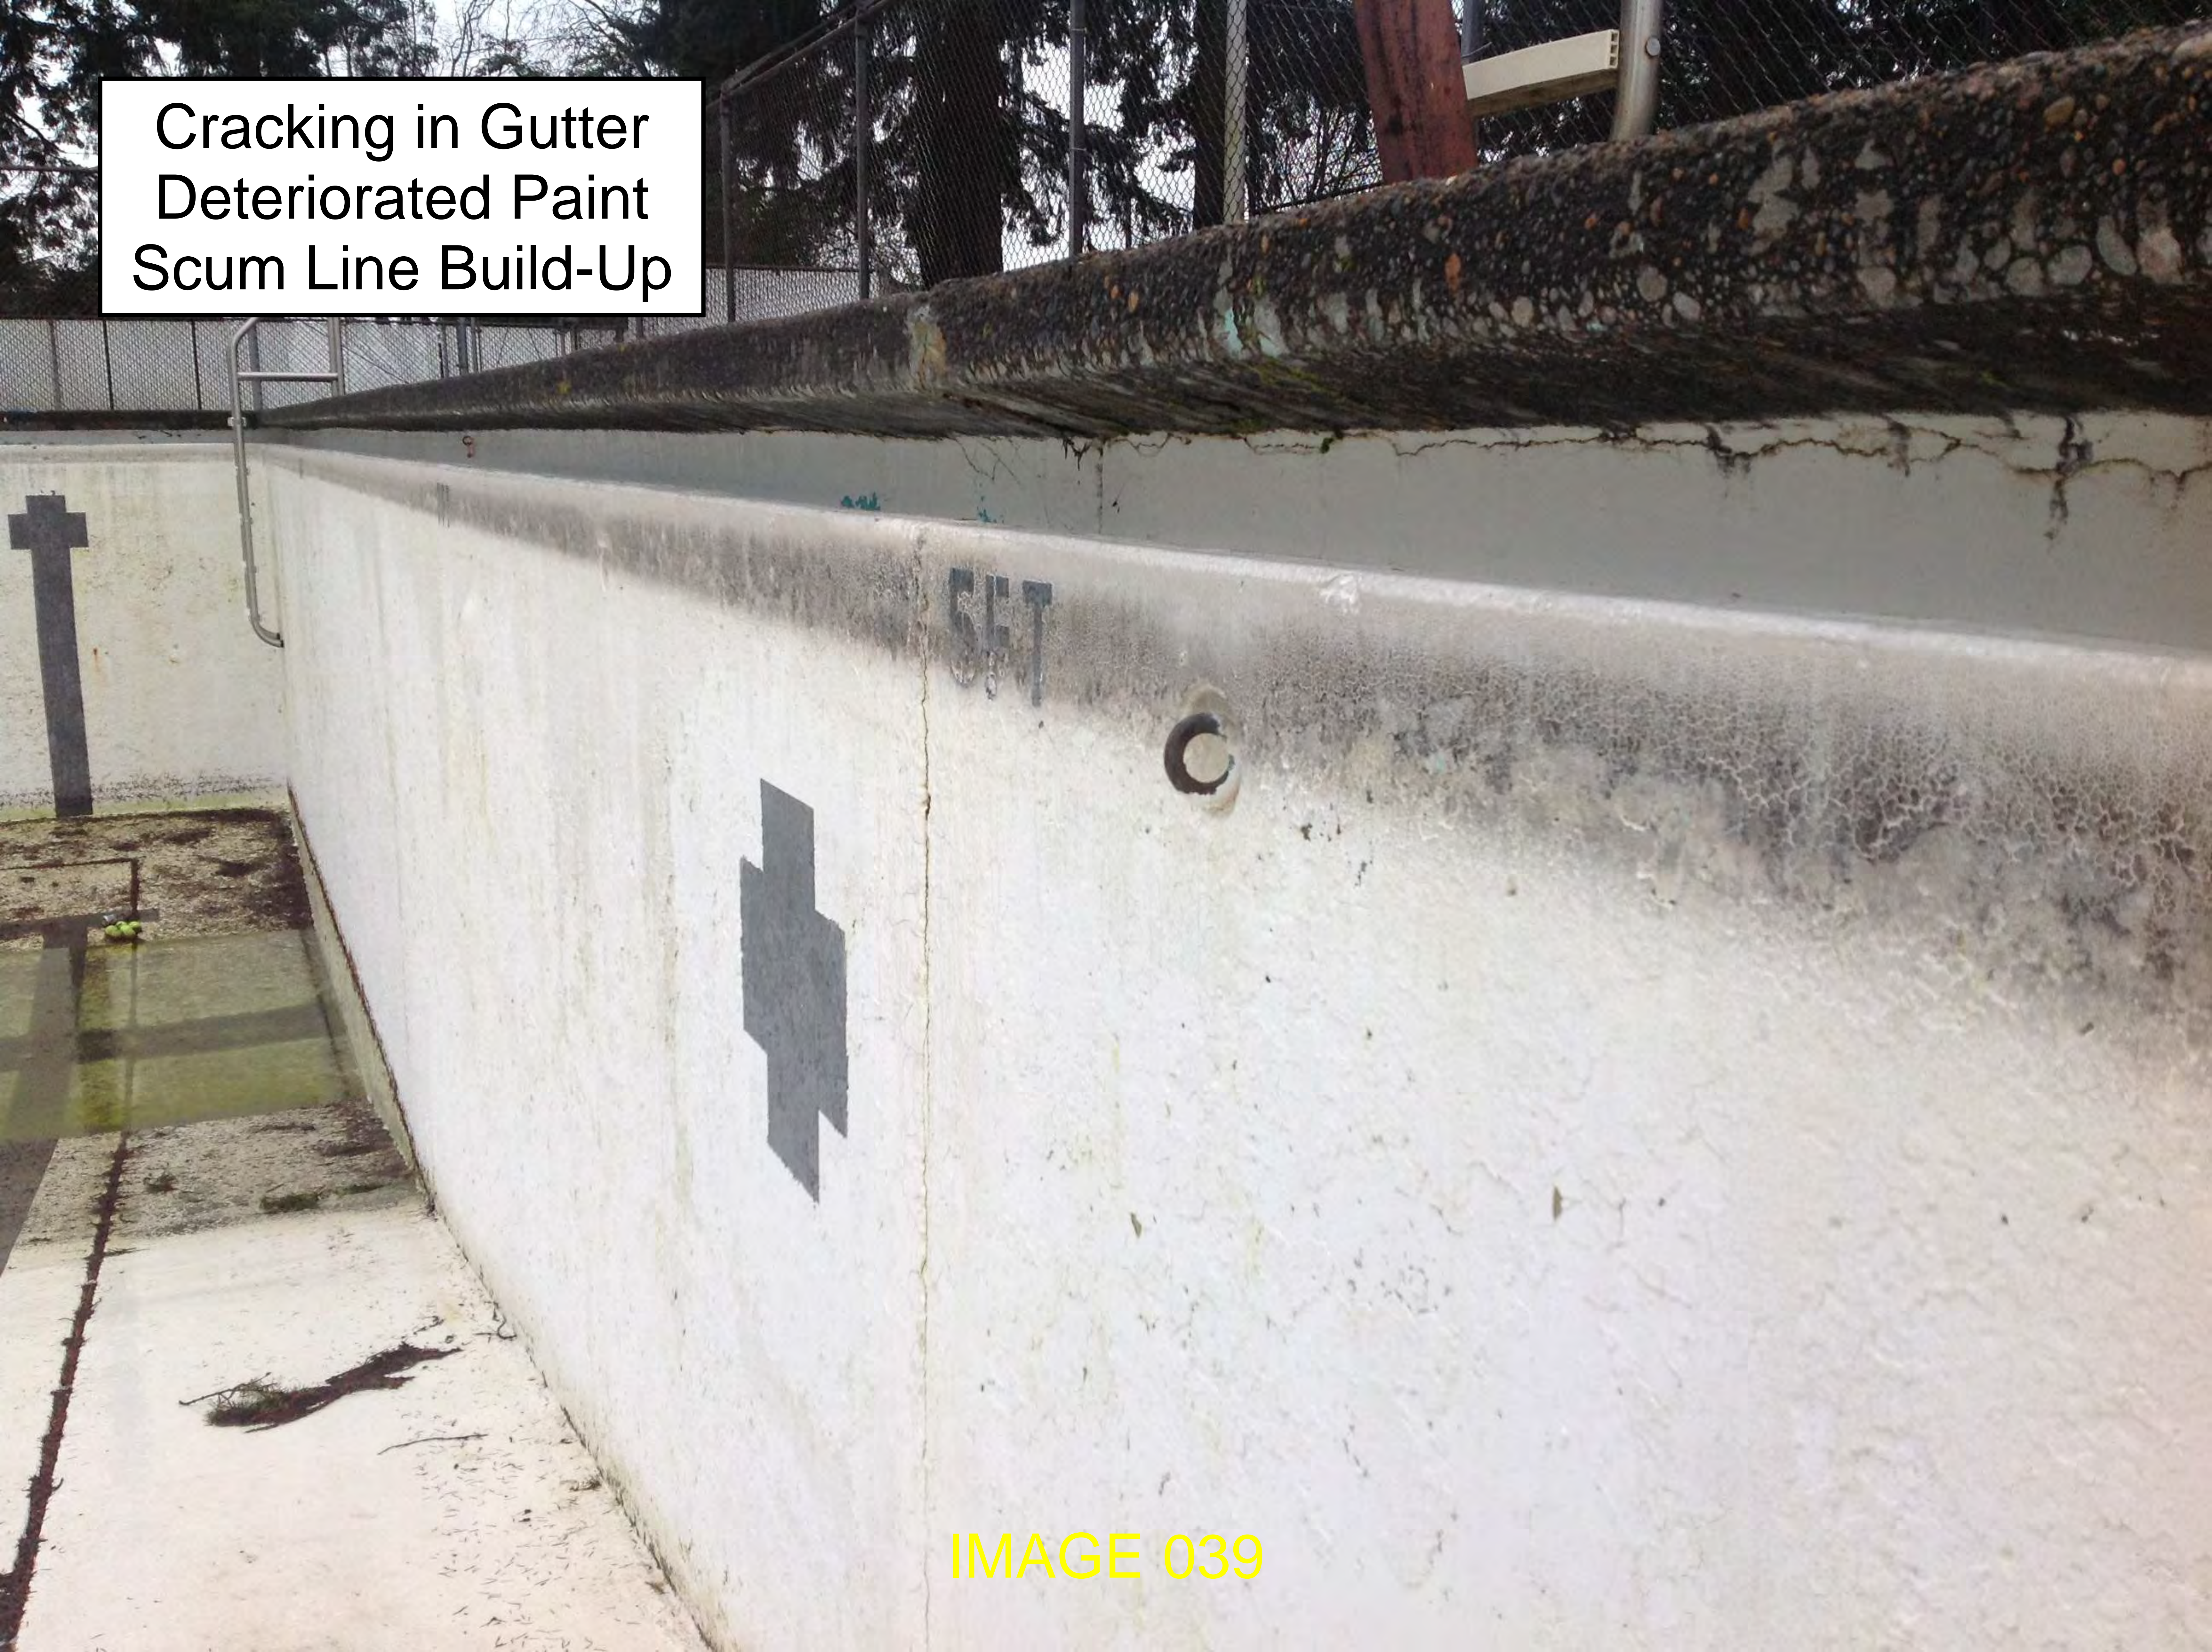
IMAGE 039

Cracking in Gutter
Deteriorated Paint
Scum Line Build-Up

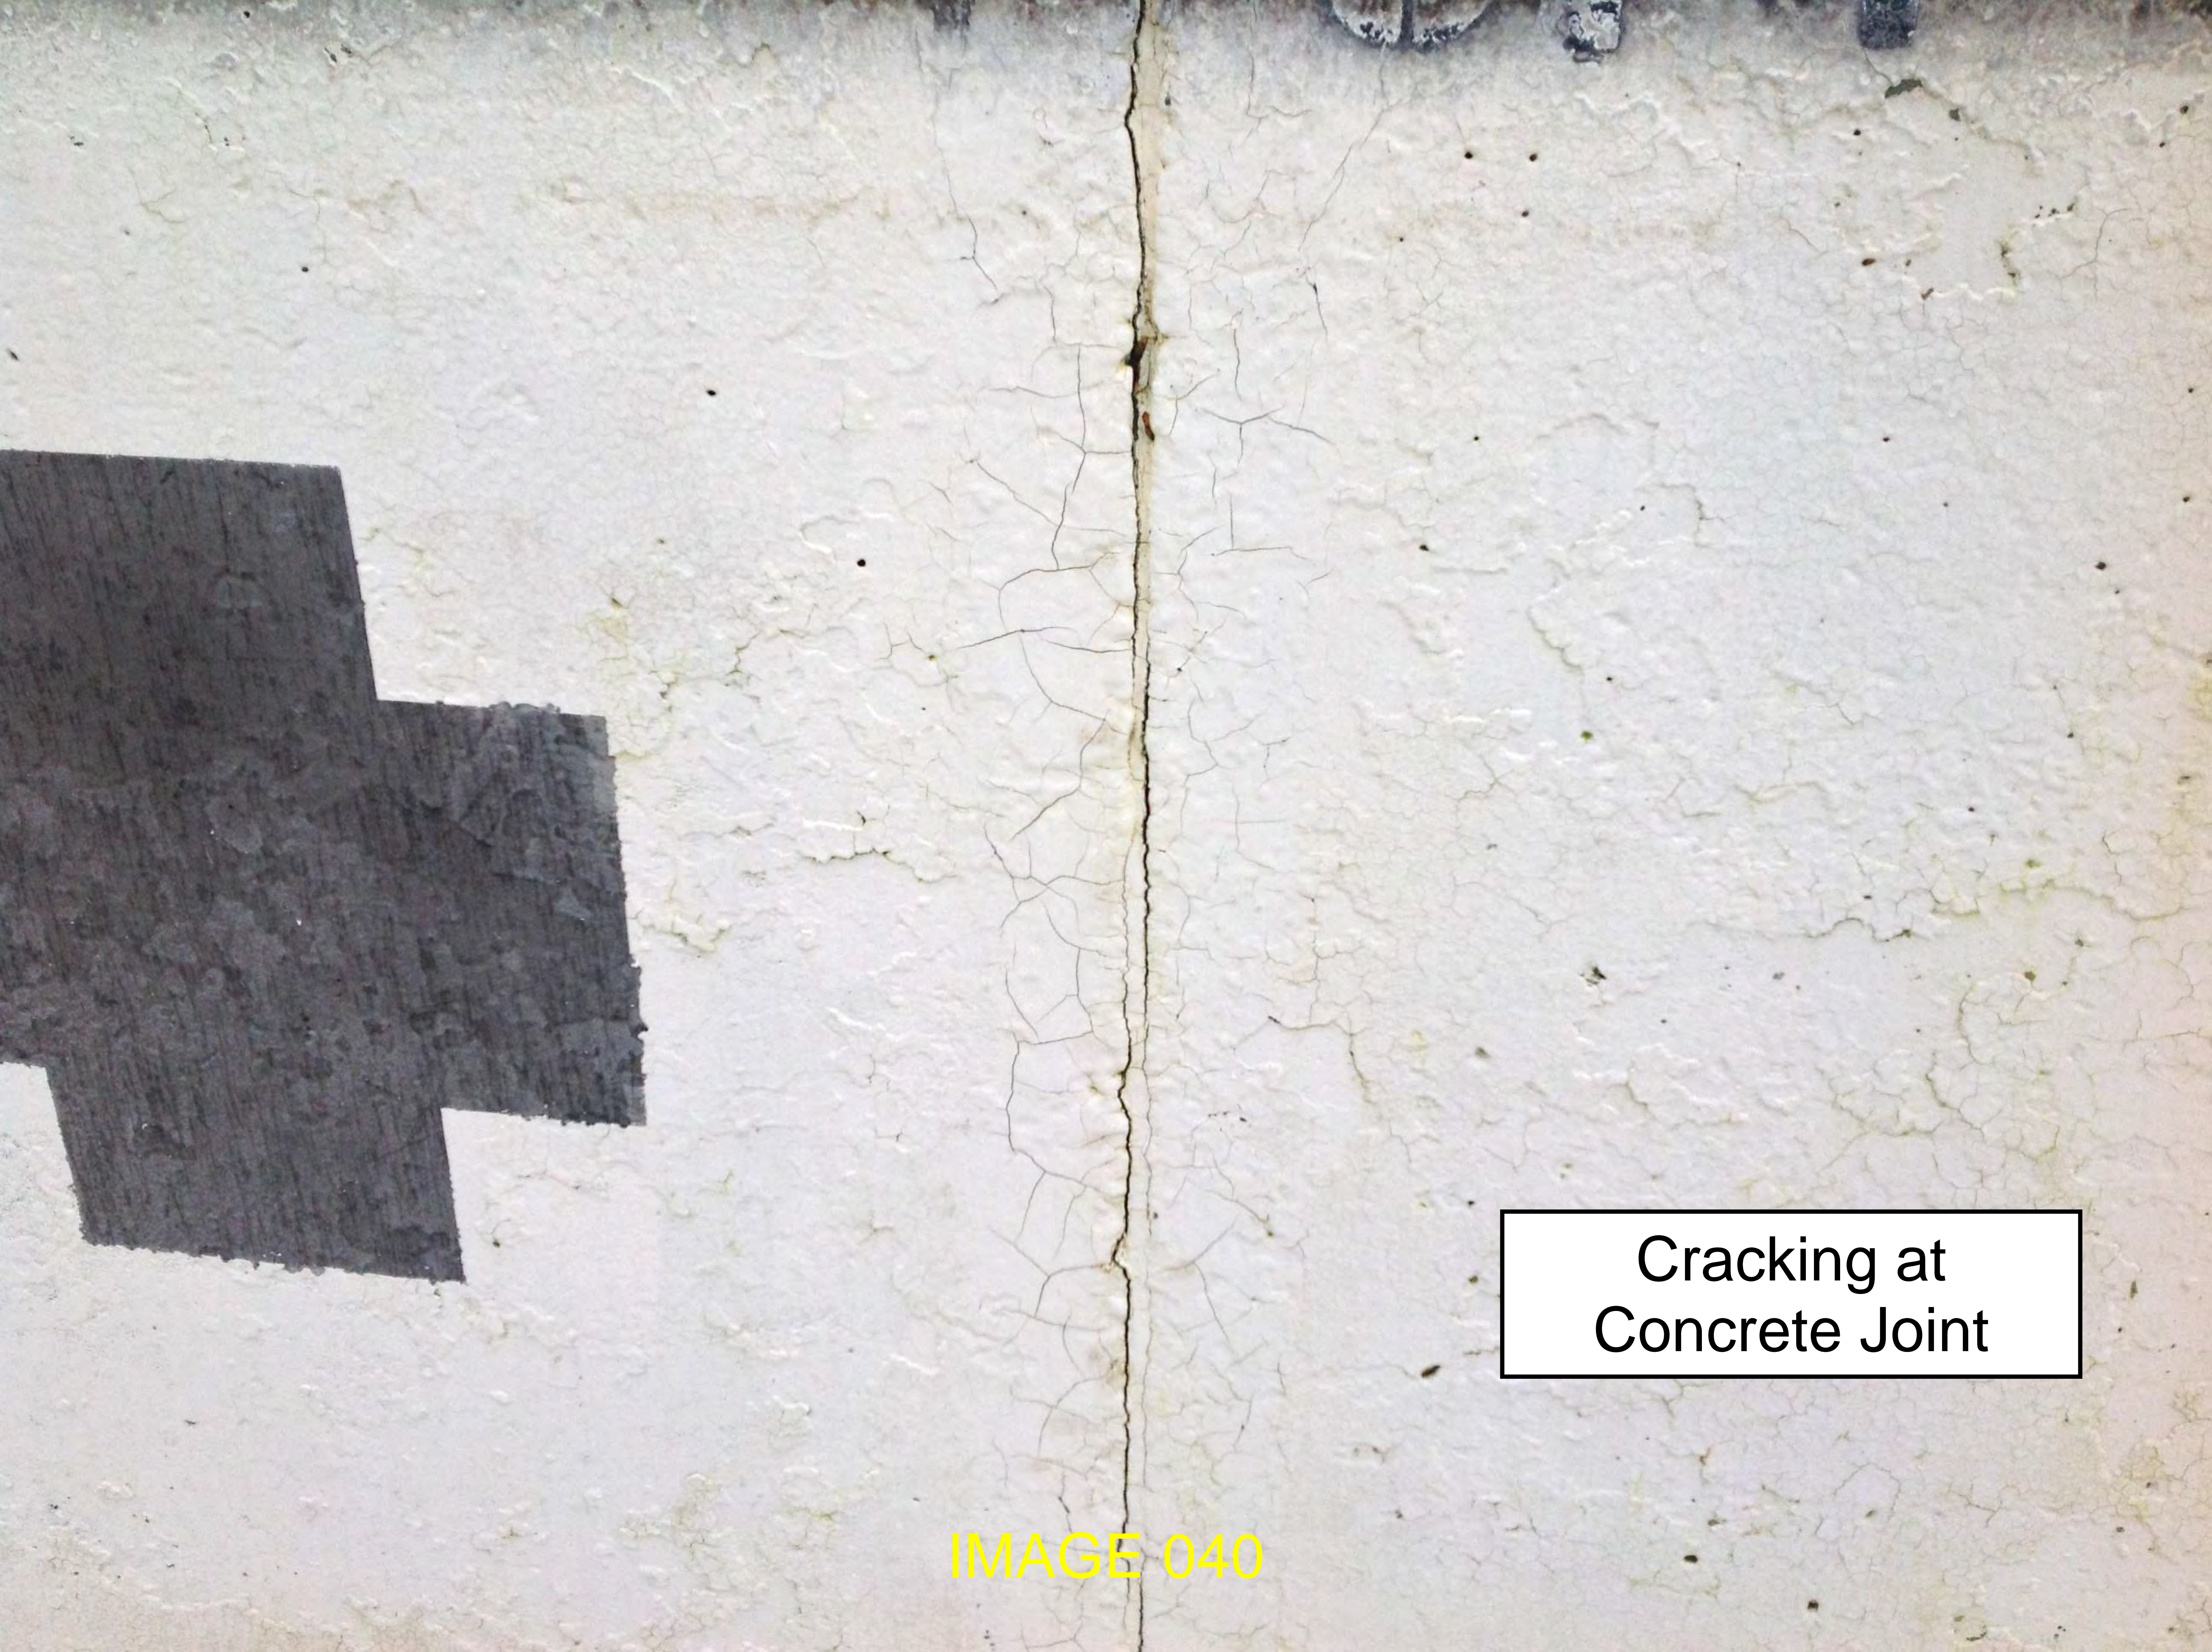
IMAGE 040

Cracking at
Concrete Joint

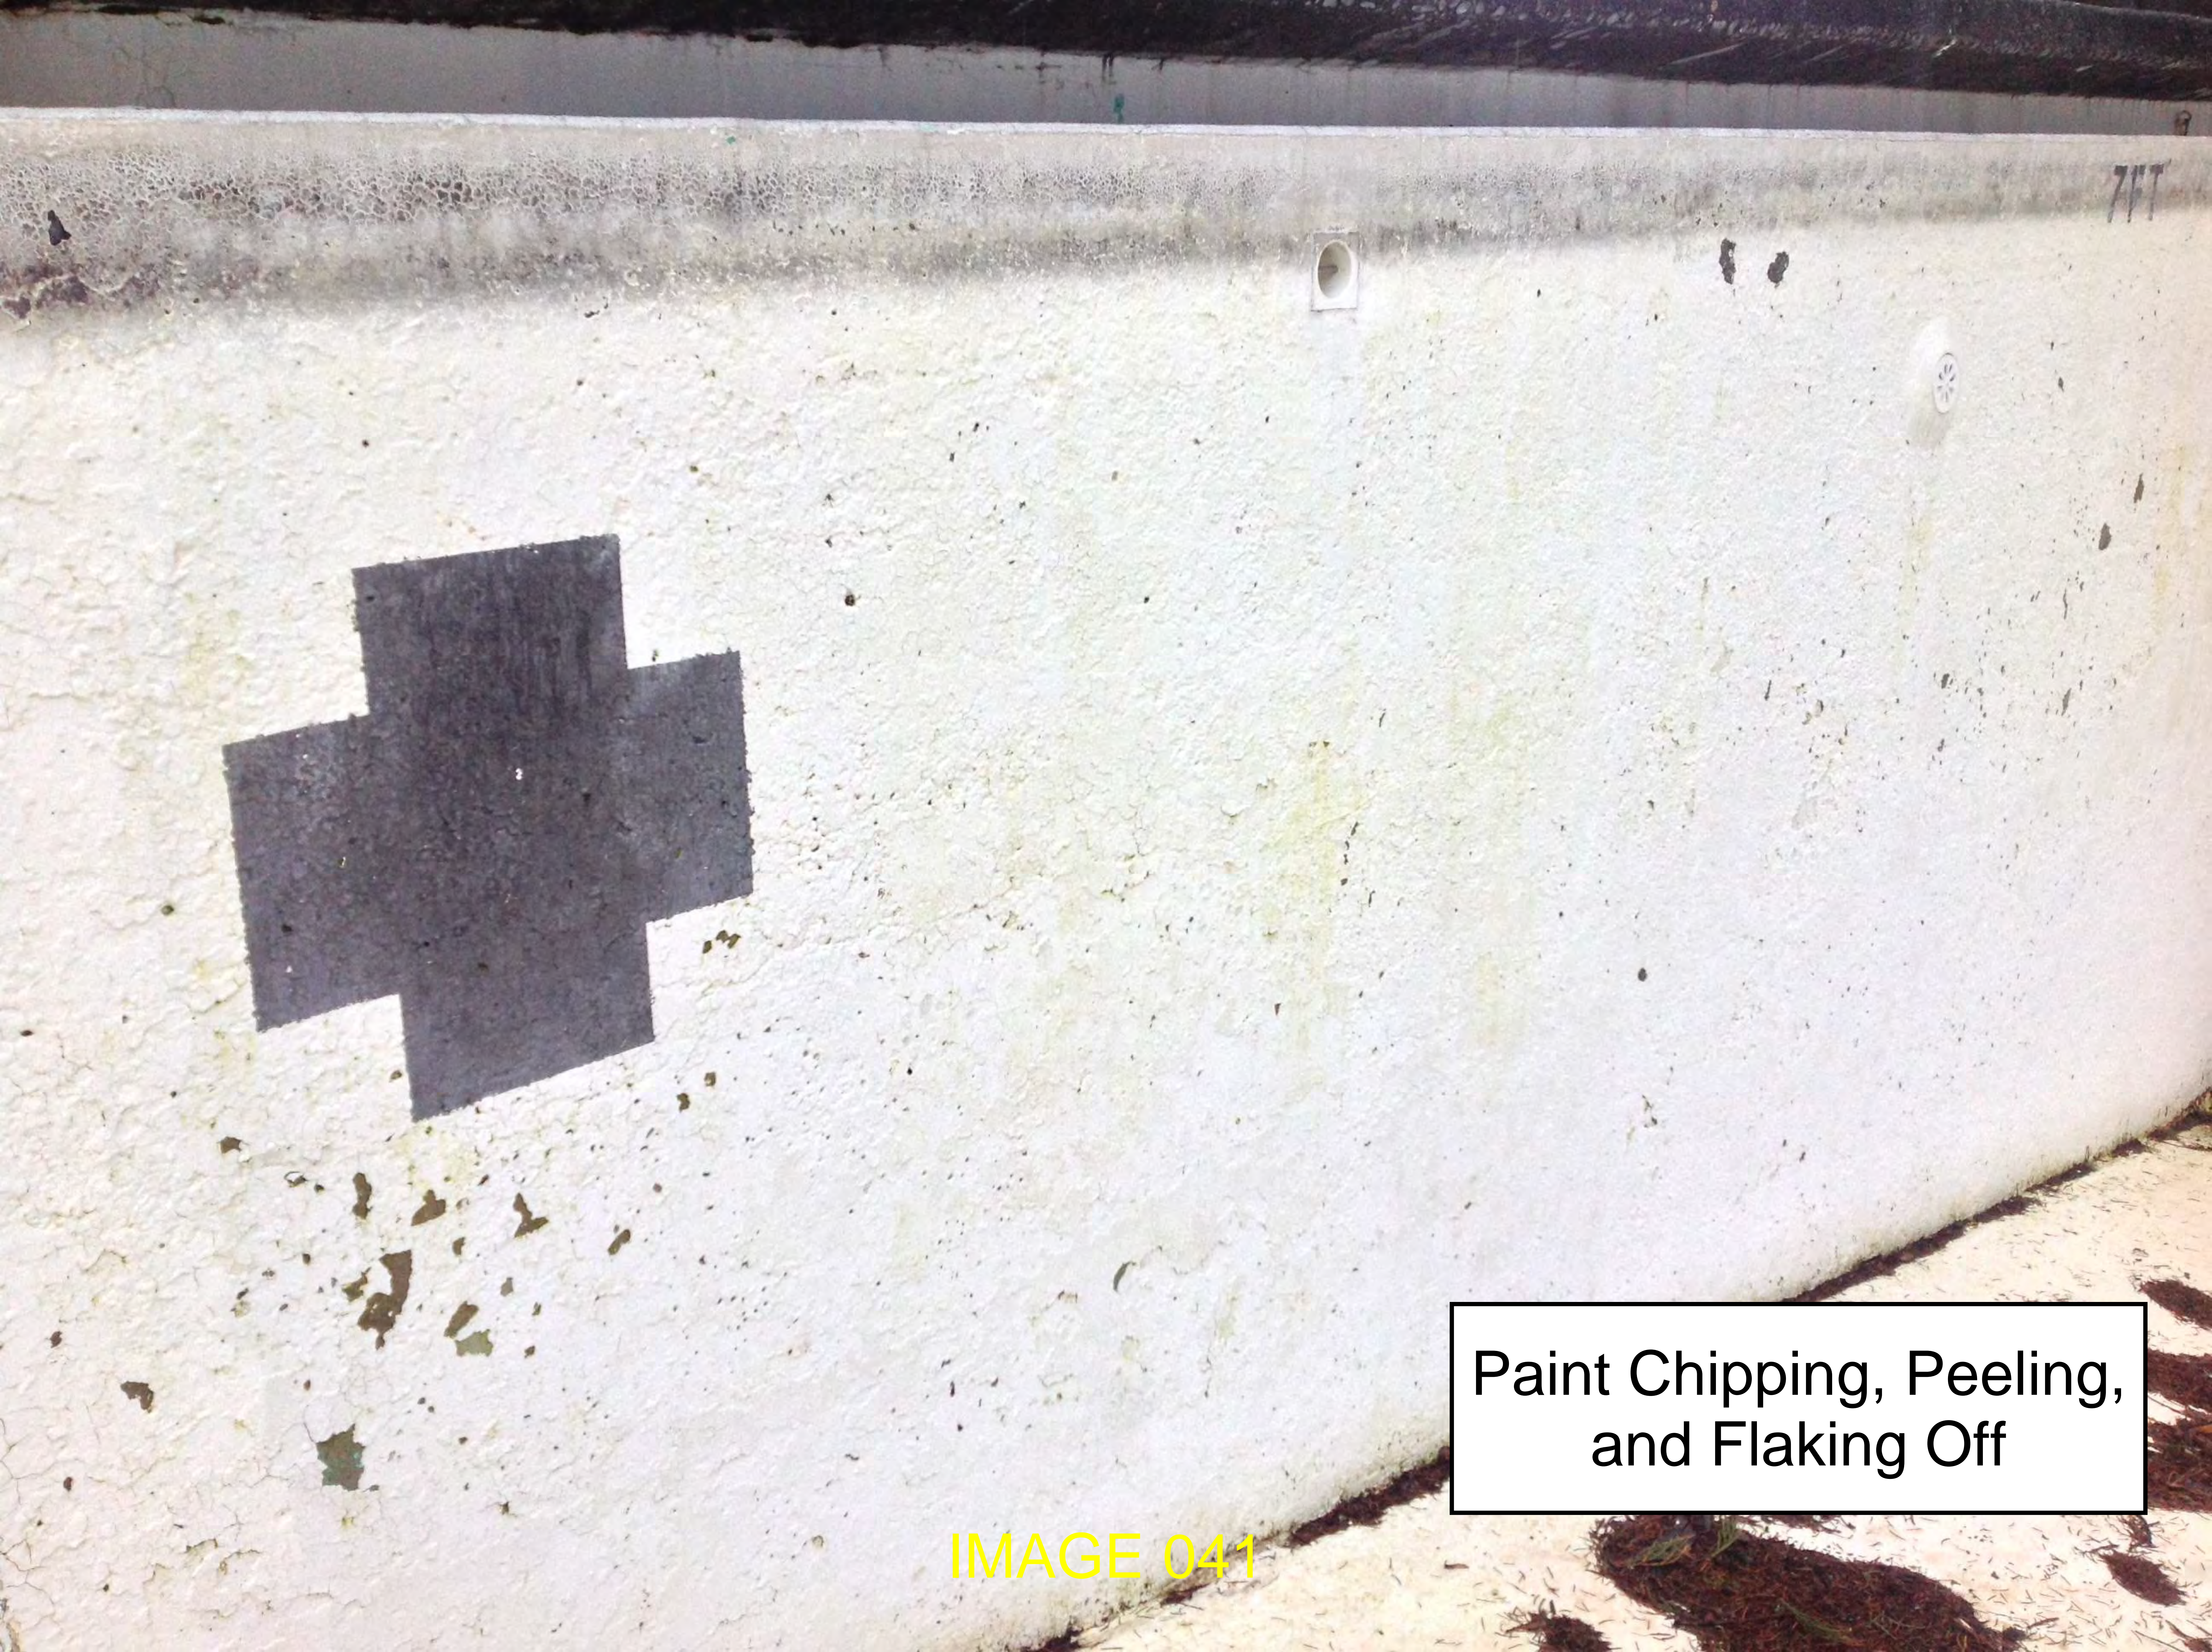
IMAGE 041

Paint Chipping, Peeling,
and Flaking Off

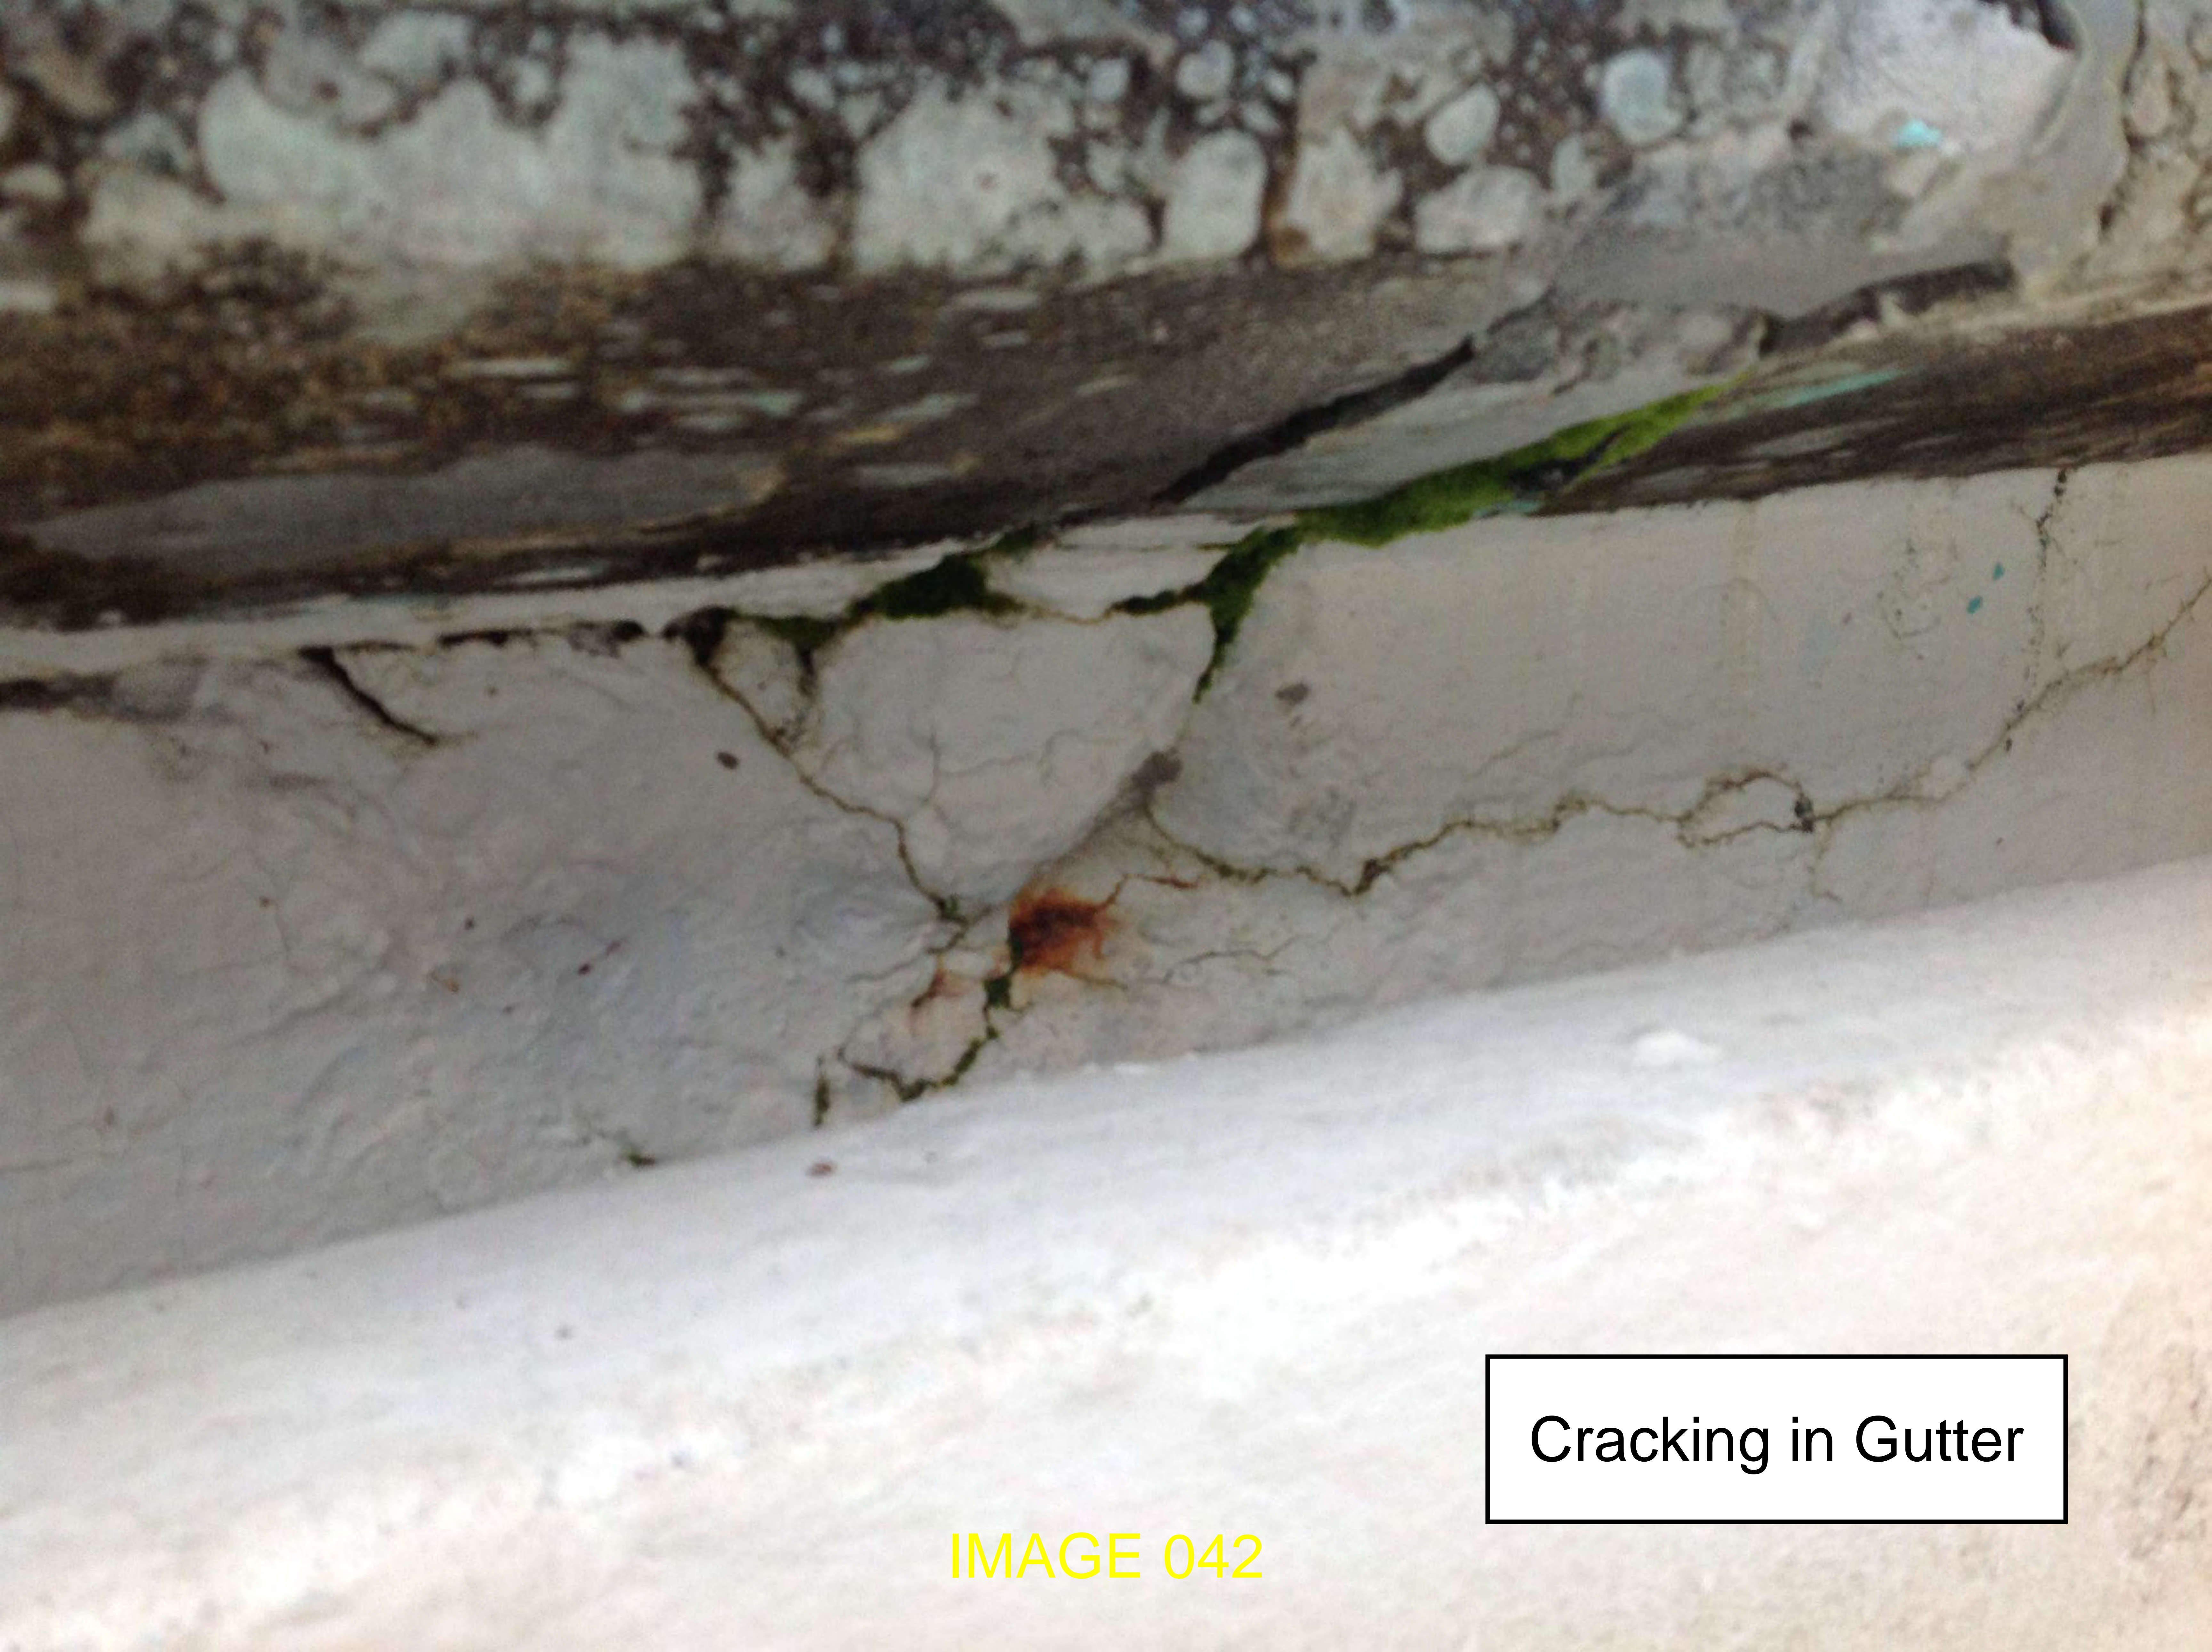
IMAGE 042

Cracking in Gutter
