CAMAS MUNICIPAL POOL
City of
Camas
WASHINGTON

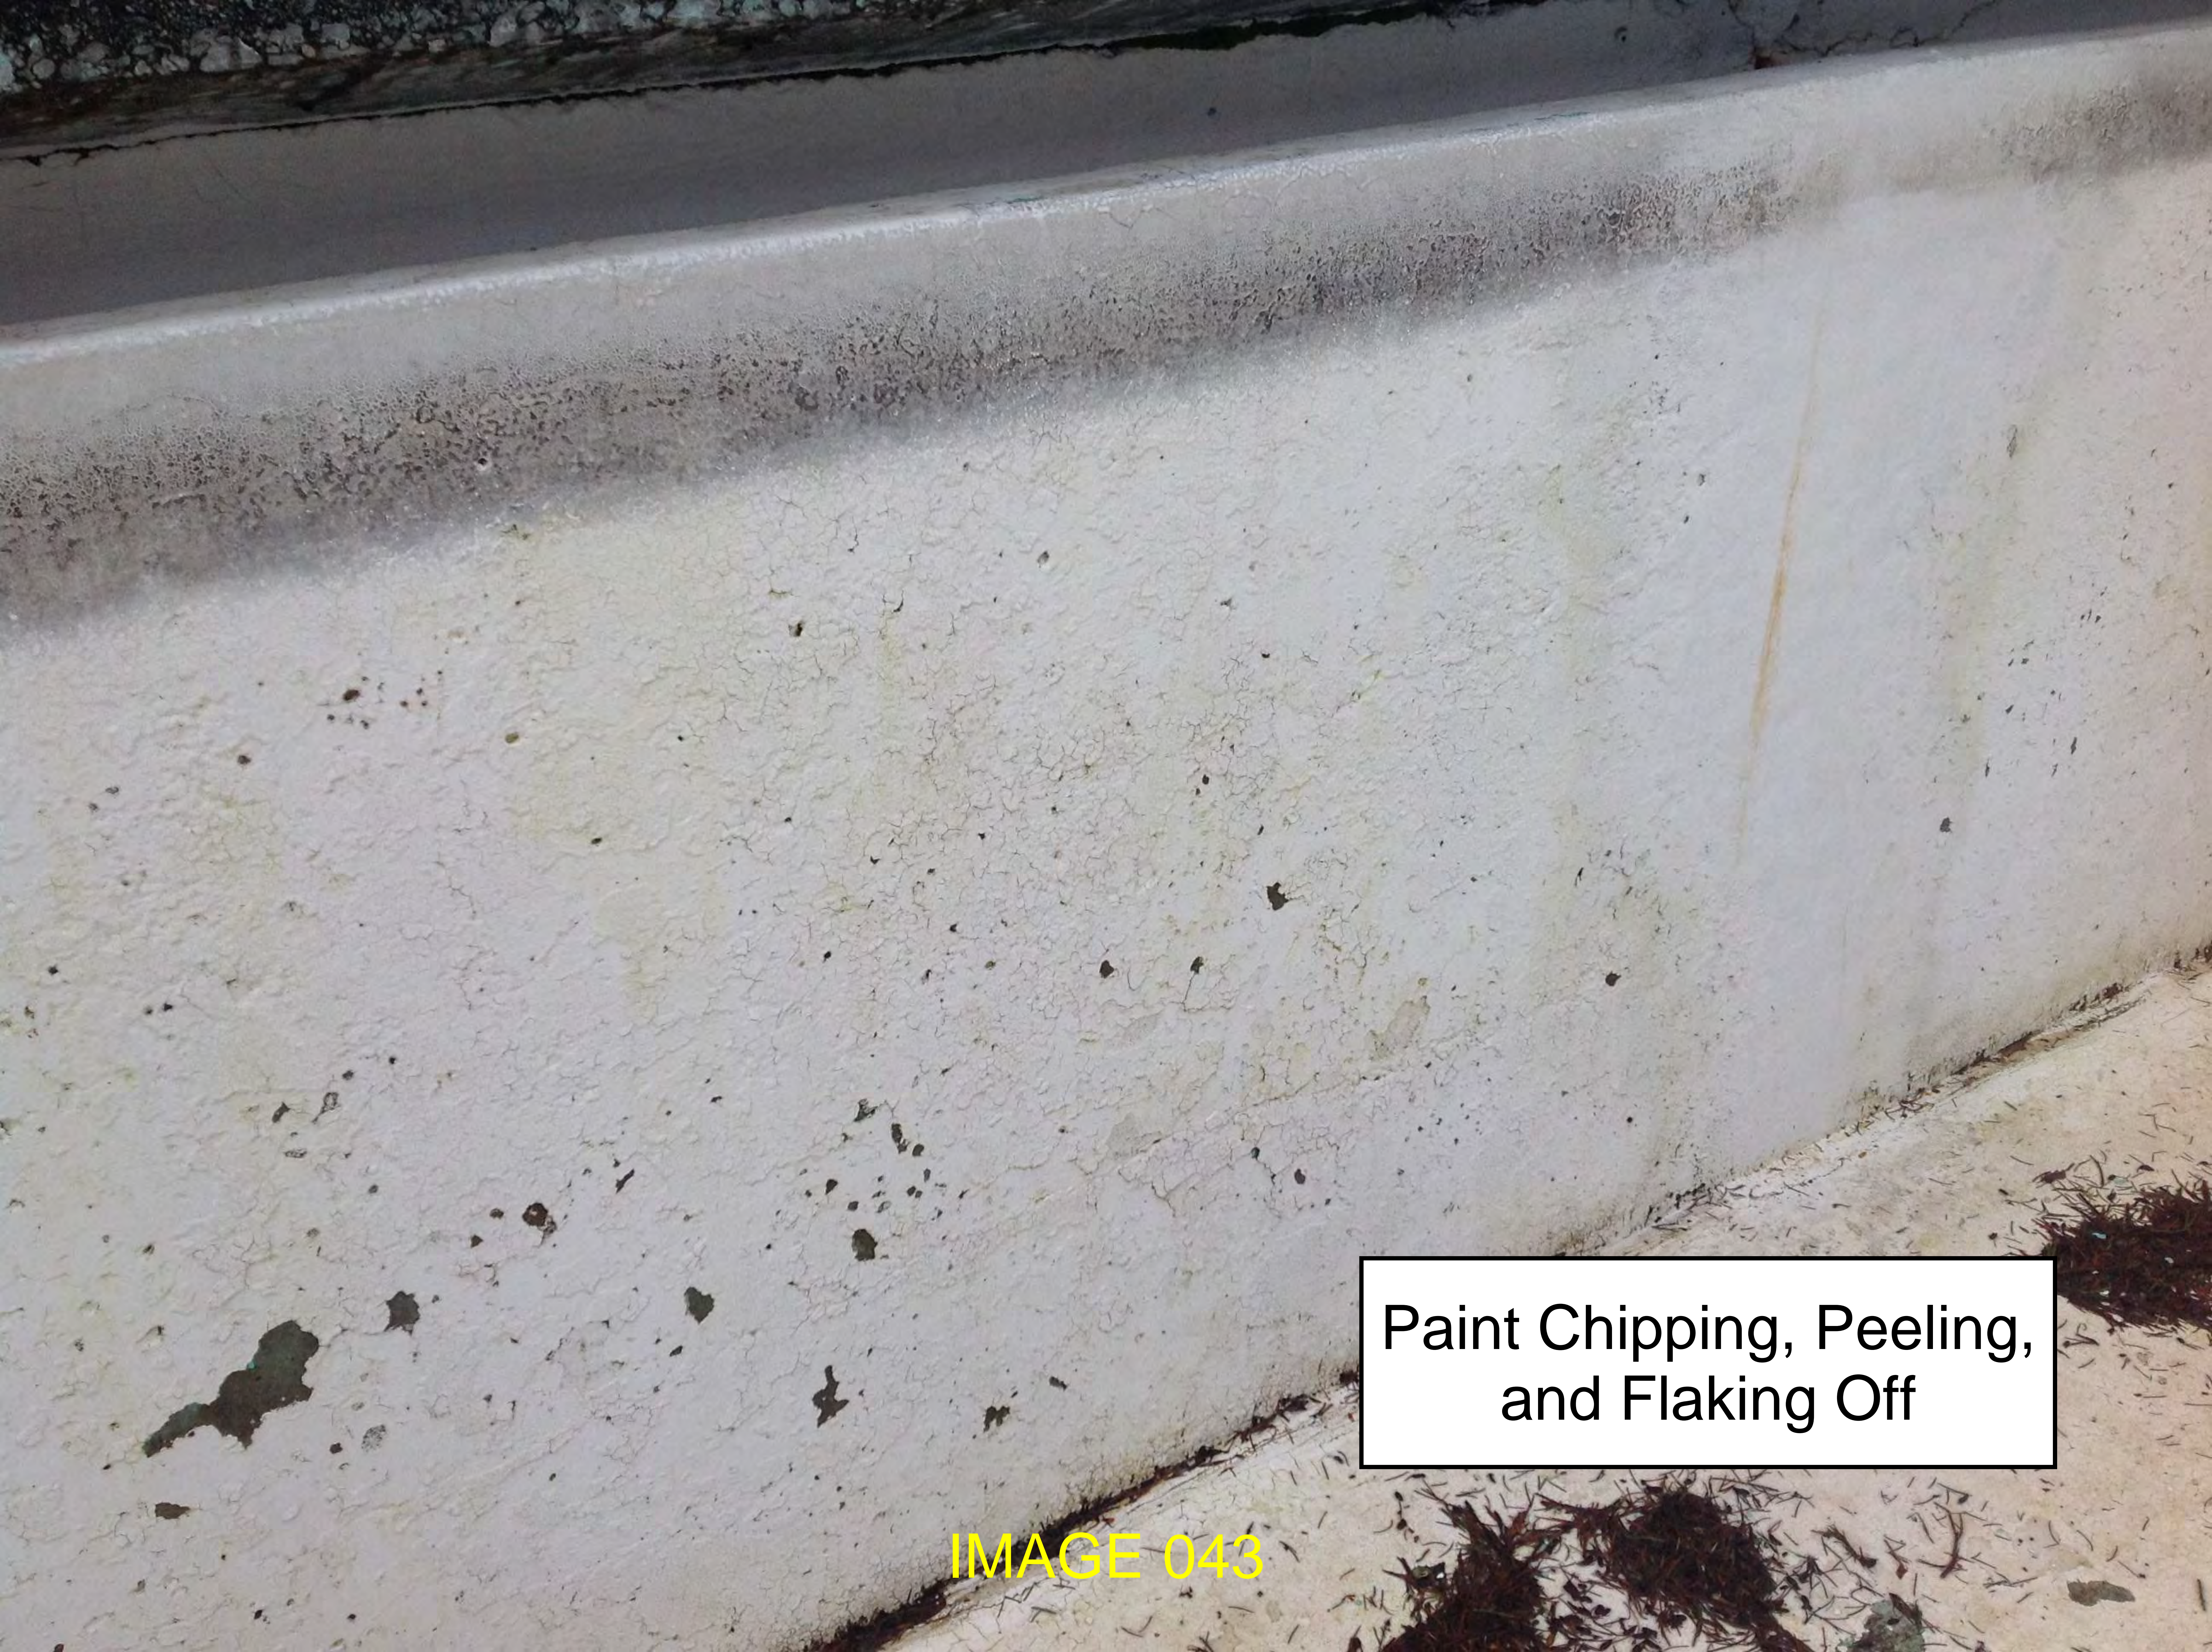
IMAGE 043

Paint Chipping, Peeling,
and Flaking Off
