Columbia River Homes Development

Arboricultural Assessment and Survey

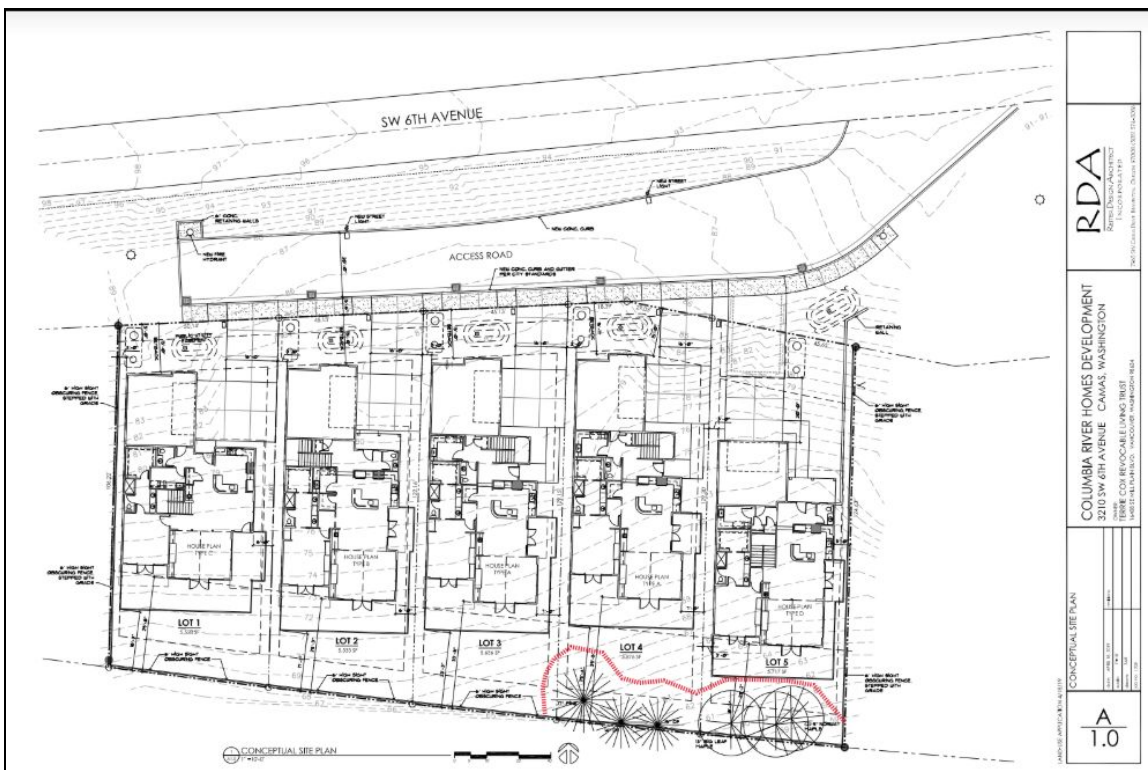
TREE PROTECTION PLAN

This letter summarizes the assessment and survey of 24 trees located on the development site to comply with Camas Municipal Code **18.13.045** where a tree survey is required. Trees numbered 104 to 109 in the tree survey have been proposed for retention by the developer and Tree Protection Zones have been prescribed to comply with Camas Municipal Code **18.03.050** - Environmental Definitions, which in this case provides 1ft radial offset protection area from the center of each tree's trunk for every wood inch or 1"DBH. Of the 24 trees subject to formal arboricultural assessment 14 can be considered "Significant" under the City's Environmental Definitions, where it is proposed to preserve and protect six trees in relation to the development.

From an arboricultural and urban forestry perspective, I support the proposed development in this instance and have found no individual tree or stand of trees that should preclude appropriate development provided a suitable mitigation and density strategy is implemented and enforced. For the trees subject to retention, it is recommended that standard tree protect measures are implemented including the erection of 6ft chain-link tree protection fencing as delineated by the site plan.
