**COLUMBIA RIVER HOMES DEVELOPMENT**  
3210 SW 6TH AVENUE CAMAS, WASHINGTON

EXISTING TREE SURVEY - INVENTORY

LAND-USE APPLICATION 5/21/19

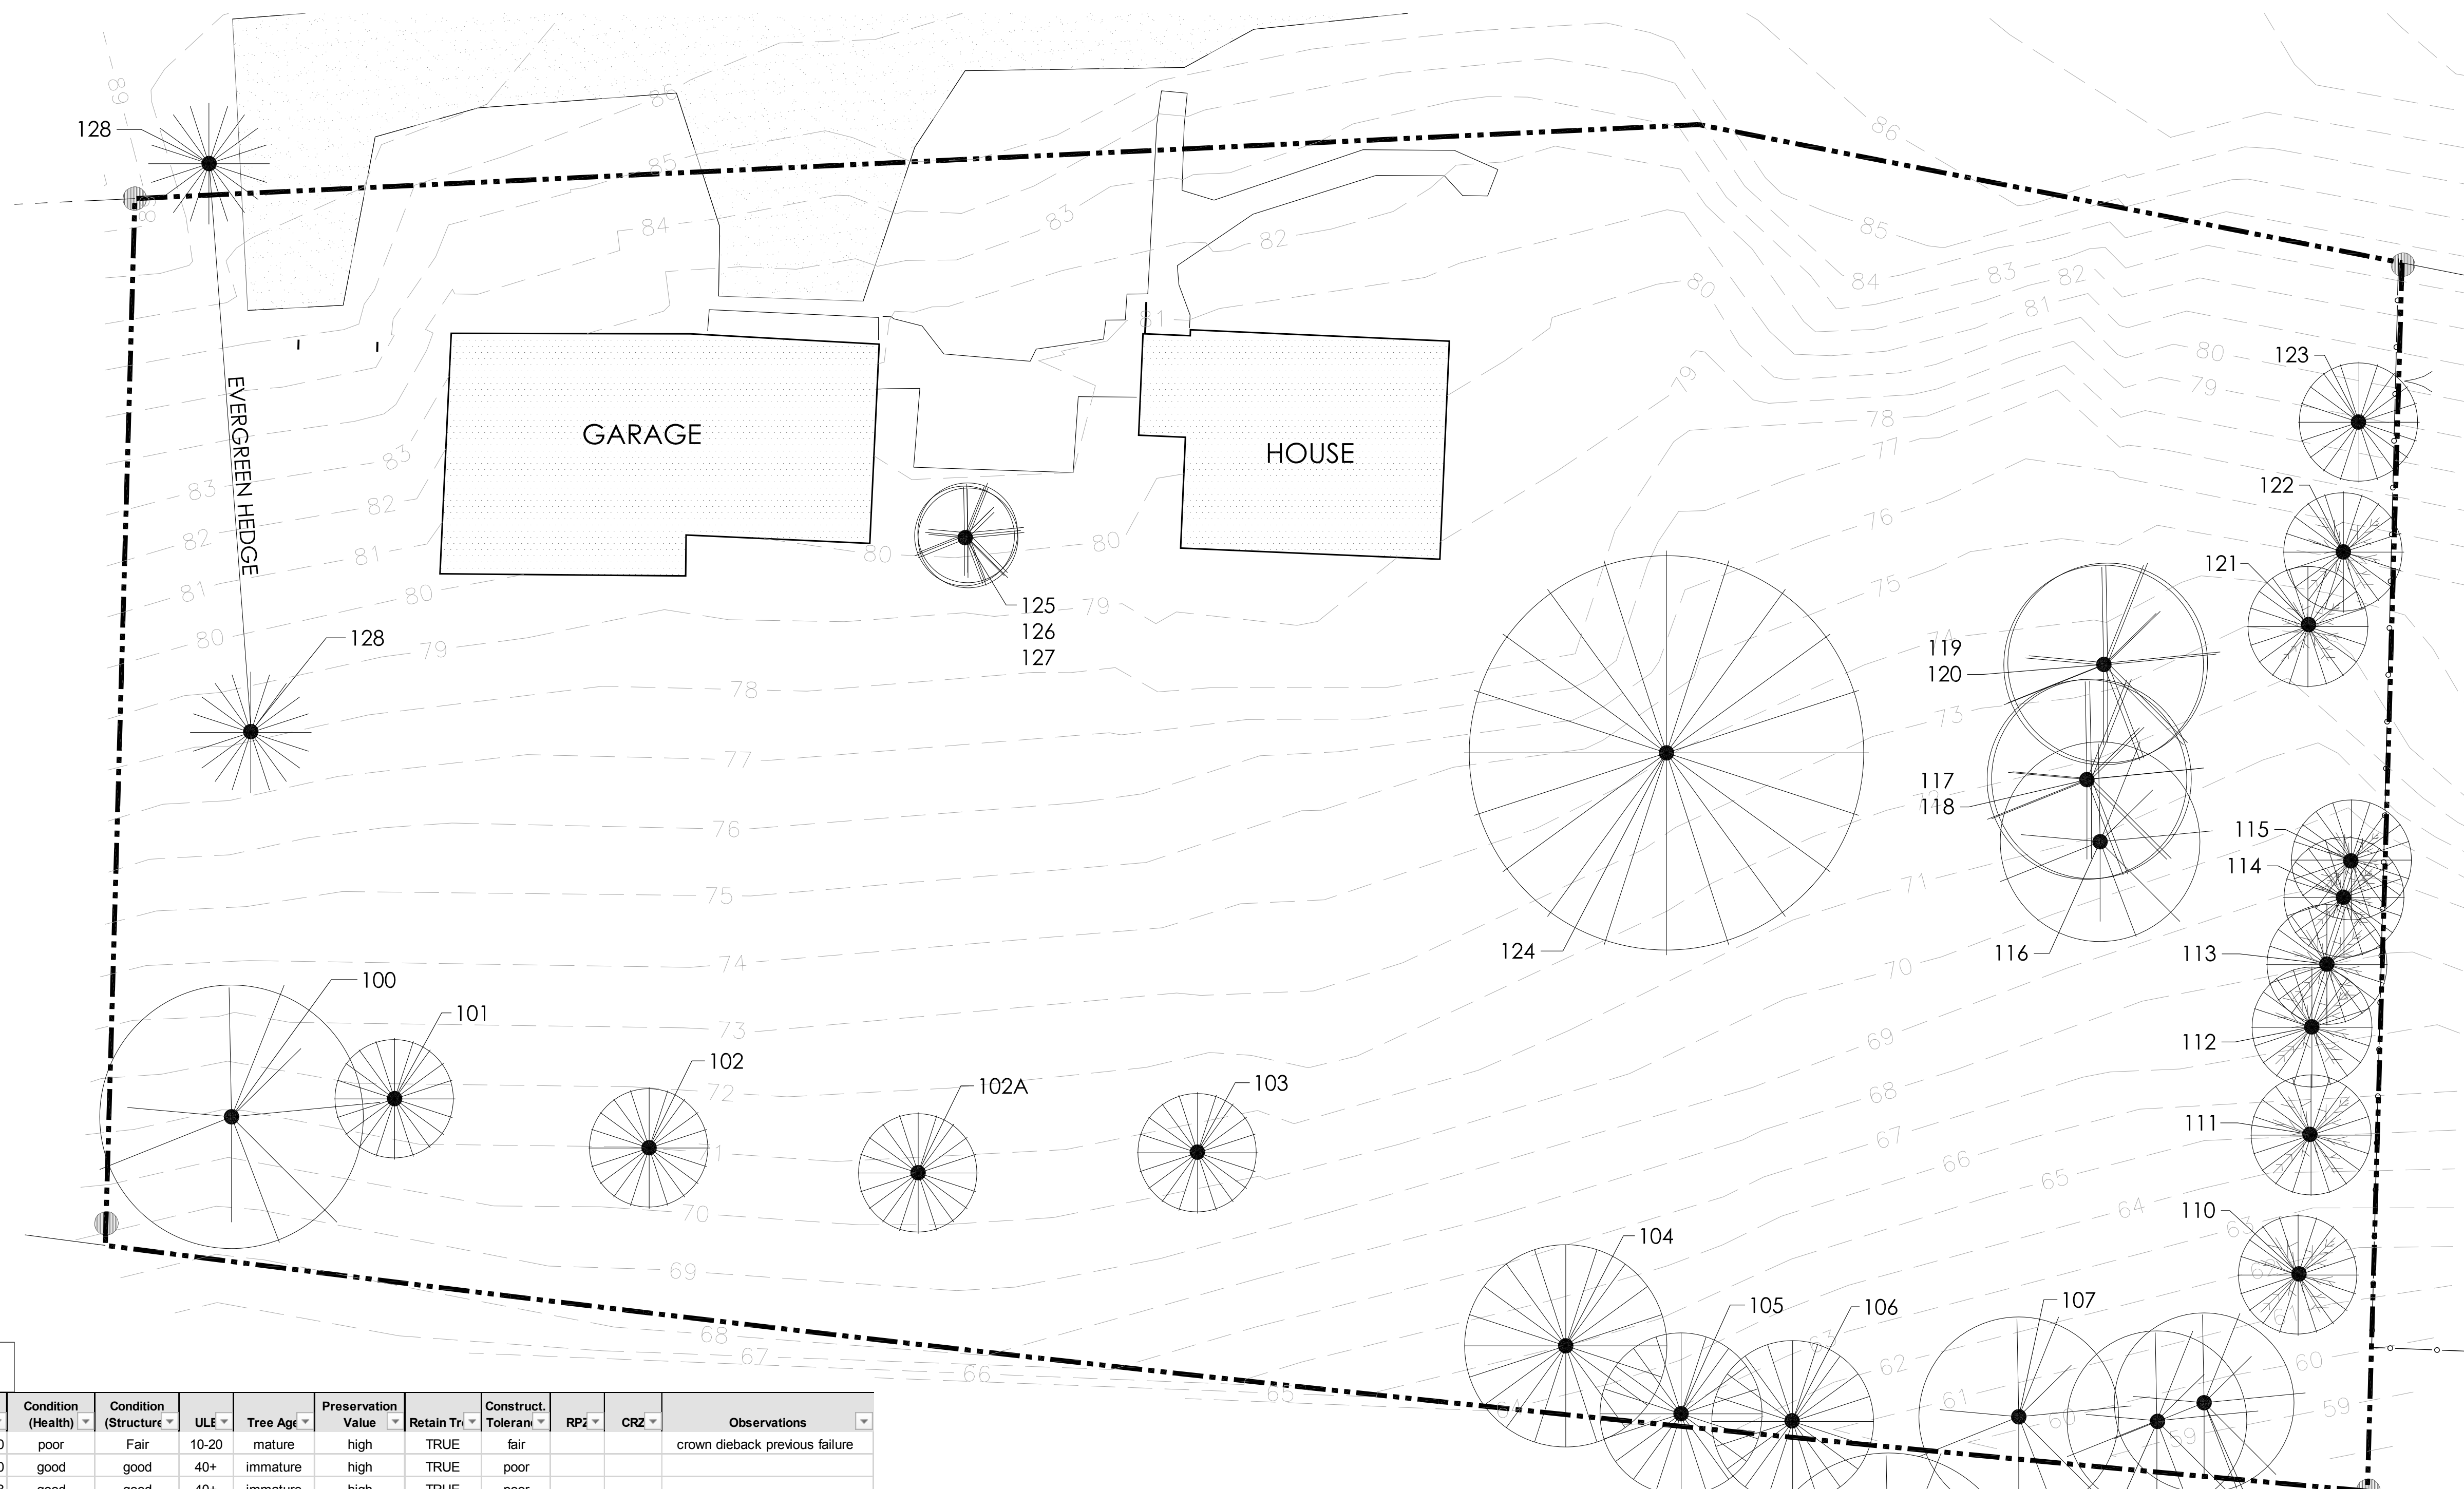
1 TREE SURVEY  
A1.2 1"=10'-0"

Tree #	Scientific Name	Common Name	DBH	Height	Spread	Condition (Health)	Condition (Structure)	ULÉ	Tree Age	Preservation Value	Retain Tr	Construct. Tolerant	RP2	CRZ	Observations
100	<i>Quercus garryana</i>	Oregon White Oak	28"	55	10	poor	Fair	10-20	mature	high	TRUE	fair			crown dieback previous failure
101	<i>Pseudotsuga menziesii</i>	Douglas fir	4"	20	10	good	good	40+	immature	high	TRUE	poor			
102	<i>Pseudotsuga menziesii</i>	Douglas fir	4"	23	8	good	good	40+	immature	high	TRUE	poor			
102a	<i>Pseudotsuga menziesii</i>	Douglas fir	3"	17	8	good	good	40+	immature	high	TRUE	poor			Additional tree
103	<i>Pseudotsuga menziesii</i>	Douglas fir	4"	17		good	good	40+	immature	high	TRUE	poor			
104	<i>Pinus nigra</i>	Black Pine	17"	45	25	good	good	20+	mature	moderate	TRUE	poor	17'	8.5'	Visual evidence of pest infest - pitch moth mid trunk
105	<i>Pseudotsuga menziesii</i>	Douglas fir	14"	45	15	good	good	40+	mature	high	TRUE	fair	14'	7'

106	<i>Pseudotsuga menziesii</i>	Douglas fir	15"	40	15	good	good	40+	mature	high	TRUE	fair	15'	7.5'	
106a	<i>Quercus garryana</i>	Oregon White Oak	21"	50	18	good	good	40+	mature	high	TRUE	fair	21'	10'	Additional tree on neighboring property - identified per code
107	<i>Acer macrophyllum</i>	Big-leaf Maple	13"	20	20	good	poor	20-30	mature	moderate	TRUE	poor	13'	6.5'	
108	<i>Acer platanoides</i>	Norway Maple	9"	22	12	good	poor	10-20	mature	low	TRUE	poor	9'	4.5'	
109	<i>Acer platanoides</i>	Norway Maple	9"	22	12	good	poor	10-20	mature	low	TRUE	poor	9'	4.5'	
110	<i>Pseudotsuga menziesii</i>	Douglas fir	10"	20	8	good	good	40+	immature	high	TRUE	fair			
111	<i>Cupressus x leylandii</i>	Leyland Cypress	9"	25	10	good	good	20-30	mature	very low	TRUE	poor			
112	<i>Cupressus x leylandii</i>	Leyland Cypress	9"	25	10	good	good	20-30	mature	very low	TRUE	poor			
113	<i>Cupressus x leylandii</i>	Leyland Cypress	8"	25	10	good	good	20-30	mature	very low	TRUE	poor

114	<i>Cupressus x leylandii</i>	Leyland Cypress	8"	25	10	good	good	20-30	mature	very low	TRUE	poor			
115	<i>Pseudotsuga menziesii</i>	Douglas fir	4"	20	5	good	good	40+	immature	High	TRUE	fair			
116	<i>Acer macrophyllum</i>	Maple - stump regrowth	20"	15	15	poor	poor	0	over mature	none	FALSE	very poor	0	0	stump regrowth mod dbh Visual evidence of fungal pathogen - 50% crown dieback - basal decay and wood degradation.
117	<i>Acer macrophyllum</i>	Big-leaf Maple (one 24" tree)	12"	55	30	very poor	very poor	0	over mature	none	FALSE	very poor	0	0	Visual evidence of fungal pathogen - 50% crown dieback - basal decay and wood degradation.
118	<i>Acer macrophyllum</i>	Big-leaf Maple (one 24" tree)	12"	55	30	very poor	very poor	0	over mature	none	FALSE	very poor	0	0	Visual evidence of fungal pathogen - 50% crown dieback - basal decay and wood degradation.
119	<i>Acer macrophyllum</i>	Big-leaf Maple (one 14" tree)	8"	25	15	good	poor	5-10	Immature	very low	FALSE	very poor	0	0	Regrowth or self sown

120	<i>Acer macrophyllum</i>	Big-leaf Maple (one 14" tree)	6"	25	15	good	poor	5-10	Immature	very low	FALSE	very poor	0	0	Regrowth or self sown
121	<i>Pseudotsuga menziesii</i>	Douglas fir	3"	8	4	good	good	40+	Immature	high	TRUE	moderate			species updated from wr cedar
122	<i>Pseudotsuga menziesii</i>	Douglas fir	5"	12	5	good	good	40+	Immature	high	TRUE	moderate			
123	<i>Pseudotsuga menziesii</i>	Douglas fir	5"	10	3	good	good	40+	Immature	high	TRUE	moderate			
124	<i>Thuja plicata</i>	Western Red Cedar	28"	65	25	fair	poor	20-30	Immature	high	TRUE	moderate			bifurcated crown - poor structure codom stem - topped previously
125	<i>Acer palmatum var.</i>	Japanese Maple (one 19" tree)	7"	15	21	good	fair	10-20	Mature	low	TRUE	low			codom stem - topped previously
126	<i>Acer palmatum var.</i>	Japanese Maple (one 19" tree)	6"	15	21	good	fair	10-20	Mature	low	TRUE	low			codom stem - topped previously
127	<i>Acer palmatum var.</i>	Japanese Maple (one 19" tree)	6"	15	21	good	fair	10-20	Mature	low	TRUE	low			codom stem - topped previously

128	<i>Cupressus x leylandii</i>	hedge	<6"	hedge	hedge	fair	fair	40+		low	TRUE	low			mixed evergreen hedge
