Lacamas North Shore Trail Project

City Project P1005

SEPA Environmental Checklist

February 23, 2018

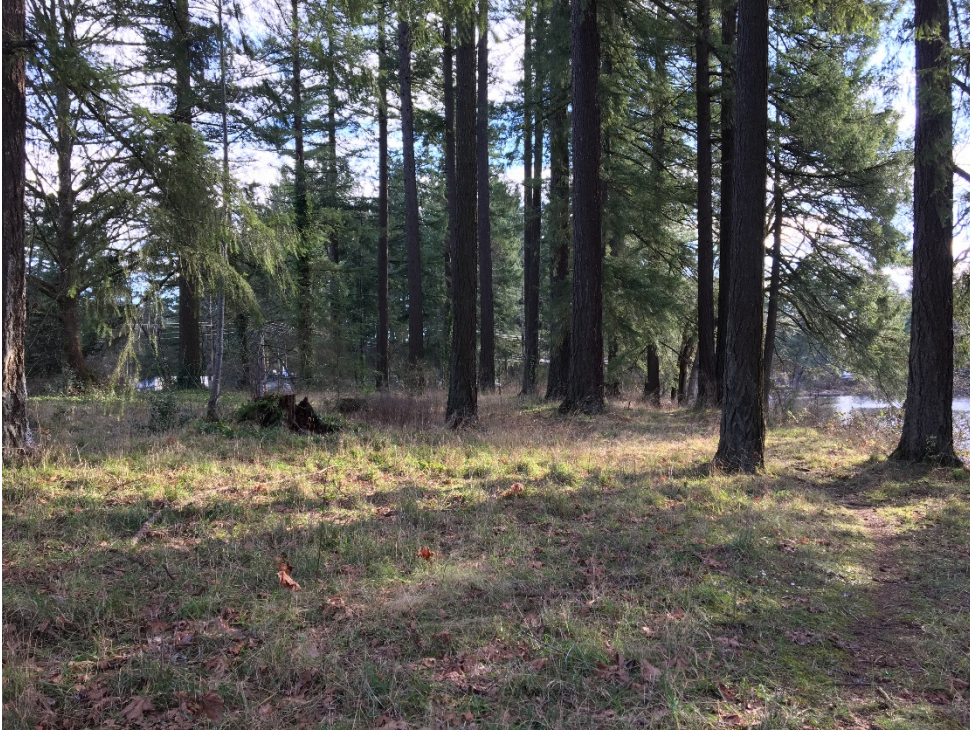
Photograph 1: View looking south toward NE Everett Street. Proposed Main trail to pass through Douglas fir stand, avoiding trees. Photograph taken January 14, 2018.

Lacamas Lake, a man-made lake, lies to the west of the proposed trail alignment, which traverses an eroded stream terrace. The route is typically through Douglas fir stands (Photograph 1, Appendix B), except for a 450-foot long segment that passes through mowed lawns (Photograph 2). The southerly portion, from NE Everett Street northward for approximately 1,200 feet, traverses City property abutting single family residences. The trails would pass through parcels 178099-000, 124244-000, and 177896-000 within: the NW $\frac{1}{4}$ of Section 2 of Township 1 North, Range 3 East; SW $\frac{1}{4}$ of Section 35 of Township 2 North, Range 3 East; and SE $\frac{1}{4}$ of Section 34 of Township 2 North, Range 3 East. These parcels are owned by the City and zoned Open Space (Camas 2017).

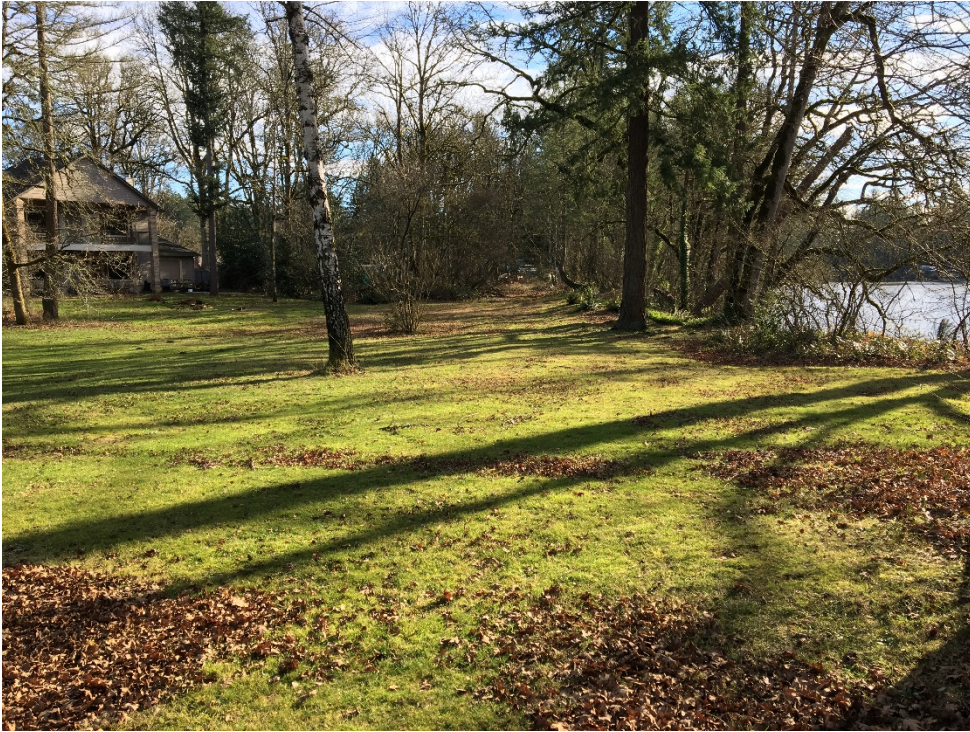
Photograph 2: View looking south where the proposed Main trail crosses mowed lawns. Abandoned access road visible through shrubs beyond lawn, in center mid-ground of photograph. Photograph taken January 14, 2018.

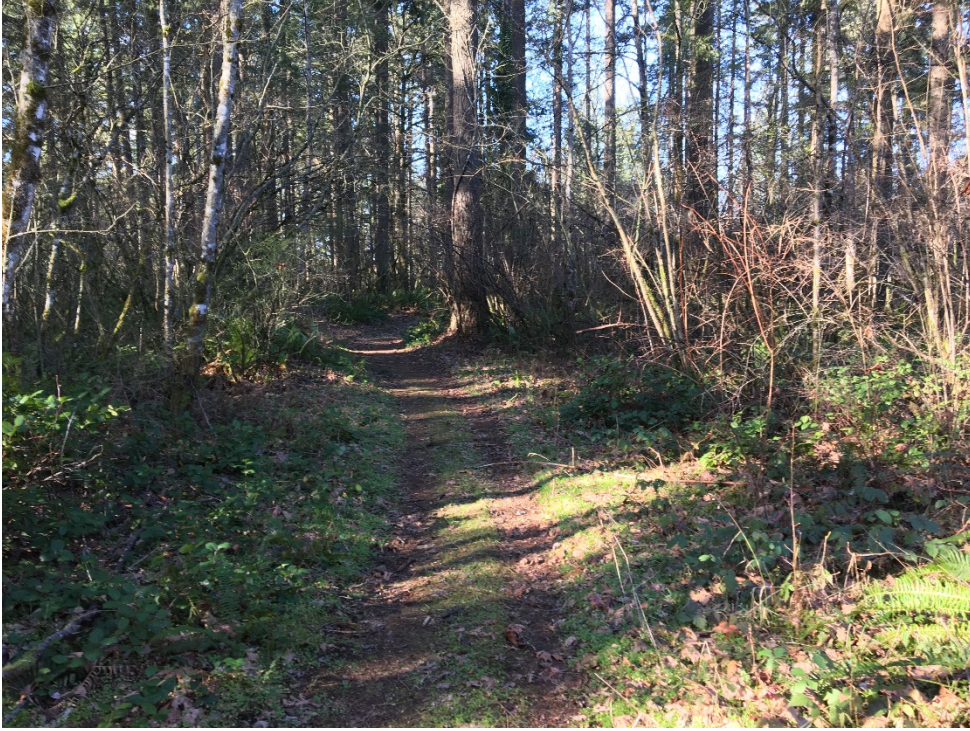
Photograph 3: View looking north along abandoned access road to be used for proposed Main trail. Photograph taken January 14, 2018.

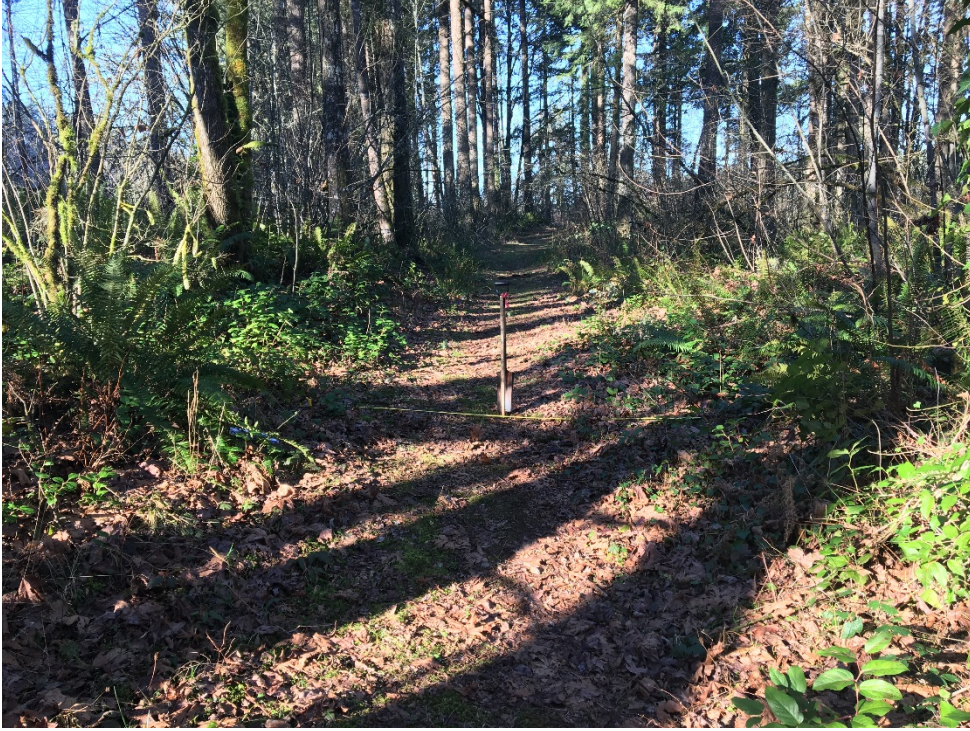
Photograph 4: View looking north along abandoned access road at the northern junction of proposed Main and Loop trails. Photograph taken January 14, 2018.

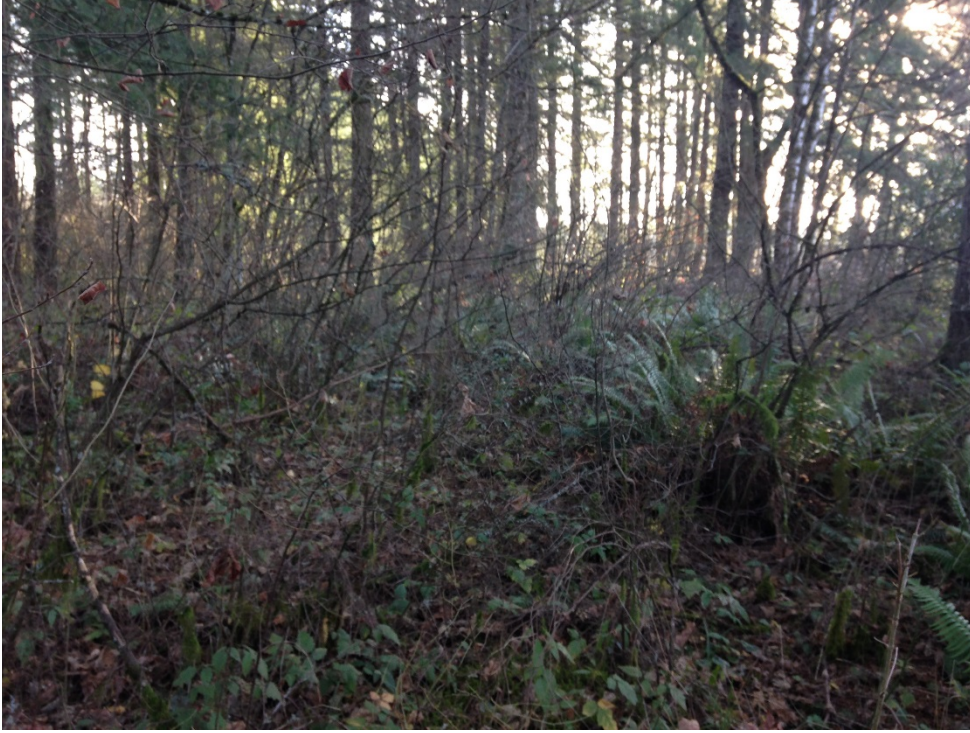
Photograph 5: View of typical vegetation along proposed route of Loop trail. Photograph taken December 14, 2017.

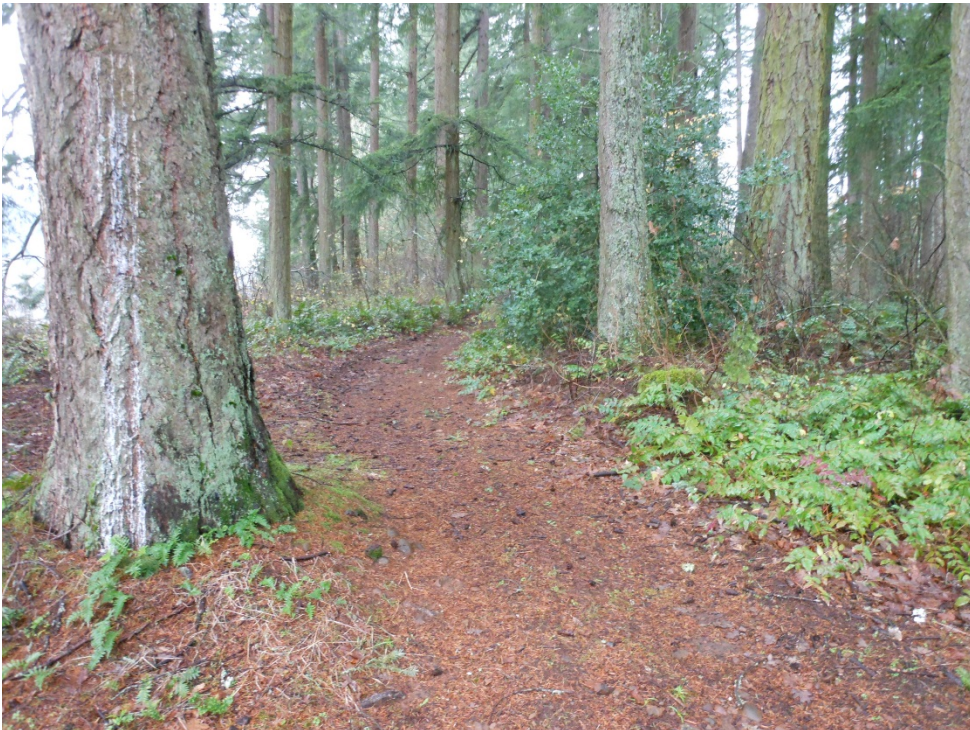
Photograph 6: View along current packed dirt trail to be used for Spur trail. Photograph taken December 1, 2016.

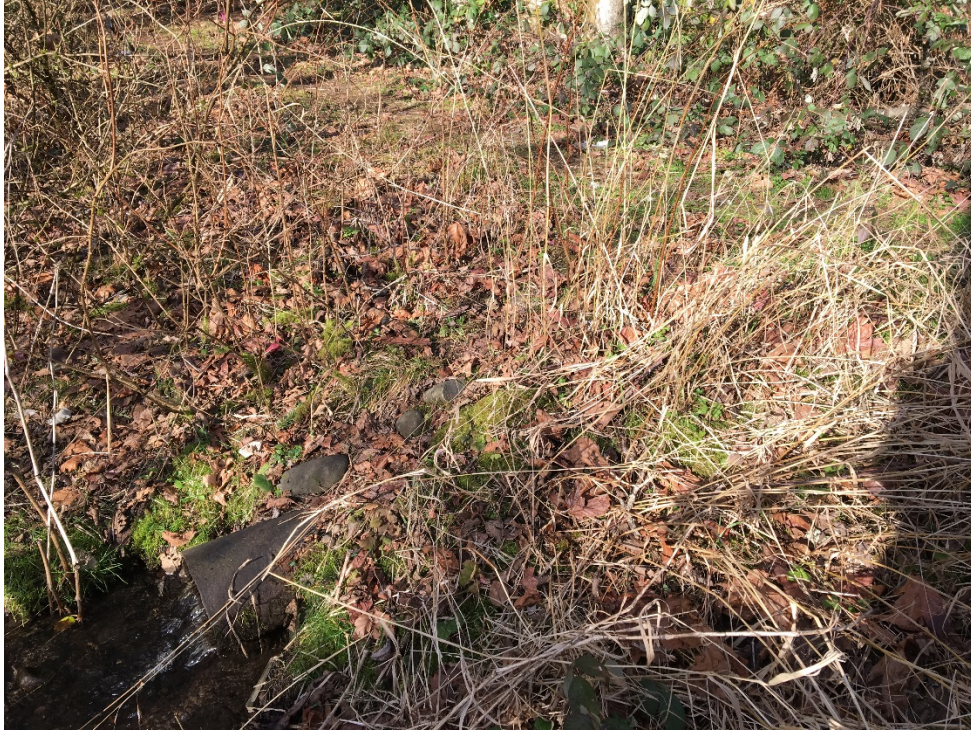
Photograph 7: Culvert outfall (bottom left) at the abandoned access road crossing where the boardwalk is proposed. Photograph taken January 14, 2018.

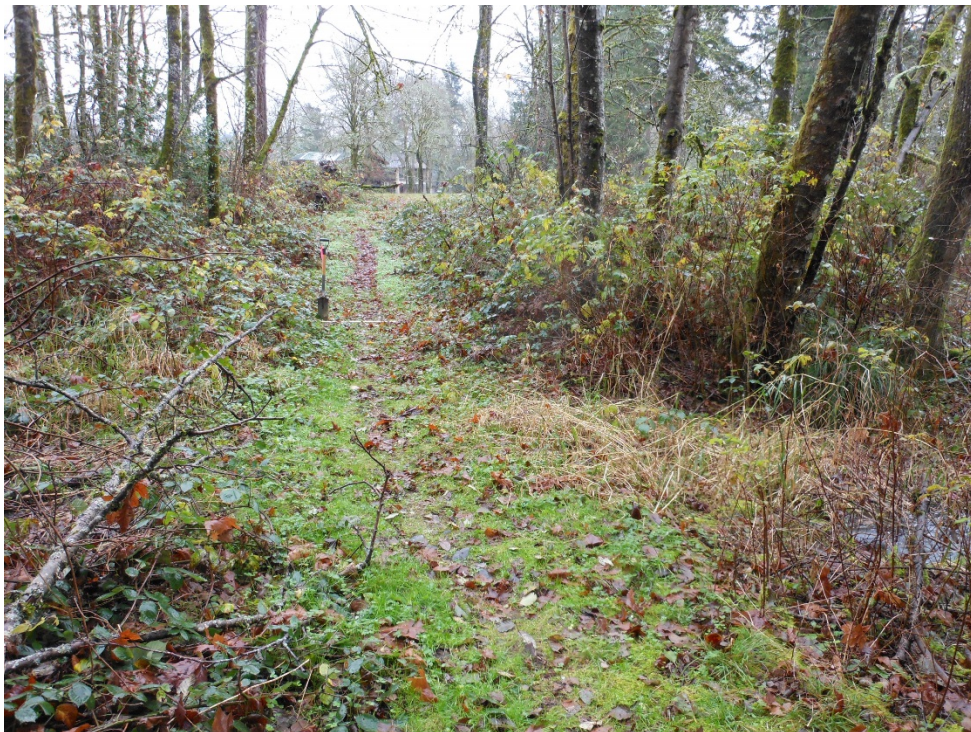
Photograph 8: View south where the abandoned access road (culvert out fall on left side) crosses the East wetland and where the boardwalk is proposed. Photograph taken December 1, 2016.

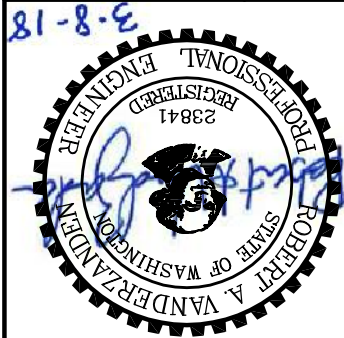
CRUSHED SURFACING TRAIL EXCAVATED SECTION
N.T.S.

NOTE: THIS SECTION TO BE USED FOR THE MAIN TRAIL, EXCEPT FIRST 250 FEET AT NE EVERETT STREET.

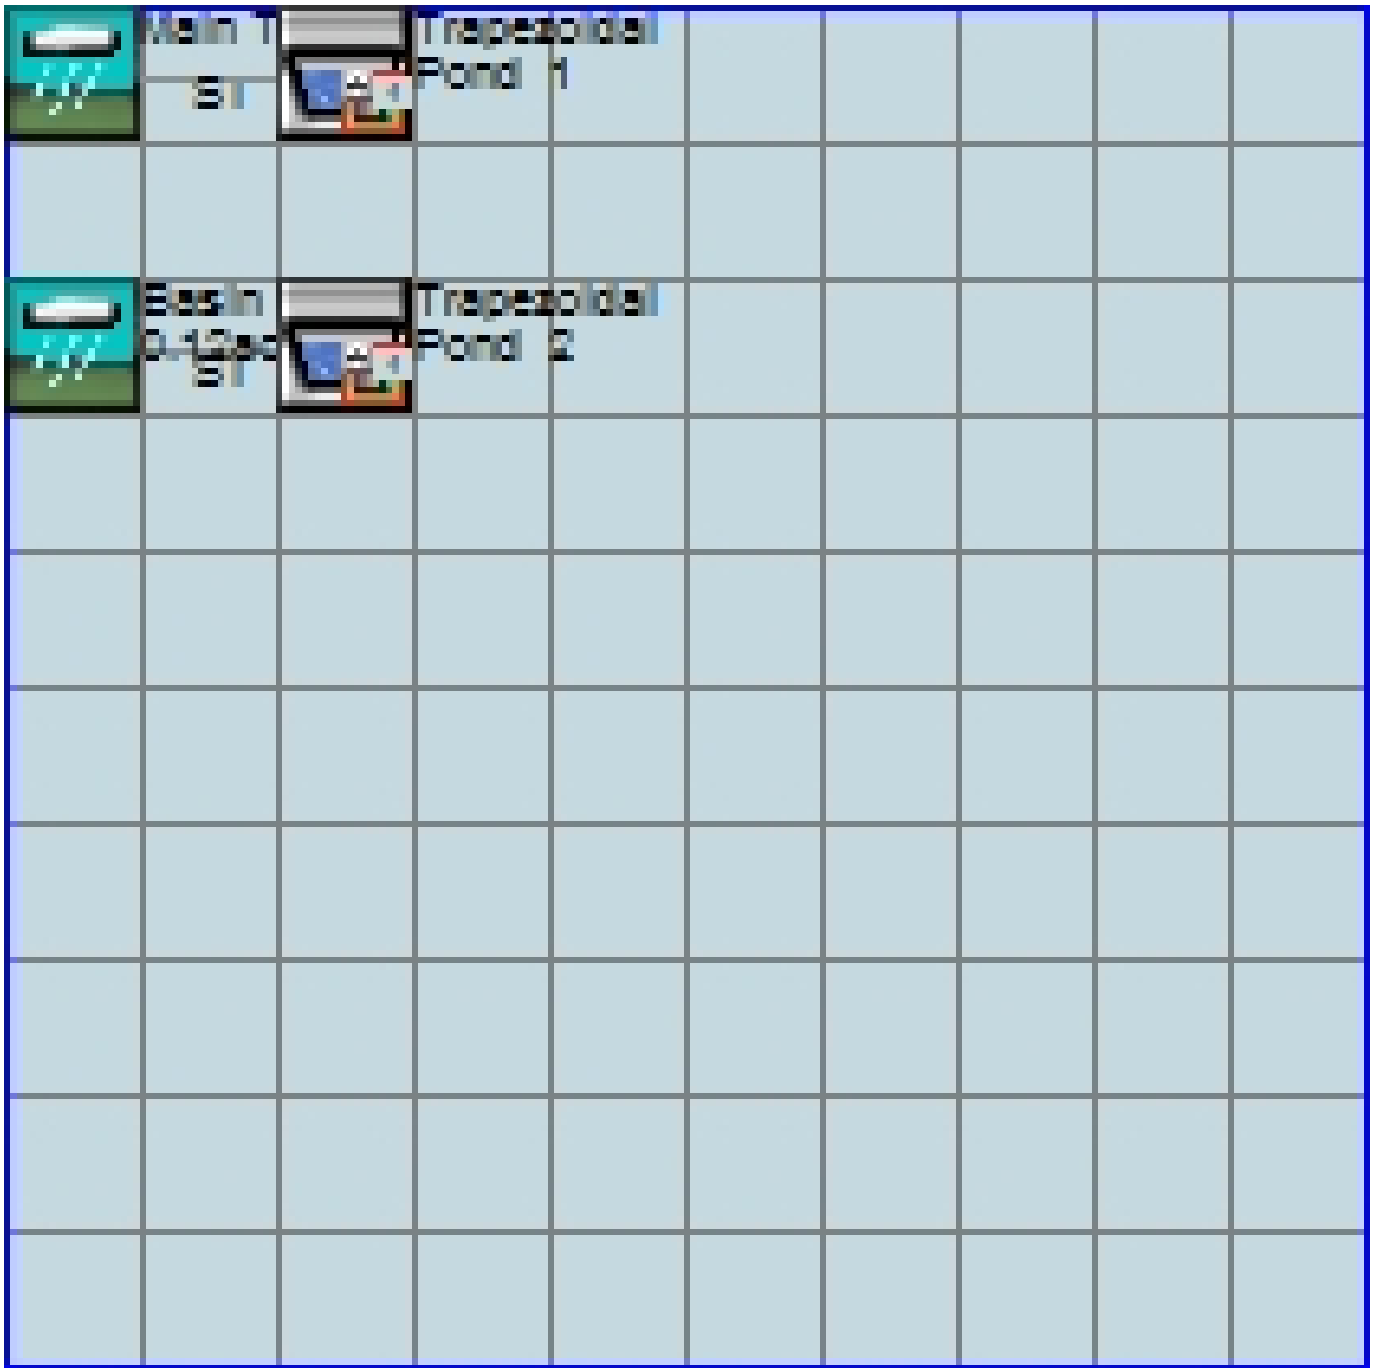
Mitigated Schematic

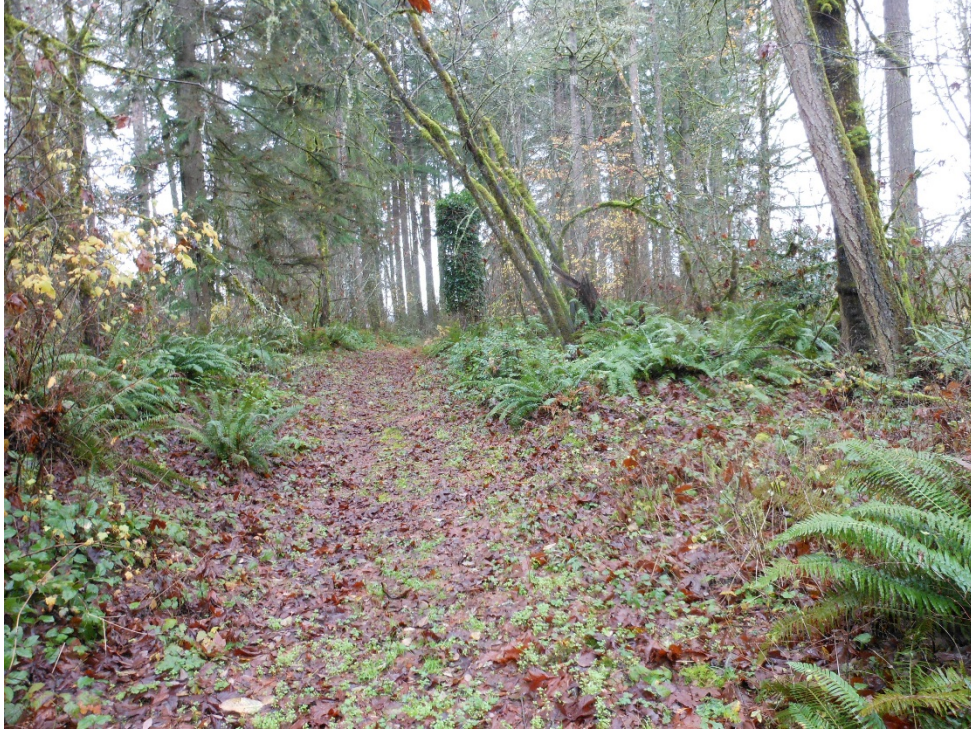
Photograph 1: View looking north showing abandoned access road and typical Douglas fir forest present along the majority of the proposed trail alignment. Photograph taken December 1, 2016.

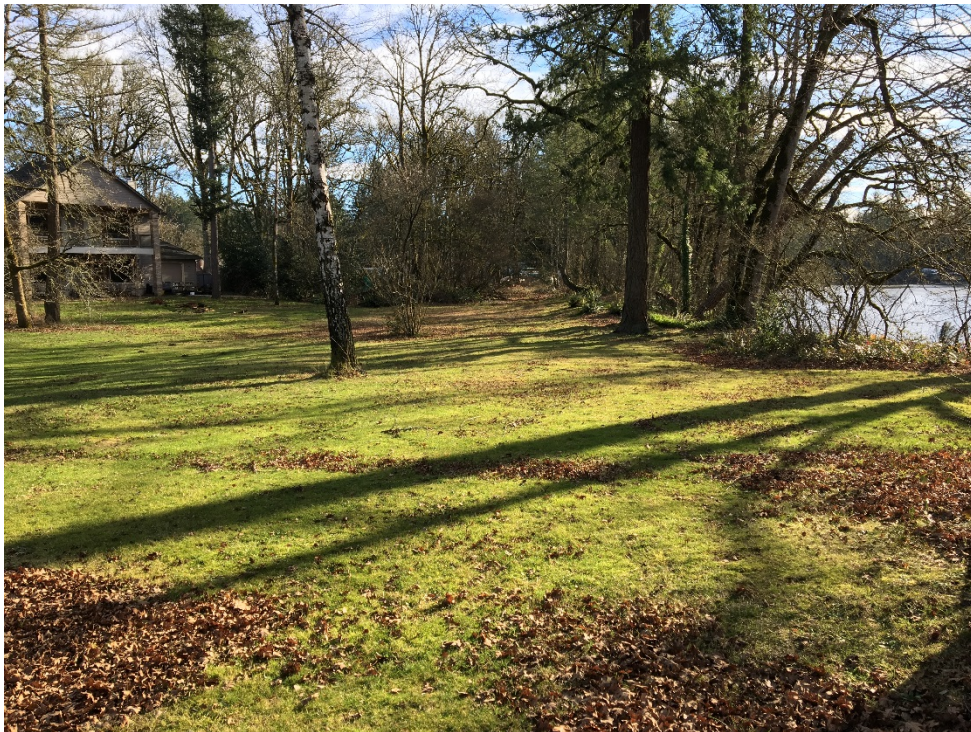
Photograph 2: View looking south where the proposed alignment crosses mowed lawns. In this area, private residences (left) are close to the shore. Photograph taken January 14, 2018.

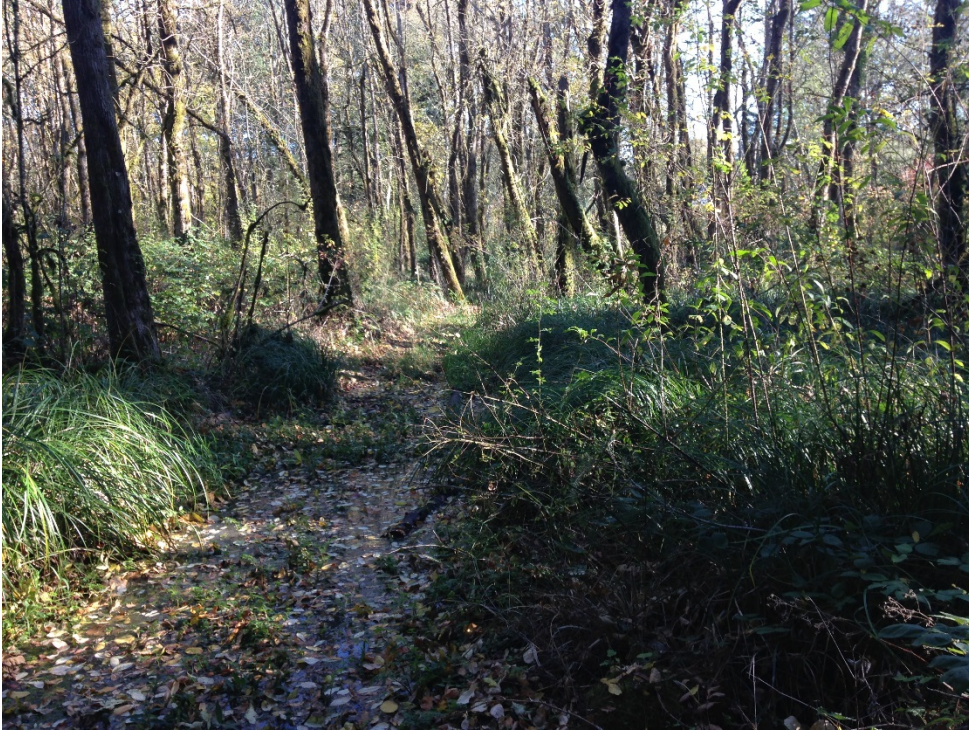
Photograph 3: View looking south, showing typical forest in core of East wetland: dense Oregon ash canopy and slough sedge understory, with areas of ponded water. Photograph taken October 30, 2017.

Approximately two-thirds of the proposed trails are laid out on a northwest-southeast oriented gravel ridge with wetlands or open water along the margins. The East wetland is a forested wetland along the east and south sides of the ridge (Table 2; Photograph 3). This wetland intersects the proposed main trail in a broad swale at the south end of the ridge, where a 12-inch steel culvert lies beneath the access road (Photographs 4 and 5). The second wetland, the Lake wetland, is a scrub-shrub fringe along Lacamas Lake at the northwest and north side of the ridge, extending into a wide aquatic bed in the lake (Table 2; Photographs 6 and 7).

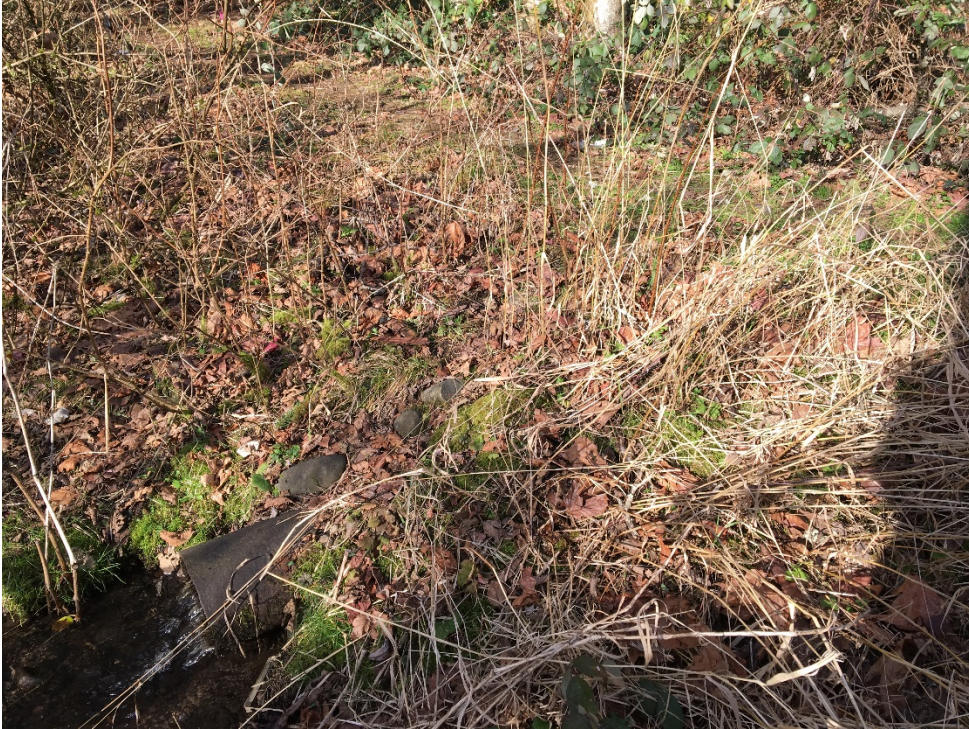
Photograph 4: Culvert outfall (bottom left) from East wetland at the abandoned access road crossing, where boardwalk proposed. Photograph taken January 14, 2018.

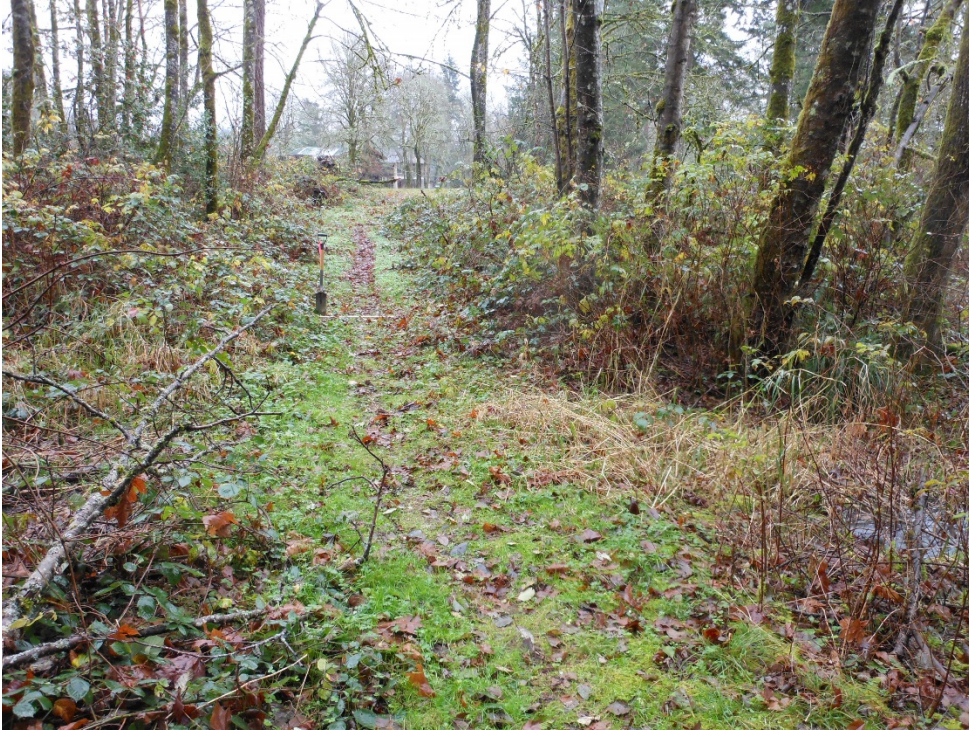
Photograph 5: View south along the abandoned access road where it crosses East wetland, where boardwalk proposed. Photograph taken December 1, 2016.

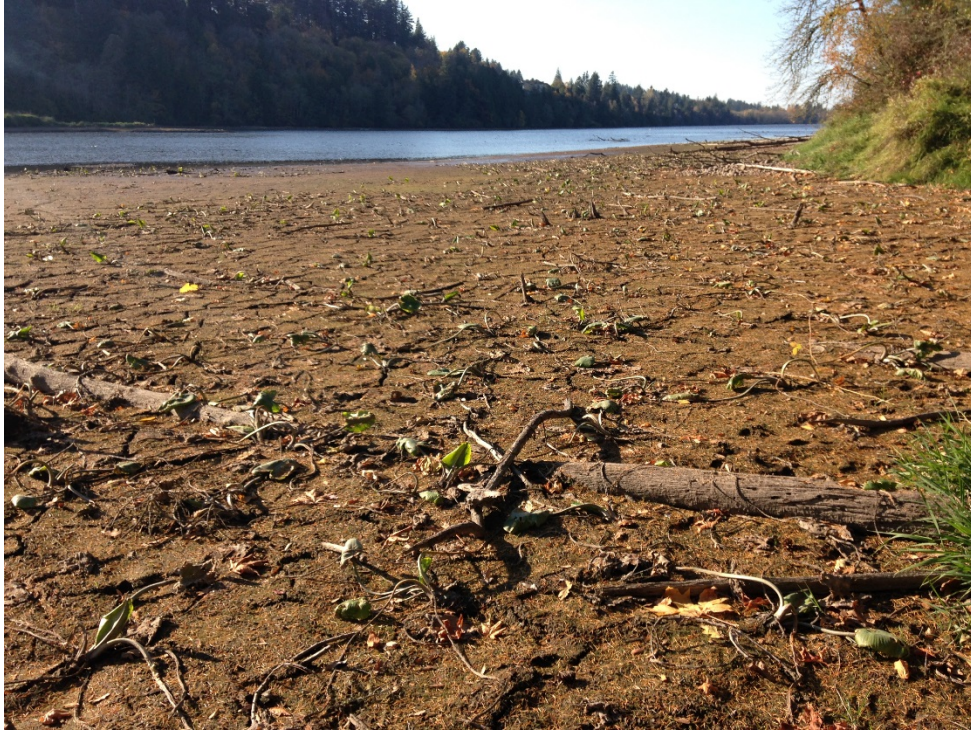
Photograph 7: View looking northwest, showing exposed aquatic bed plants in the Lake wetland when Lacamas Lake is drawn down. Photograph taken October 30, 2017.

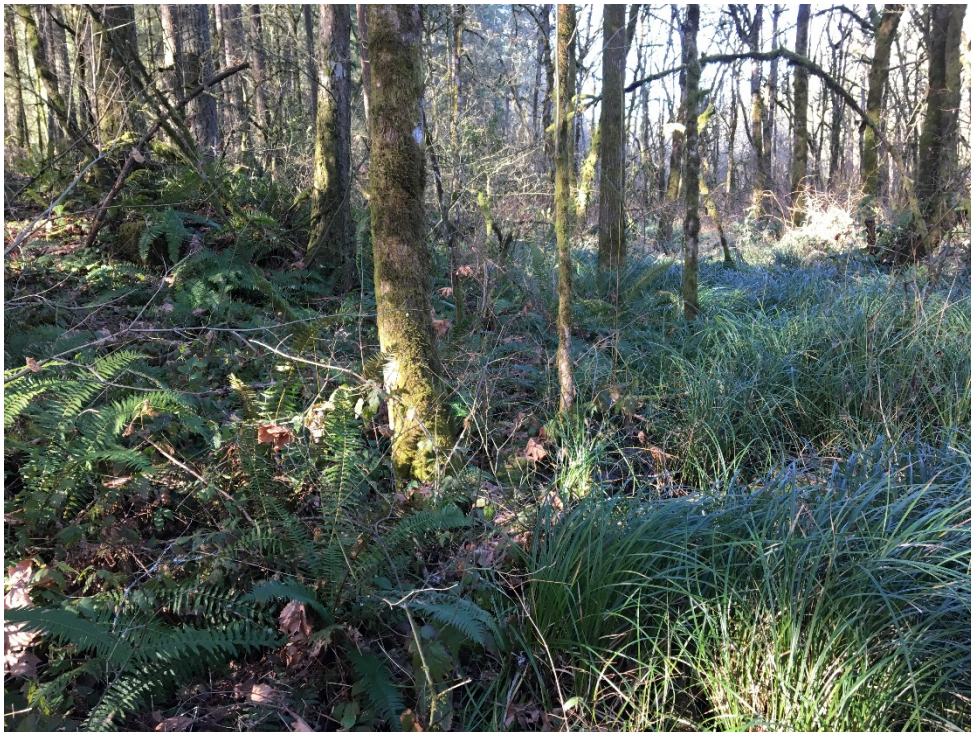
Photograph 8: View looking north along the boundary of East wetland, showing the distinct topographic break and associated change in vegetation from wetland (slough sedge, right) to upland (sword fern, left). Photograph taken January 14, 2018.

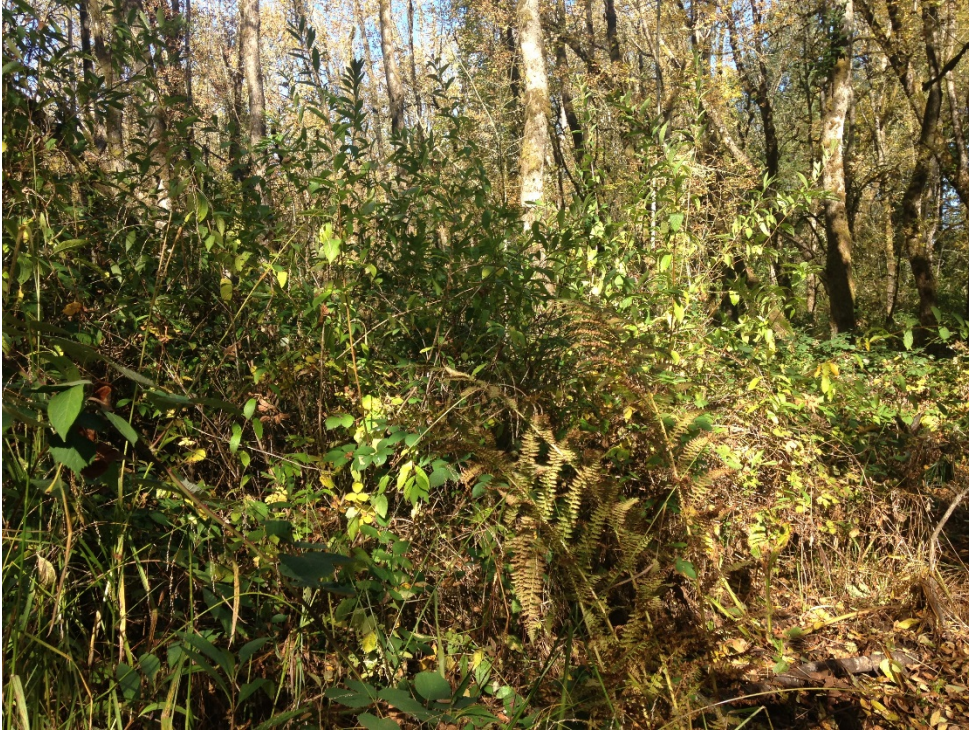
Photograph 9: View looking north, showing typical vegetation at the north and south ends of East wetland: thinner tree canopy and thickets of shrubs intermixed with patches of bare ground/open water and herbaceous vegetation. Photograph taken October 26, 2017.

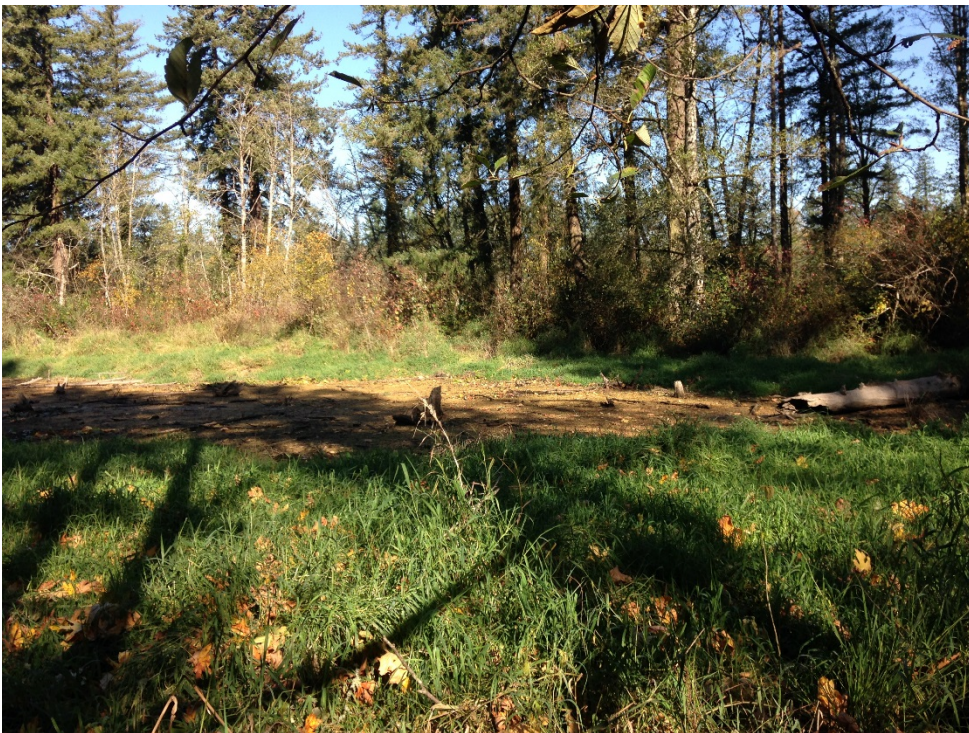
Photograph 10: View looking east, showing a strip of reed canarygrass along the OHWM of Lacamas Lake, part of Lake wetland. Bare ground (center) is below the OHWM. Photograph taken October 30, 2017.

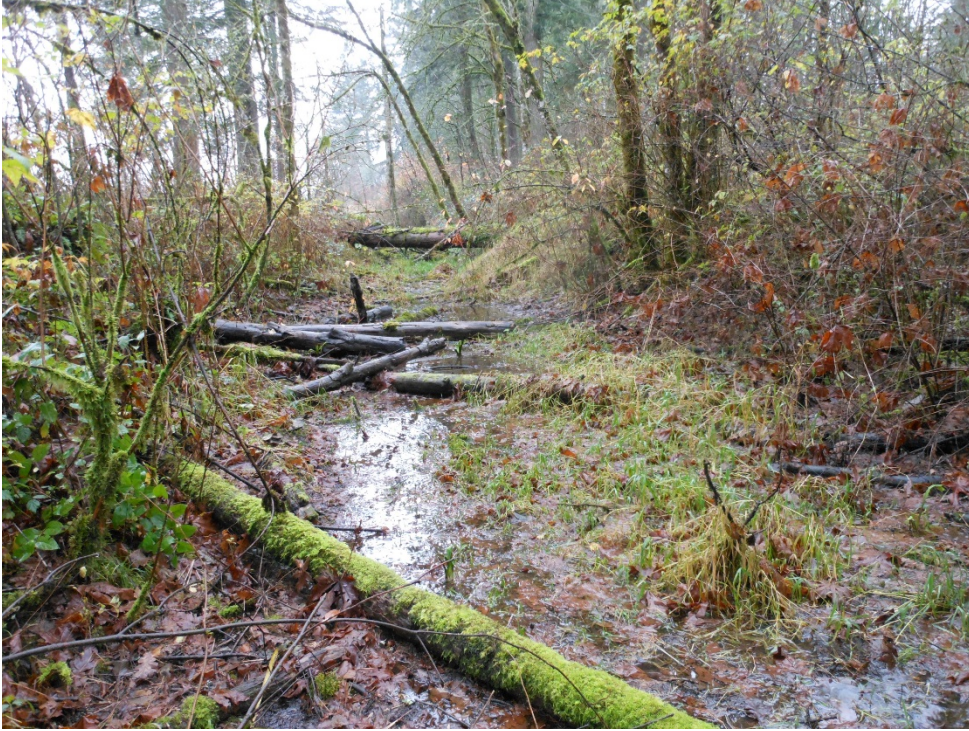
Photograph 11: View looking northwest along one of the backwaters, showing areas of bare ground, open water, and patches of herbaceous vegetation below the OHWM of Lacamas Lake. Photograph taken December 1, 2016.

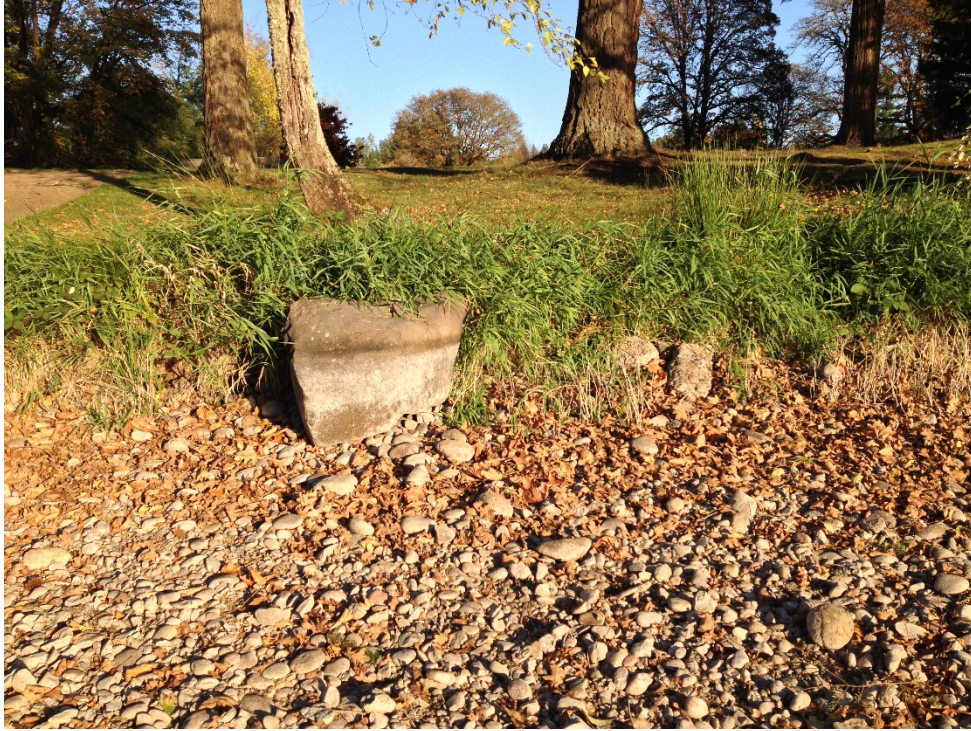
Photograph 13: View looking southeast showing watermarks on a large boulder on the shore of Lacamas Lake. Photograph taken October 30, 2017.

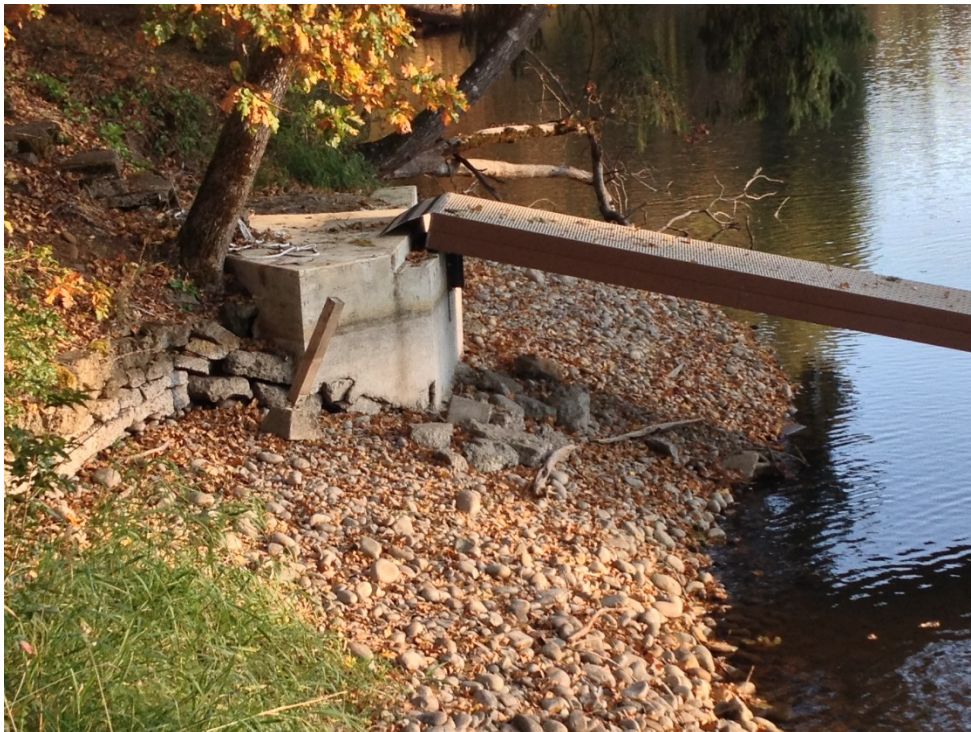
Photograph 14: View looking southeast along the shore of Lacamas Lake, showing watermarks on a dock. Photograph taken October 30, 2017.

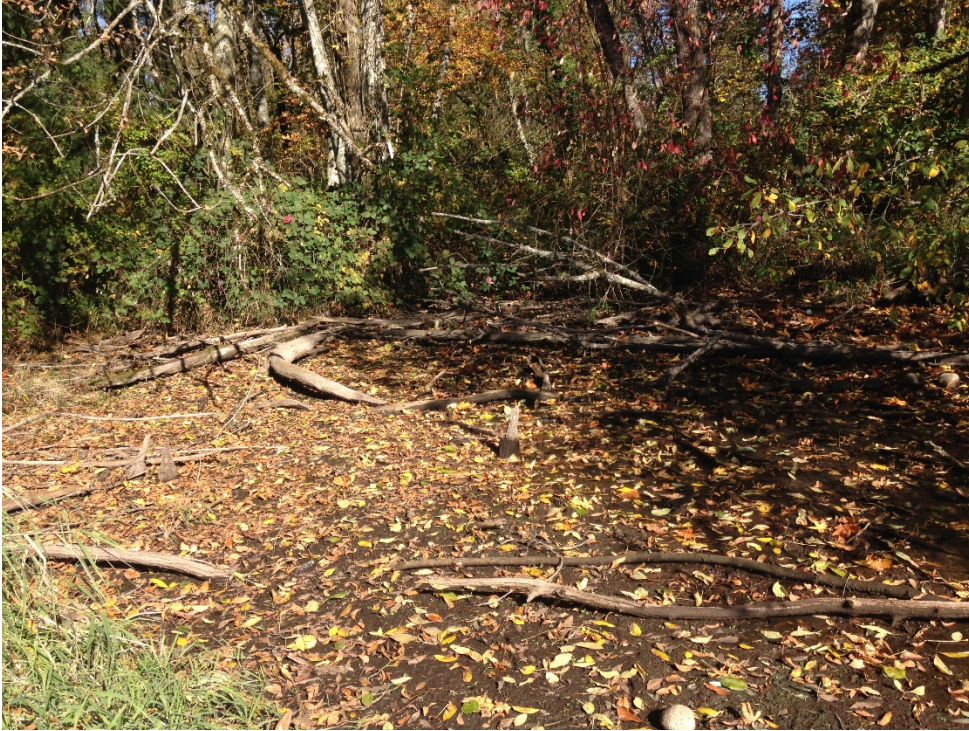
Photograph 15: View east from Lacamas Lake towards the trail alignment. Wrack accumulation and change in vegetation from bare or herbaceous to scrub-shrub can be seen at the OHWM. Photograph taken October 26, 2017.

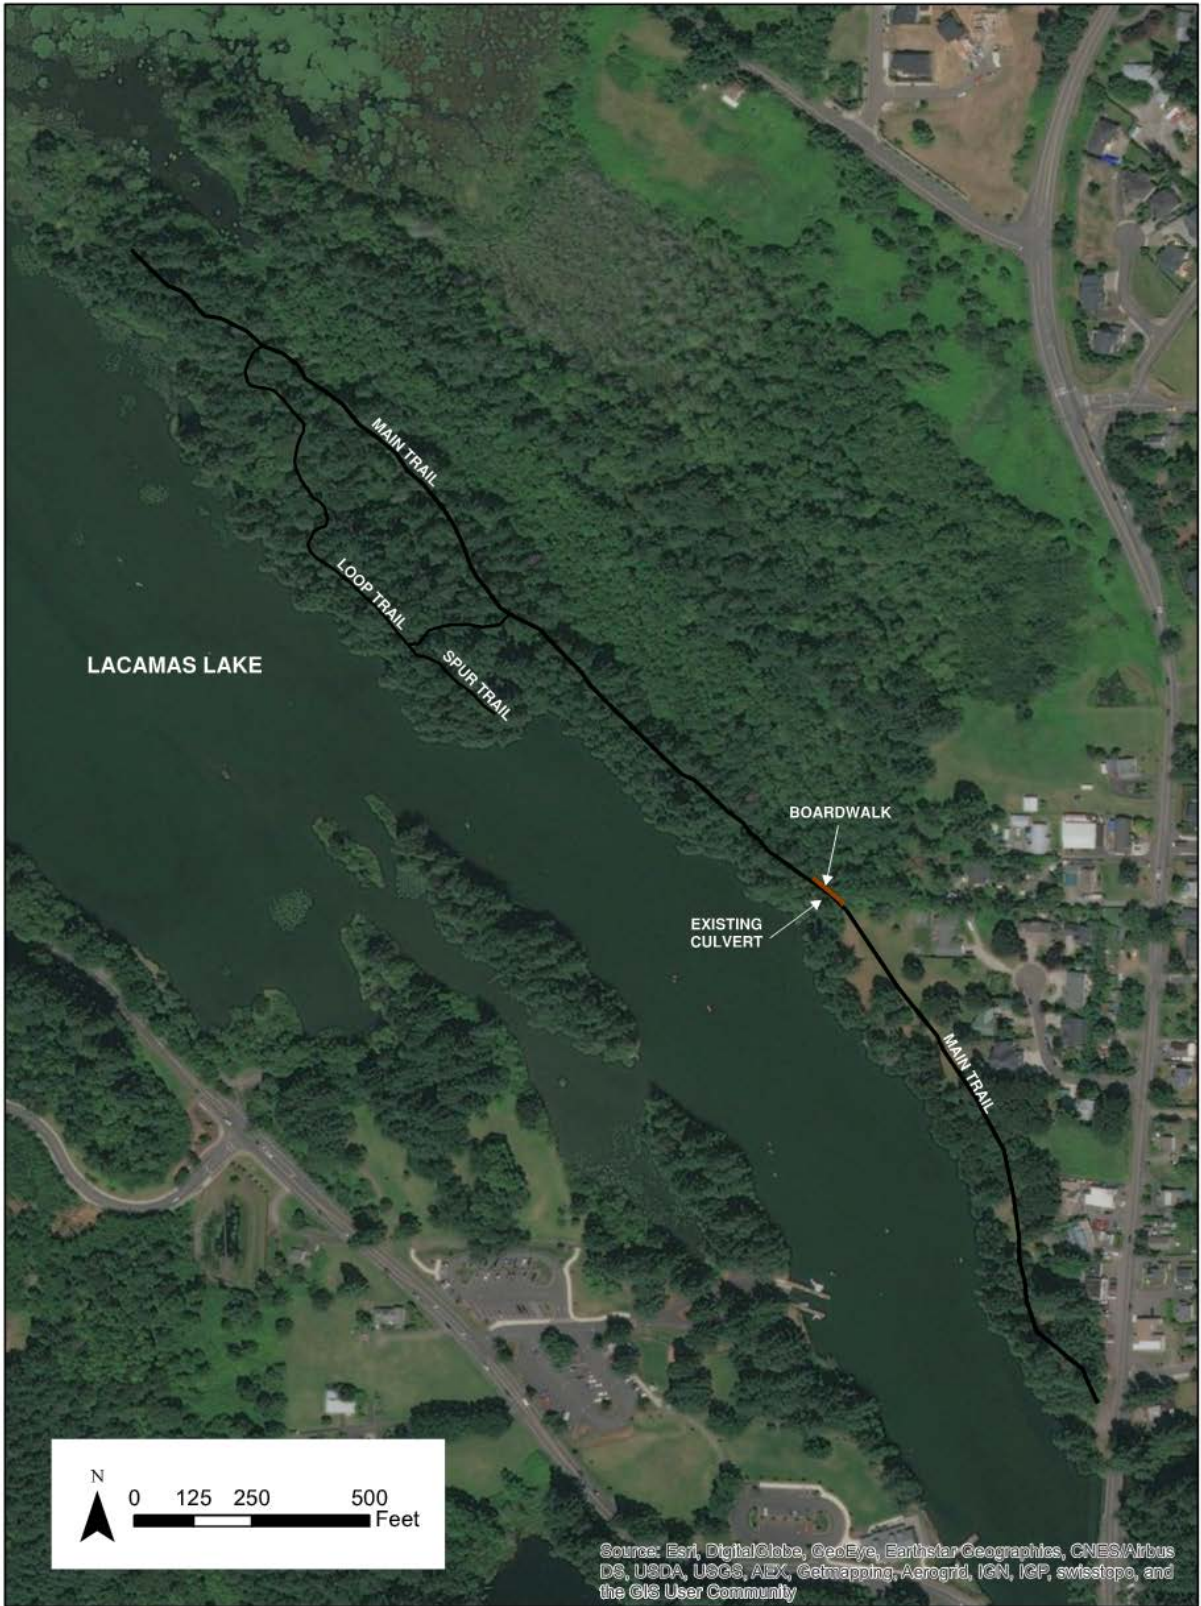
FIGURE 2. Location of proposed trails along the north shore of Lacamas Lake.

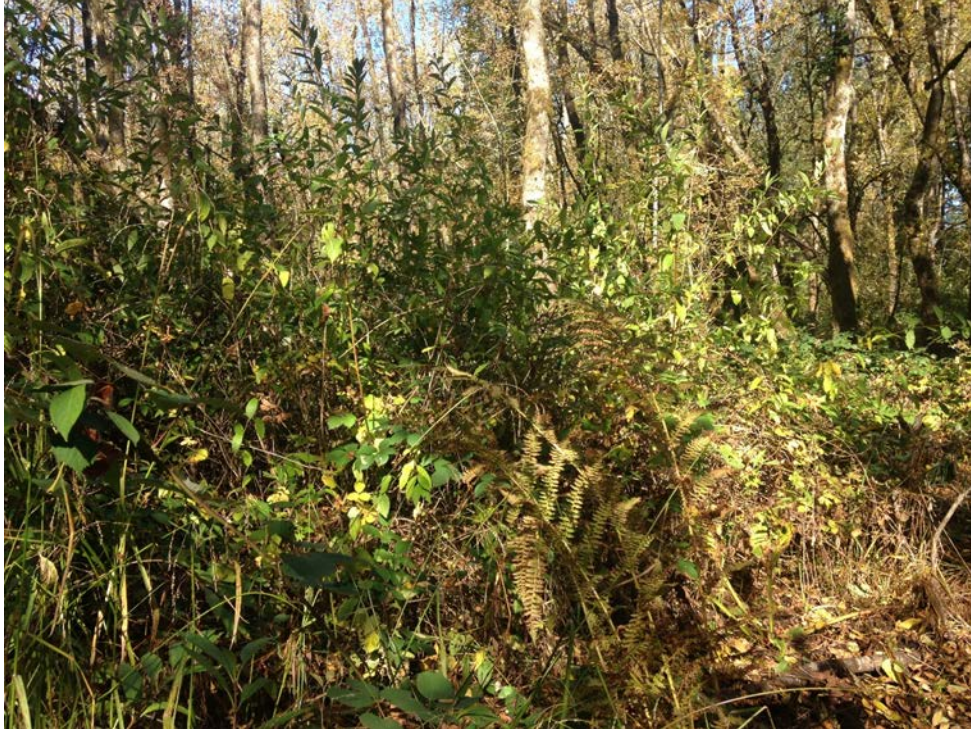
Photograph 4: View looking north, showing typical vegetation at the north and south ends of East wetland: thinner tree canopy and thickets of shrubs intermixed with patches of bare ground/open water and herbaceous vegetation. Photograph taken October 26, 2017.

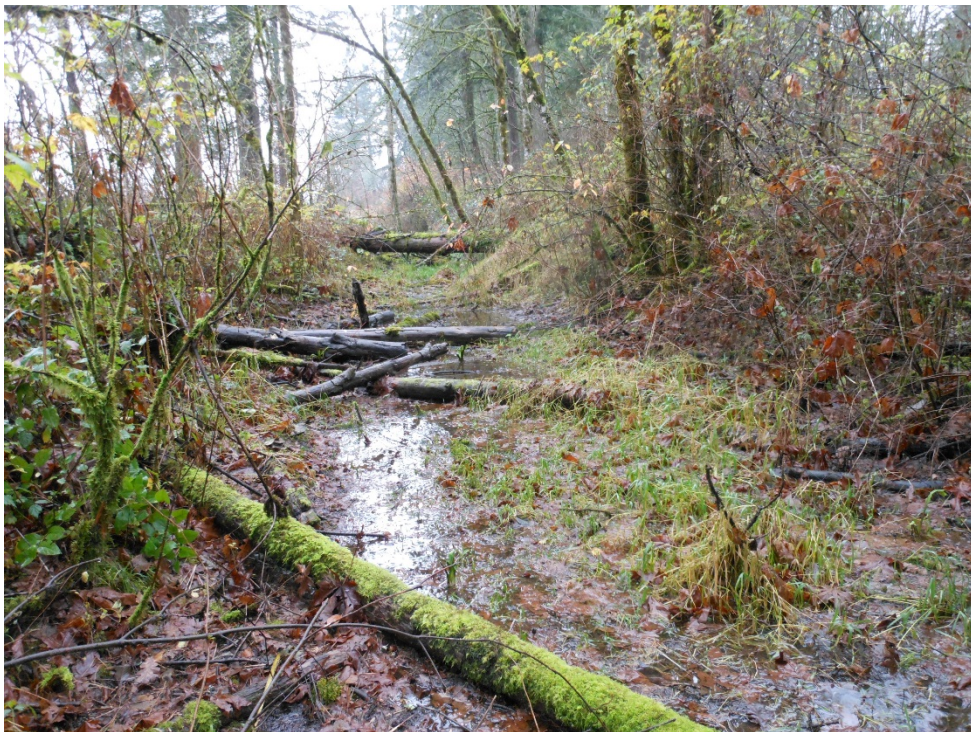
Photograph 6: View looking northwest along one of the backwaters, showing areas of bareground/open water and patches of herbaceous vegetation below the OHWM of Lacamas Lake. Photograph taken December 1, 2016.
