LACAMAS NORTH SHORE TRAIL PROJECT

City Project: P1005

Application for Shoreline Variance

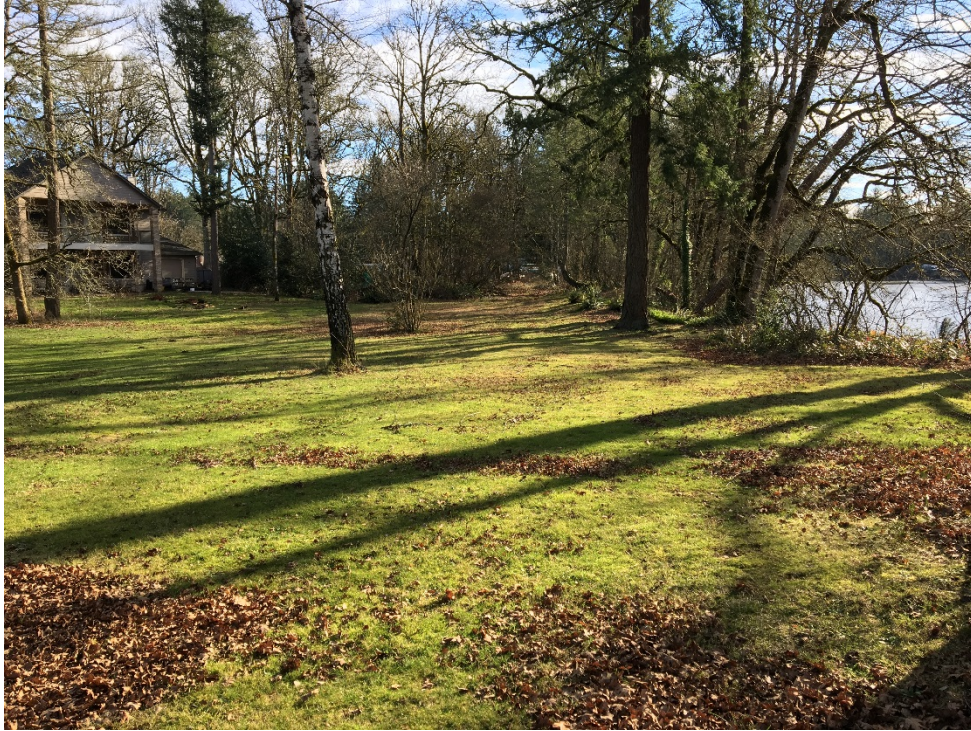
Photograph 1: View looking south, where the main trail would follow the route of an abandoned access road on City property between private residences (left) and Lacamas Lake (right). Photograph taken January 14, 2018.

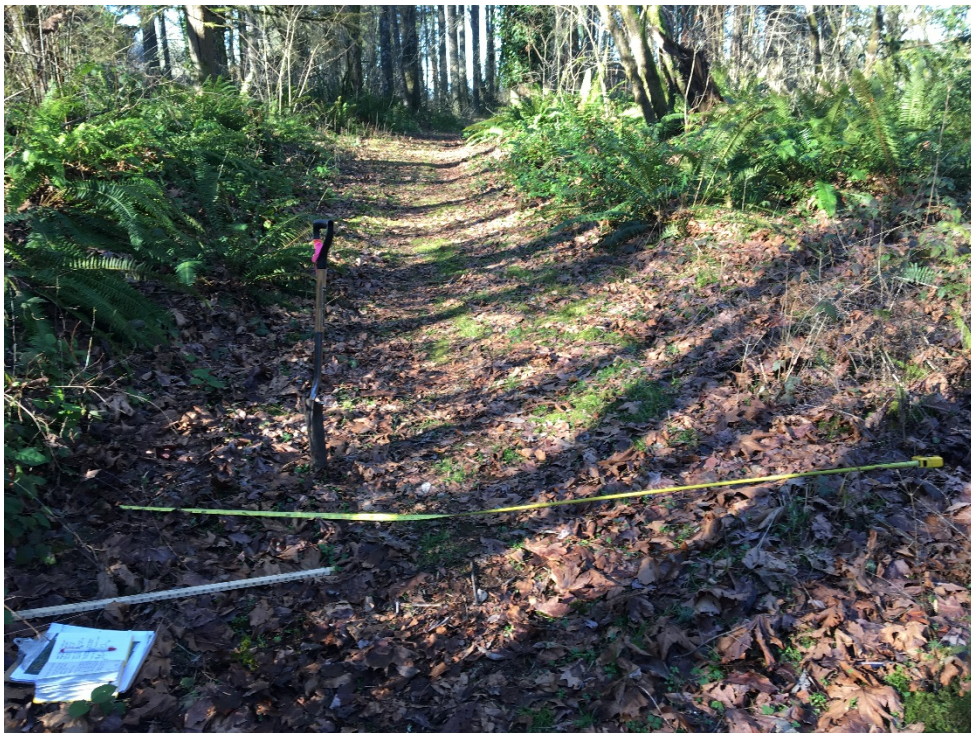
Photograph 2: View looking north, where the main trail would follow an abandoned access road through a forested natural area. Photograph taken January 14, 2018.

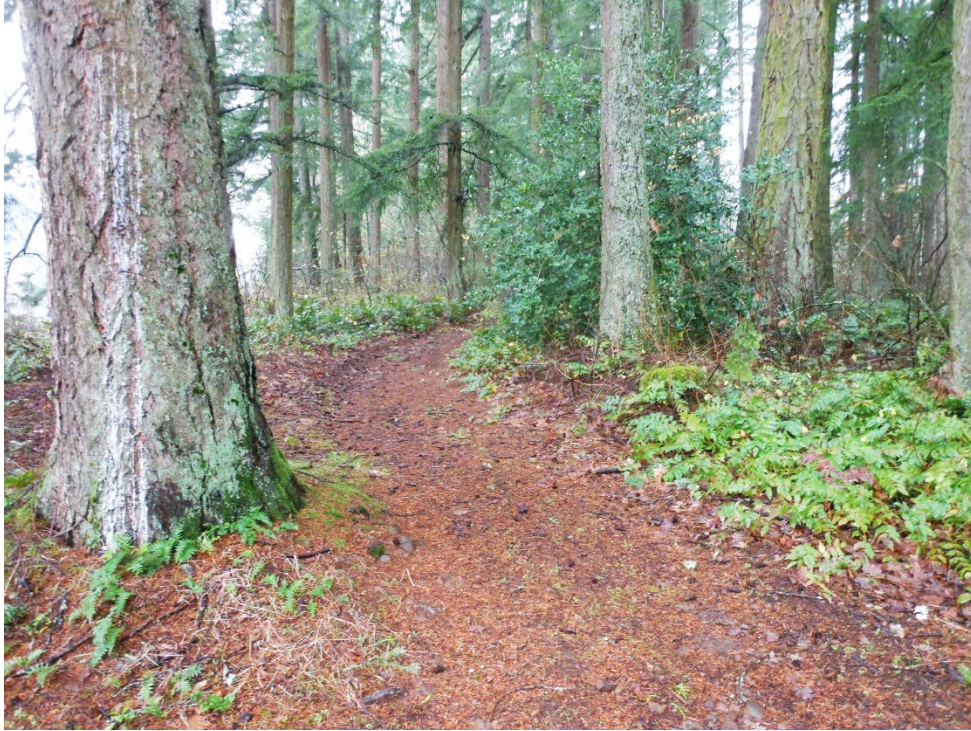
Photograph 3: View looking northwest, where the spur trail would follow an existing trail to a viewpoint of Lacamas Lake. Photograph taken December 1, 2016.

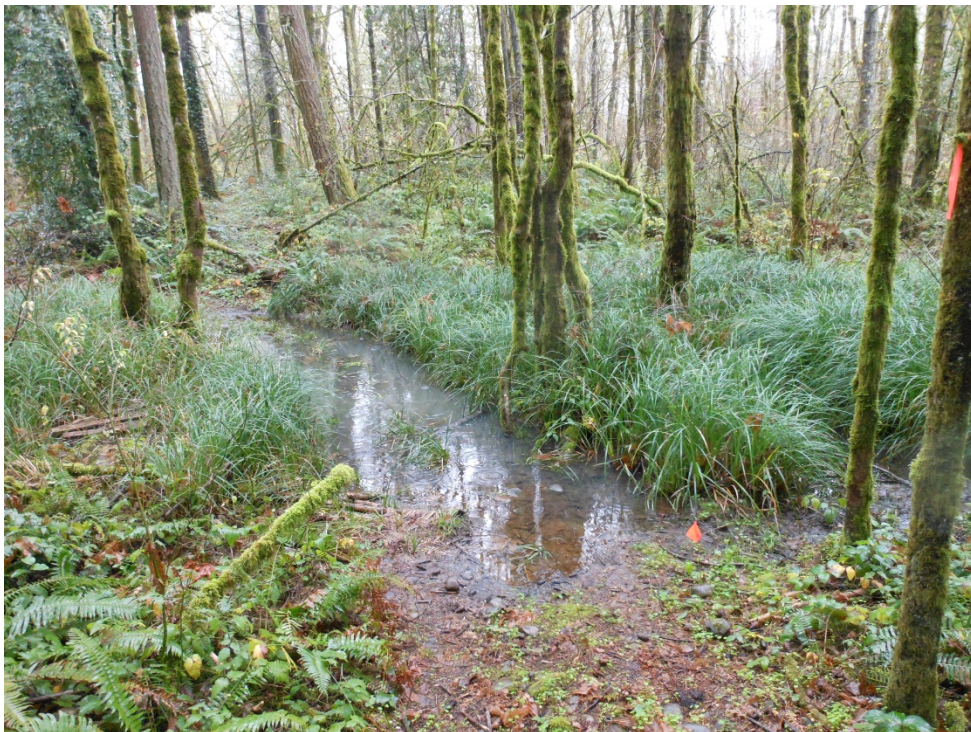
Photograph 4: View looking southeast, showing typical forest in the core of the East wetland, east of the proposed trail. Photograph taken December 1, 2016.

The East wetland (Photograph 4) is a forested wetland along the east and south sides of the upland ridge on which the proposed trail would be located. This wetland intersects the proposed trail in a broad swale at the south end of the ridge, where a 12-inch (diameter) steel culvert lies beneath the abandoned access road (Photograph 5).

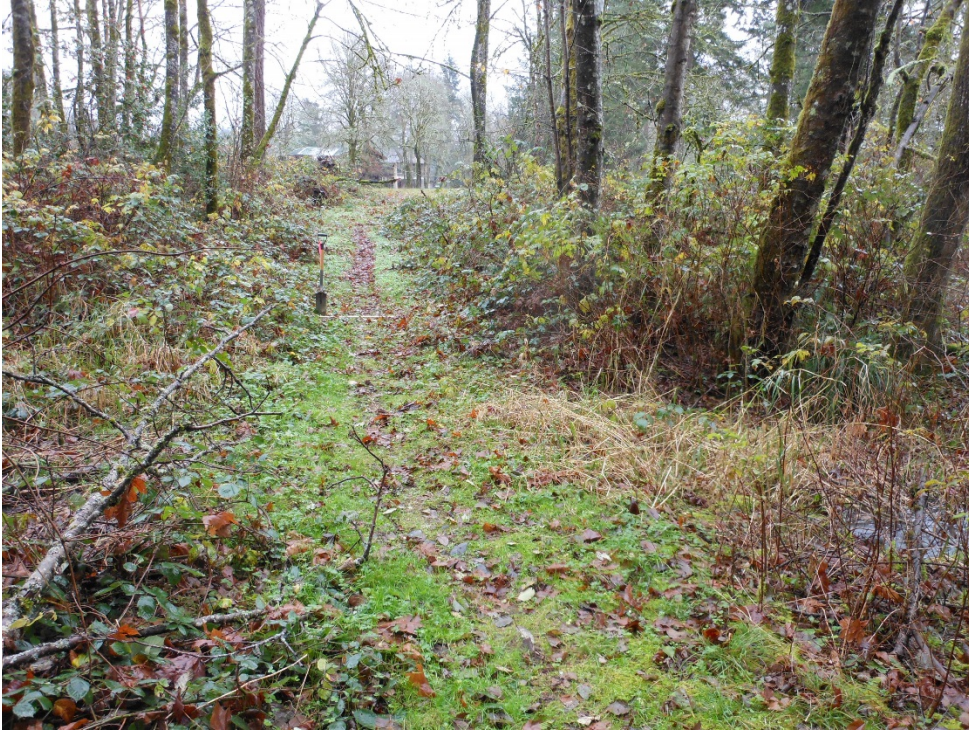
Photograph 5: View looking south, where the abandoned access road crosses the East wetland. A boardwalk would be constructed for this crossing. Photograph taken December 1, 2016.

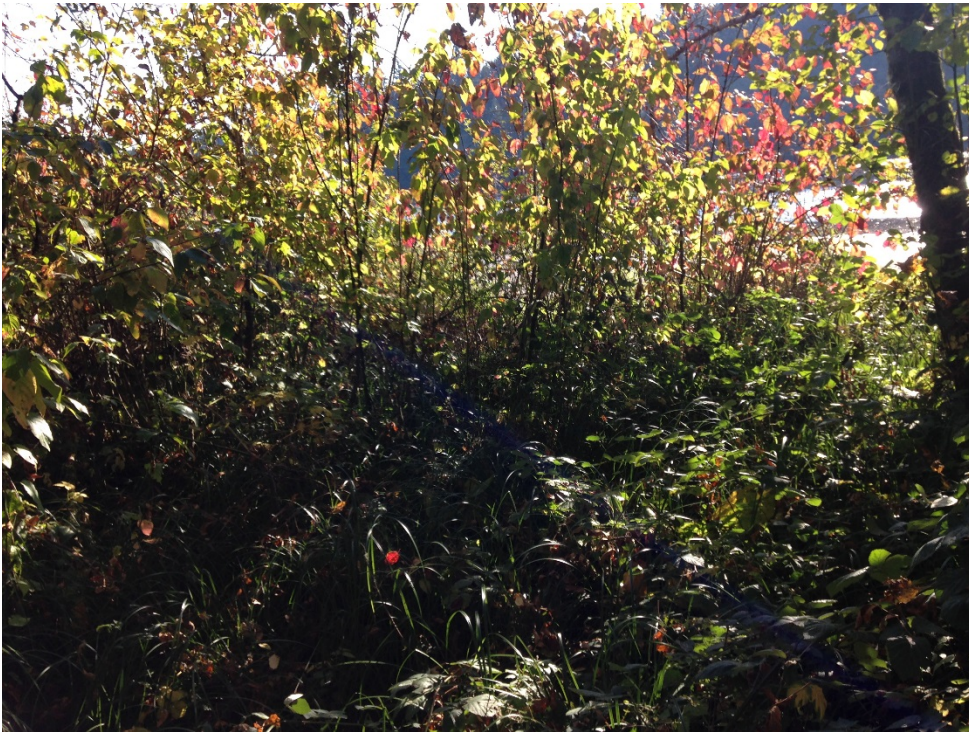
Photograph 6: View looking southwest, towards Lacamas Lake, showing typical shrub-shrub fringe in Lake wetland, shaded by trees in adjacent upland. Photograph taken October 30, 2017.

The Lake wetland (Photograph 6), is a scrub-shrub fringe along Lacamas Lake at the northwest and north side of the ridge, extending into a wide aquatic bed in the lake (Photograph 7). The proposed trail would not intersect this wetland.

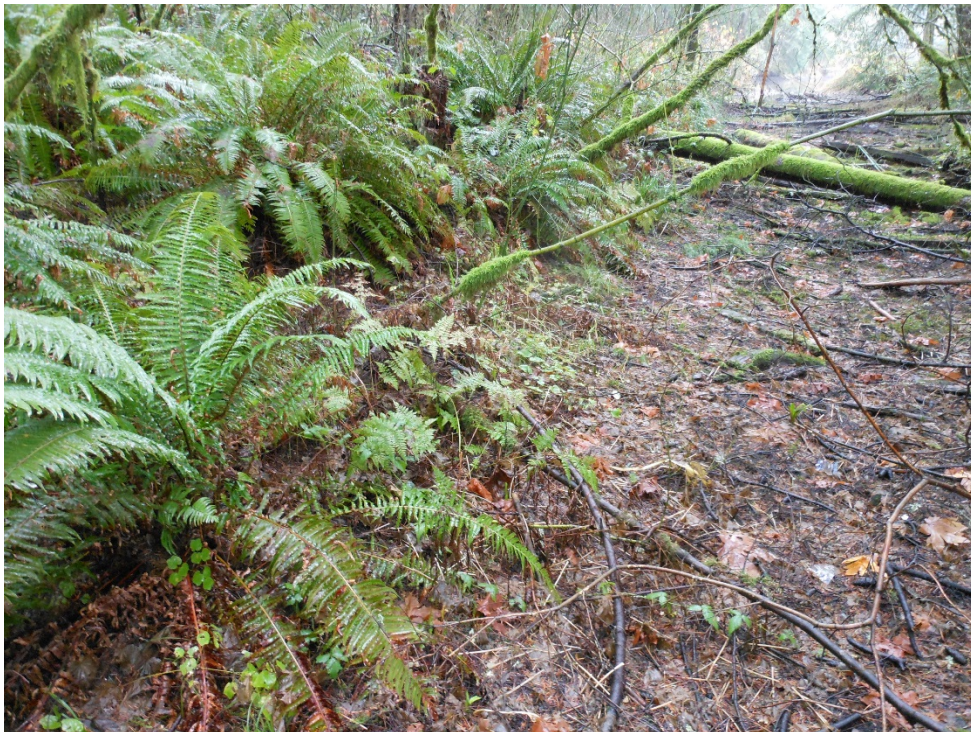
Photograph 8: View looking southeast, showing typical bare ground in backwater 1 (right) and sword ferns in upland (left). The preliminary trail alignment would have crossed the end of this backwater. Photograph taken October 26, 2017.

Backwater areas, where water is shallow and vegetation is shaded by Douglas fir trees (*Pseudotsuga menziesii*) and protected from the fetch of the lake, are dominated by emergent species, including skunk cabbage, Western lady fern, reed canarygrass, slough sedge, and water parsley (*Oenanthe sarmentosa*, OBL) (Photograph 8).

- Changing the loop and spur trail design from a 12-foot wide impervious surface to a 4-foot wide pervious surface;
- Re-routing the loop trail around wetlands and backwaters (Photographs 8 and 10);

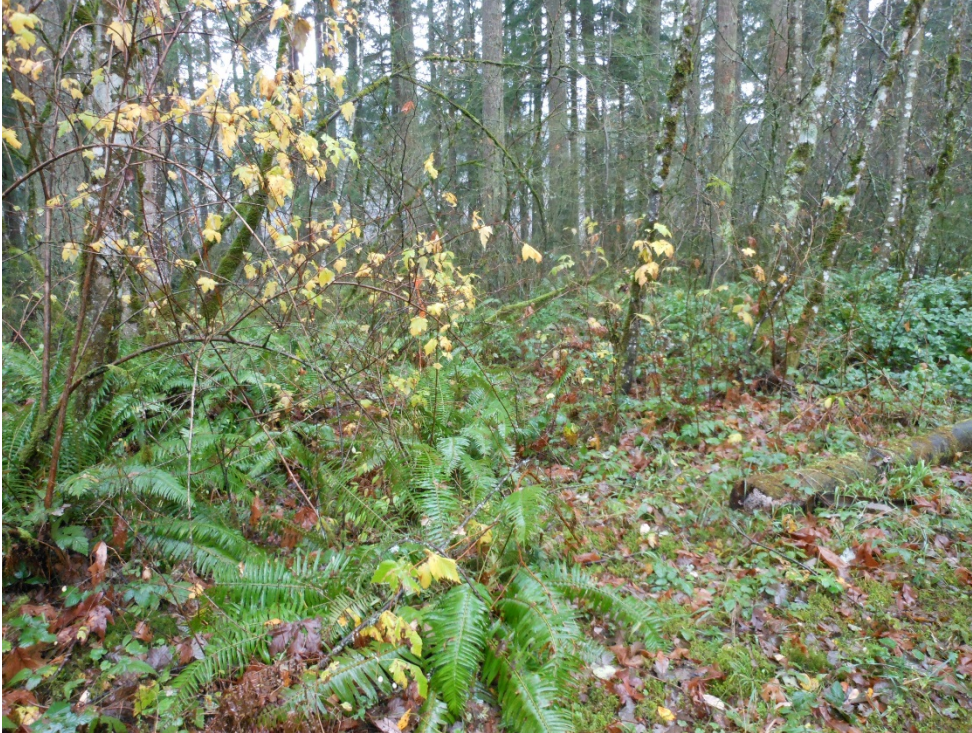
Photograph 9: View looking northwest. Showing typical upland forest in the natural area. Photograph taken December 1, 2016.

Tree canopy in the upland forest on the ridge between the two wetlands is dominated by Douglas fir and bigleaf maple (*Acer macrophyllum*, FACU), with occasional western hemlock (*Tsuga heterophylla*) (Photograph 9). There is a diverse shrub layer—including vine maple (*Acer circinatum*), beaked hazelnut (*Corylus cornuta*), Pacific ninebark, salmonberry, common snowberry (*Symphoricarpos albus*), salal (*Gaultheria shallon*), dull Oregon grape (*Mahonia nervosa*), and mock orange (*Philadelphus lewisii*)—with sword fern (*Polystichum munitum*), fringe cup (*Tellima grandiflora*), threeleaf foamflower (*Tiarella trifoliata*), and other herbs in the understory. Invasive upland species, including English holly (*Ilex aquifolium*), ivy (*Hedera spp.*), periwinkle (*Vinca sp.*), and shiny geranium (*Geranium lucidum*), are well established in some locations, but generally not dominant.

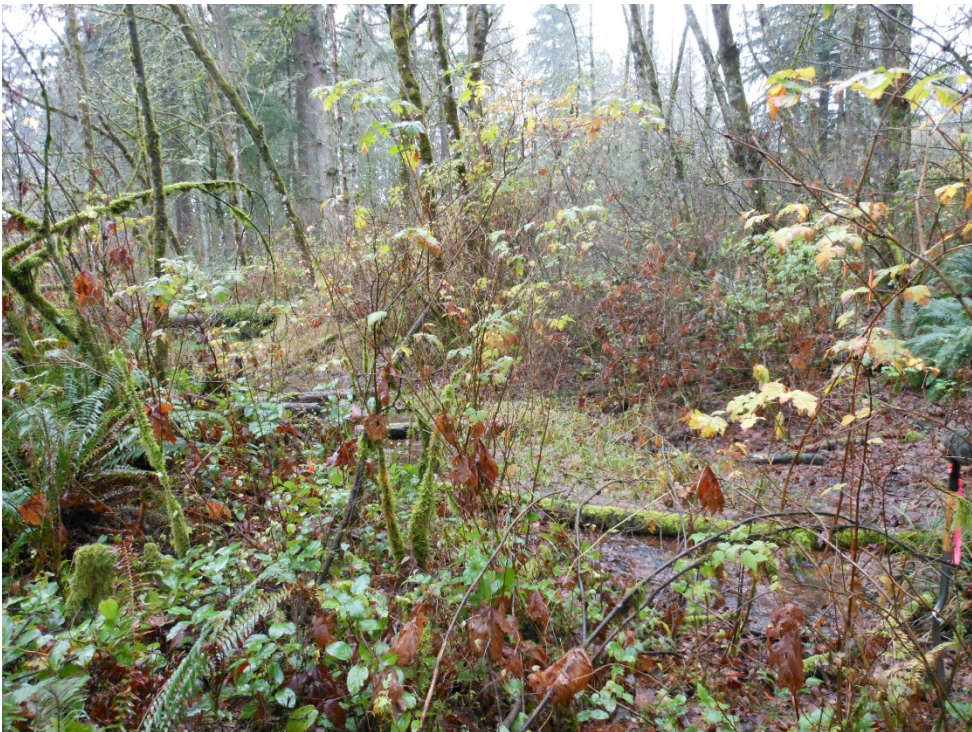
Photograph 10: View northeast, showing backwater 2 where the preliminary trail alignment would have crossed. Photograph taken December 1, 2016.

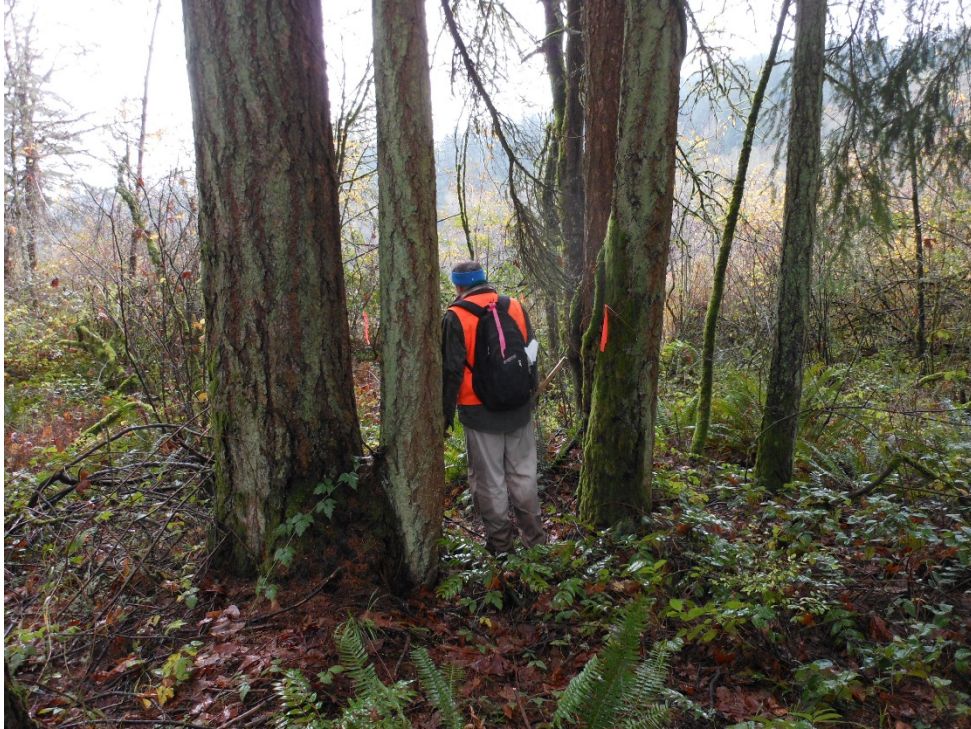
Photograph 11: View looking west, showing mature trees in the Lake wetland buffer. The final alignment was selected to avoid removal of such trees. Photograph taken December 1, 2016.

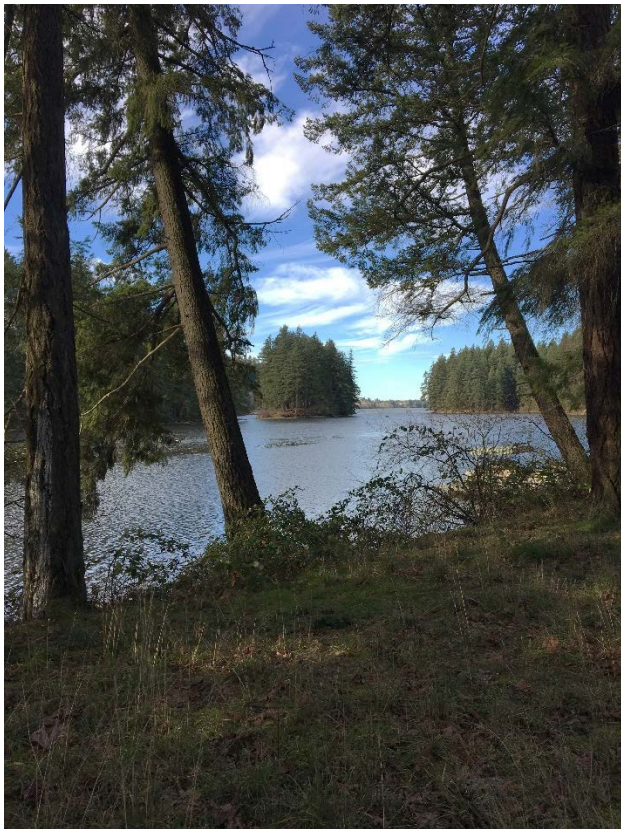
Photograph 12: View looking northwest from the vicinity of the proposed trail, showing view of Lacamas Lake. Photograph taken January 14, 2018.

Consistent with SMP 6.3.11.3, the proposed trail project will provide visual access to Lacamas Lake at multiple locations including almost continuously from NE Everett Street to the proposed boardwalk, at the terminus of the spur trail, and variously through the trees along the trails (Photograph 12).

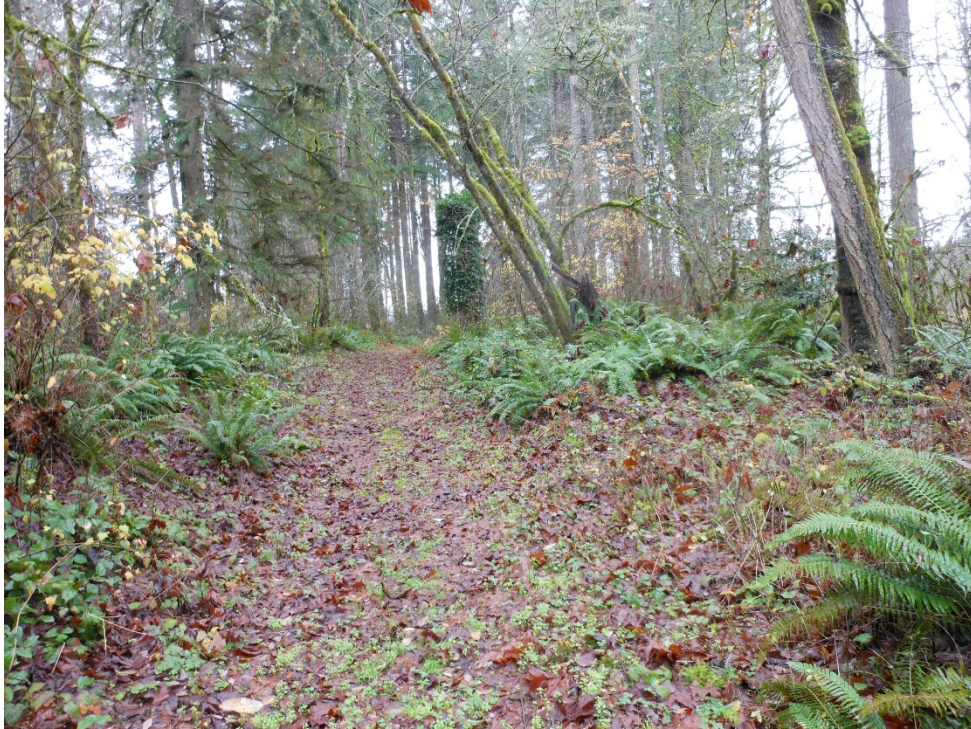
Photograph 1: View looking north showing abandoned access road and typical Douglas fir forest present along the majority of the proposed trail alignment. Photograph taken December 1, 2016.

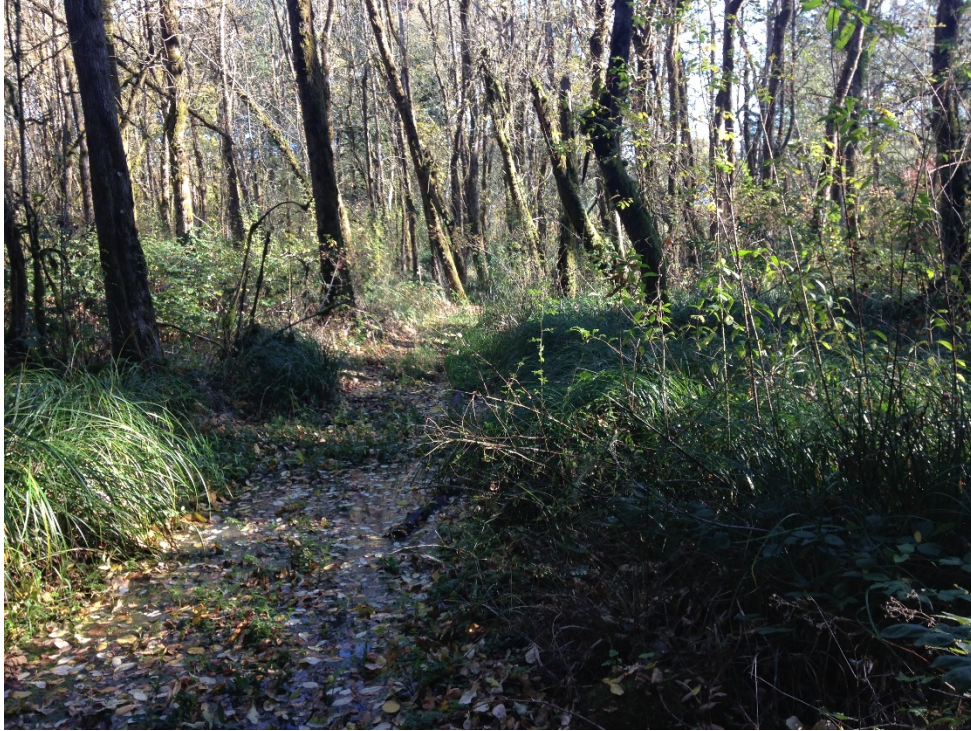
Photograph 3: View looking south, showing typical forest in core of East wetland: dense Oregon ash canopy and slough sedge understory, with areas of ponded water. Photograph taken October 30, 2017.

Approximately two-thirds of the proposed trails are laid out on a northwest-southeast oriented gravel ridge with wetlands or open water along the margins. The East wetland is a forested wetland along the east and south sides of the ridge (Table 2; Photograph 3). This wetland intersects the proposed main trail in a broad swale at the south end of the ridge, where a 12-inch steel culvert lies beneath the access road (Photographs 4 and 5). The second wetland, the Lake wetland, is a scrub-shrub fringe along Lacamas Lake at the northwest and north side of the ridge, extending into a wide aquatic bed in the lake (Table 2; Photographs 6 and 7).

The core of the East wetland is dominated by a dense canopy of Oregon ash (*Fraxinus latifolia*, FACW), with occasional red alder, and an understory of slough sedge (*Carex obnupta*, OBL) (Photograph 3). At the northwest and southeast ends, the tree canopy thins and a shrub understory is present (Photograph 9), composed of salmonberry (*Rubus spectabilis*, FAC), twinberry (*Lonicera involucrata*, FAC), redosier dogwood (*Cornus alba*, FACW), Douglas spirea (*Spiraea douglasii*, FACW), Pacific ninebark (*Physocarpus capitatus*, FACW), and occasional Himalayan blackberry (*Rubus armeniacus*, FAC). In these areas, Western lady fern (*Athyrium cyclosorum*, FAC), piggyback plant (*Tolmiea menziesii*, FAC), tall mannagrass (*Glyceria elata*, FACW), skunk cabbage (*Lysichiton americanus*, OBL), and reed canarygrass (*Phalaris arundinacea*, FACW) join slough sedge in herbaceous openings and understory.

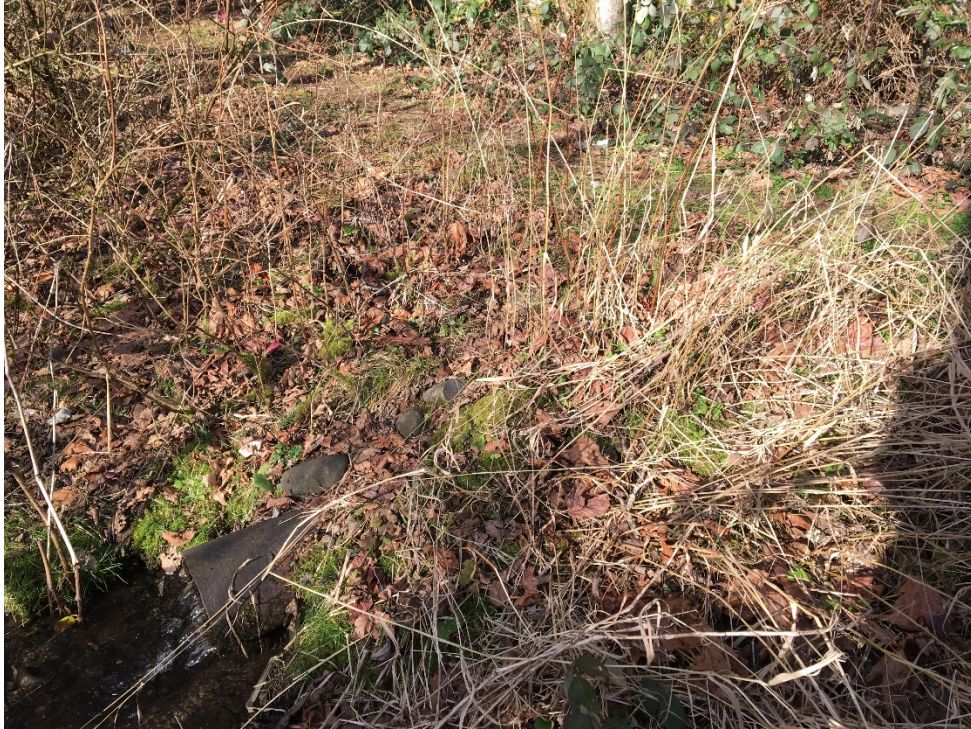
Photograph 4: Culvert outfall (bottom left) from East wetland at the abandoned access road crossing, where boardwalk proposed. Photograph taken January 14, 2018.

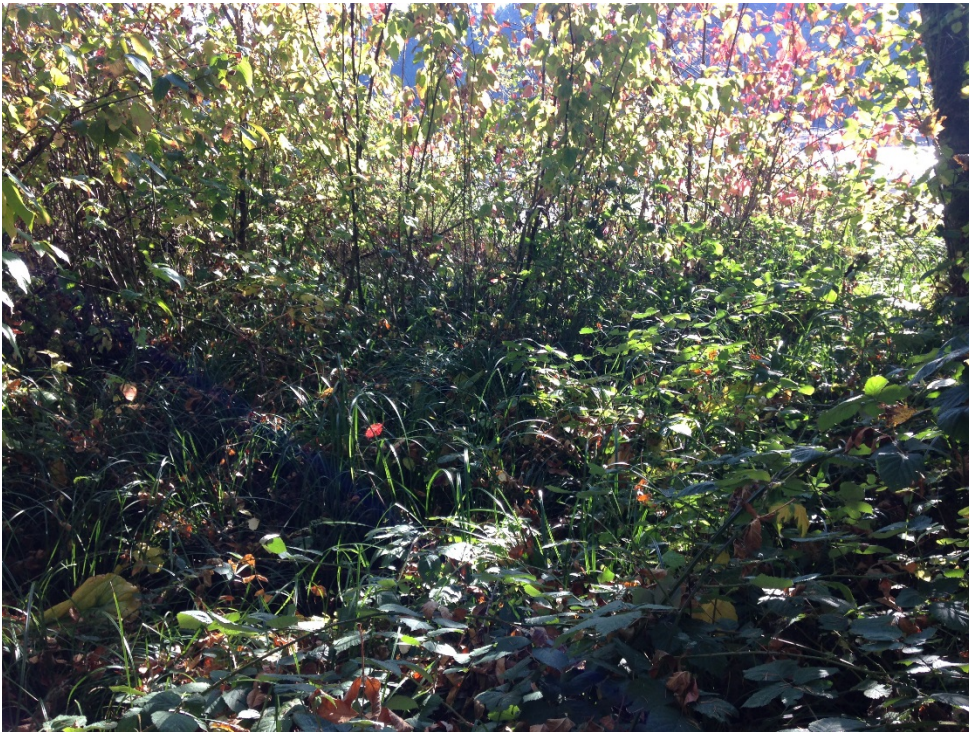
Photograph 6: View looking southwest, towards Lacamas Lake, showing typical shrub-shrub fringe in Lake wetland: redosier dogwood and Himalayan blackberry with slough sedge interspersed, shaded by trees in adjacent upland. Photograph taken October 30, 2017.

The Lake wetland contains a scrub-shrub area along the upland boundary, above the OHWM (Photograph 6). Vegetation in this area, sometimes heavily shaded by Douglas fir in adjacent uplands, is composed of a variety of shrub species, including salmonberry, redosier dogwood, Pacific ninebark, and Himalayan blackberry. Waterward of the scrub-shrub vegetation, the wetland can include a strip of reed canarygrass along the OHWM (Photograph 10). Below the OHWM, aquatic bed vegetation, dominated by yellow pond lily (*Nuphar polysepala*, OBL), extends into the lake (Photograph 7). Small, discontinuous pockets of wetland may be present along the lake below the OHWM.

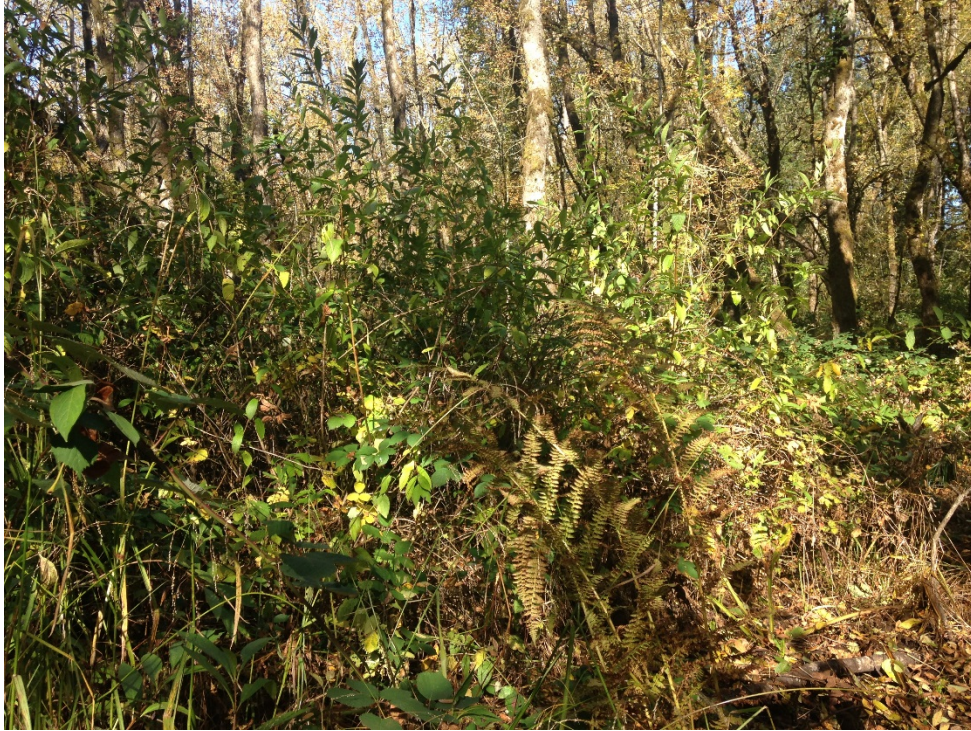
Photograph 9: View looking north, showing typical vegetation at the north and south ends of East wetland: thinner tree canopy and thickets of shrubs intermixed with patches of bare ground/open water and herbaceous vegetation. Photograph taken October 26, 2017.

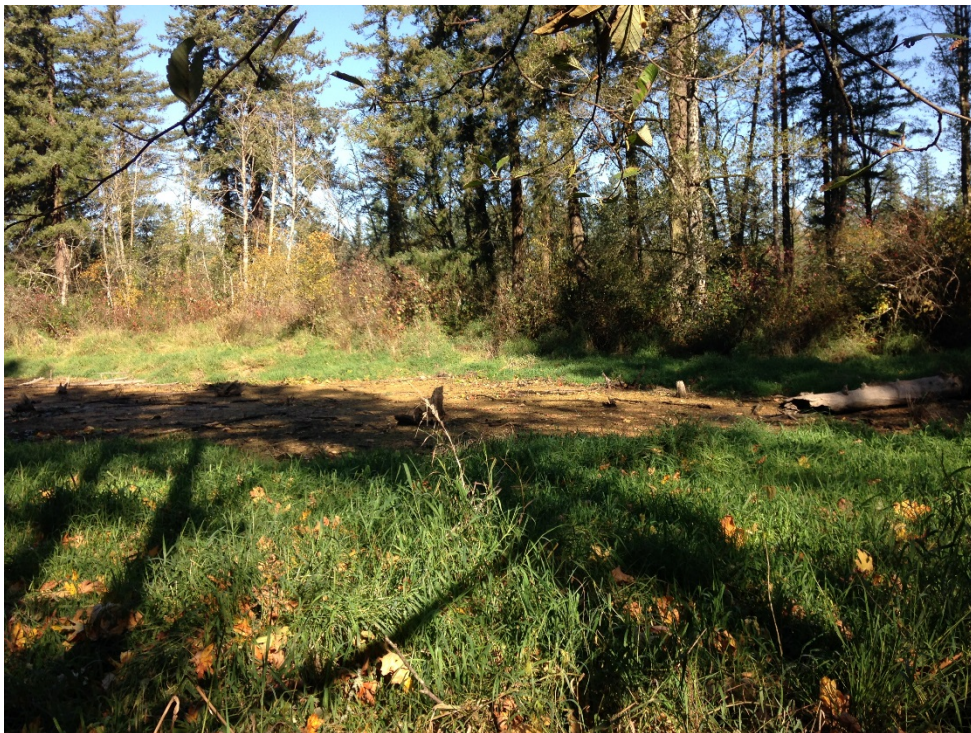
Photograph 10: View looking east, showing a strip of reed canarygrass along the OHWM of Lacamas Lake, part of Lake wetland. Bare ground (center) is below the OHWM. Photograph taken October 30, 2017.

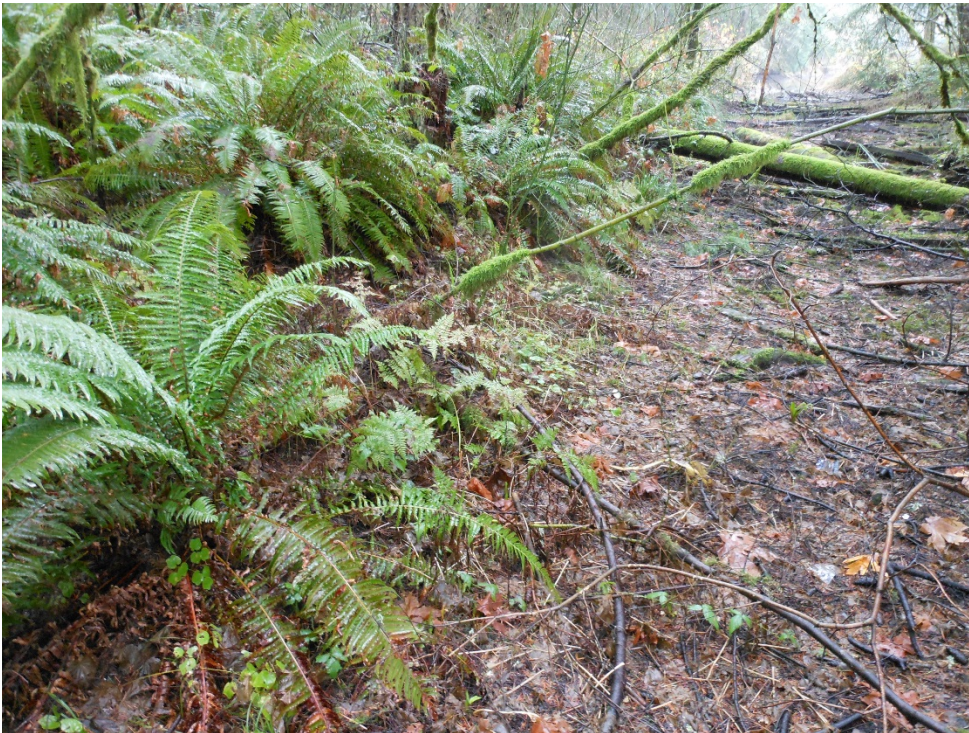
Photograph 12: View looking southeast along one of the backwaters, showing areas of bare ground and patches of herbaceous vegetation below the OHWM of Lacamas Lake. Backwater is 950 feet northwest of the proposed boardwalk. Photograph taken December 1, 2016.

Backwater areas, where water is shallow and vegetation is shaded by fir trees and protected from the fetch of the lake, are dominated by emergent species, including skunk cabbage, lady fern, reed canarygrass, slough sedge, and water parsley (*Oenanthe sarmentosa*, OBL); although, the amount of vegetation may vary (Photographs 11 and 12).

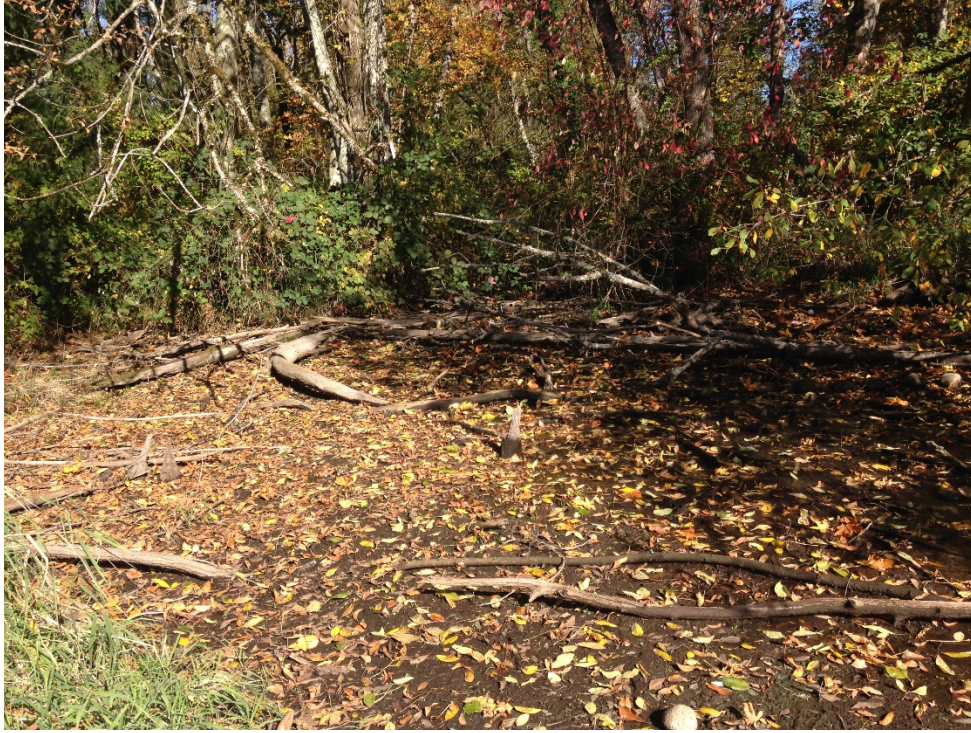
Photograph 15: View east from Lacamas Lake towards the trail alignment. Wrack accumulation and change in vegetation from bare or herbaceous to scrub-shrub can be seen at the OHWM. Photograph taken October 26, 2017.

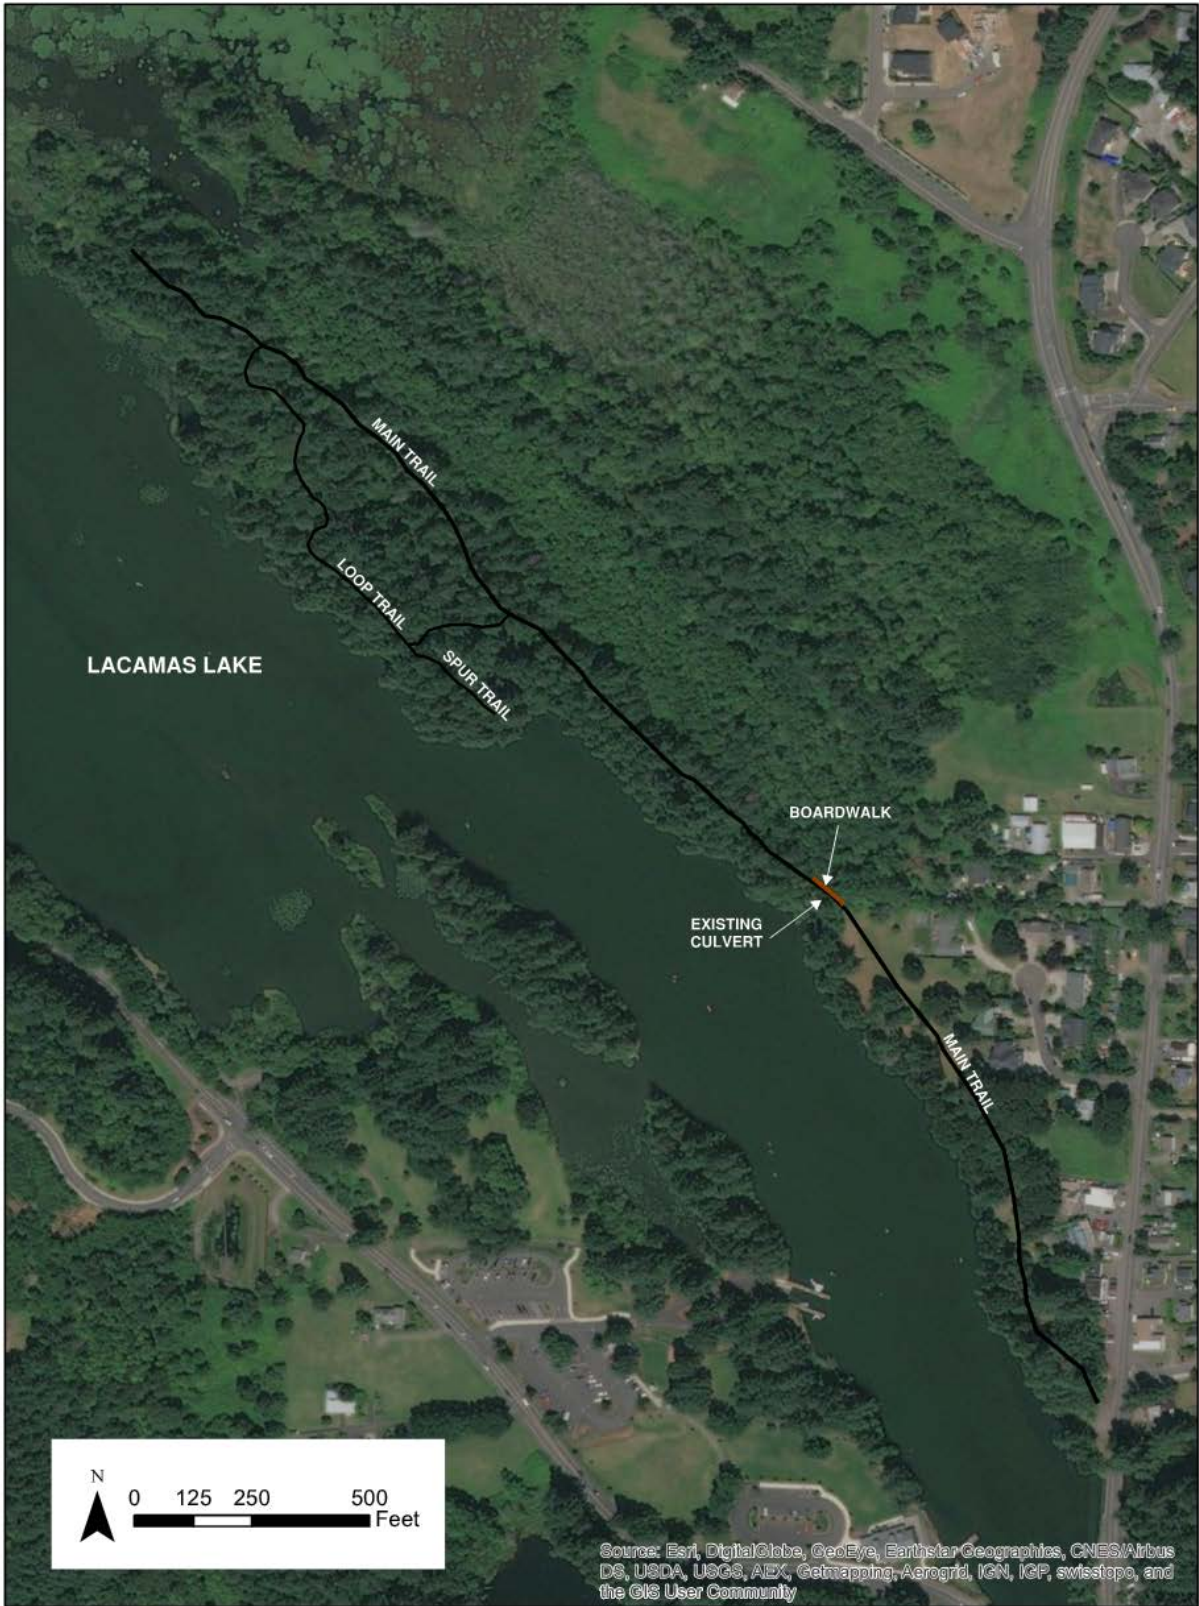
FIGURE 2. Location of proposed trails along the north shore of Lacamas Lake.

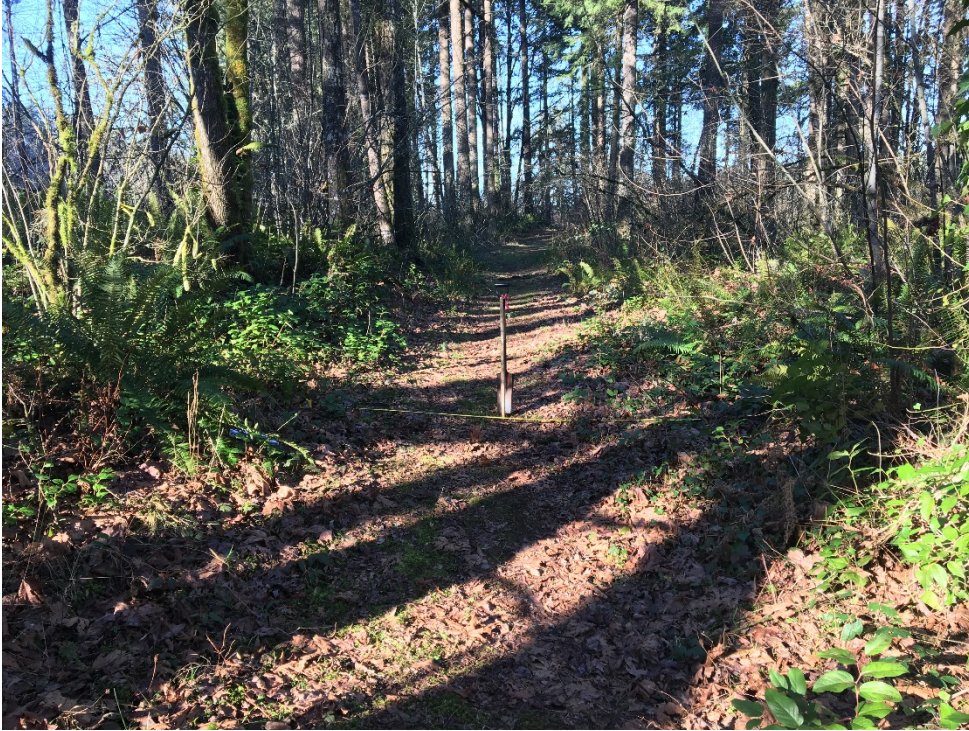
Photograph 1: View looking north along abandoned access road (at the northern junction of proposed Main and Loop trails) and typical Douglas fir forest present along the majority of the proposed trail alignment. Photograph taken January 14, 2018.

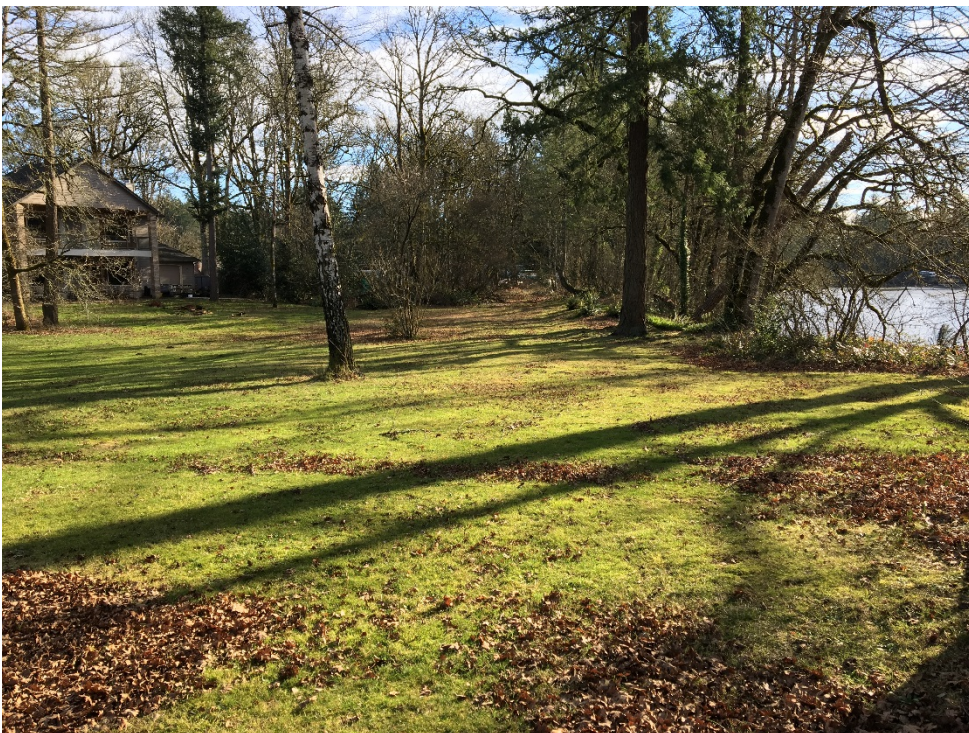
Photograph 2: View looking south where the proposed alignment crosses mowed lawns. In this area, private residences (left) are close to the shore. Photograph taken January 14, 2018.

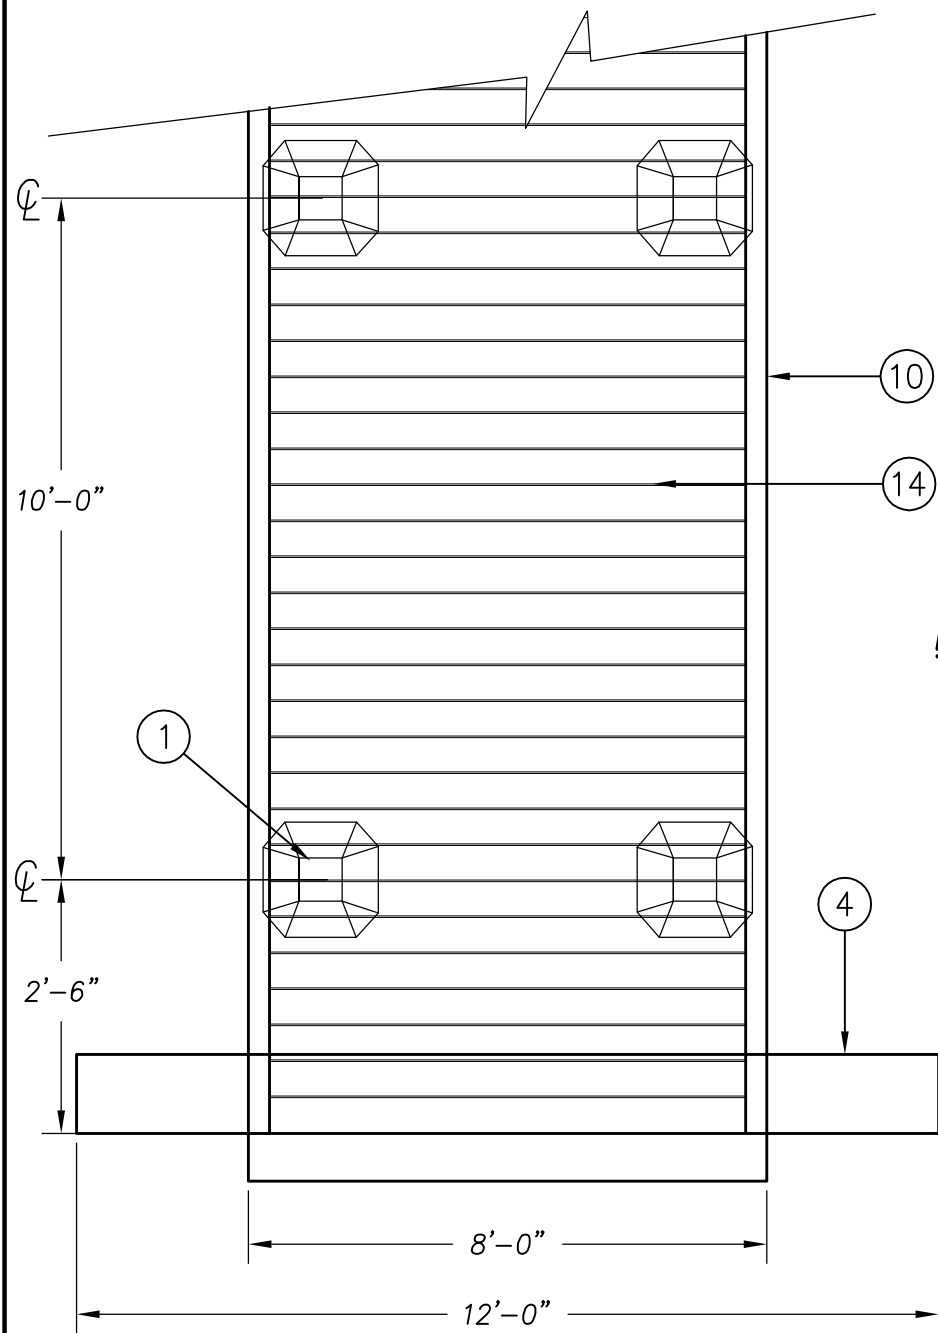
PLAN VIEW
N.T.S.

6 SQFT TOTAL WETLAND IMPACT (SIX PIN PIERS)

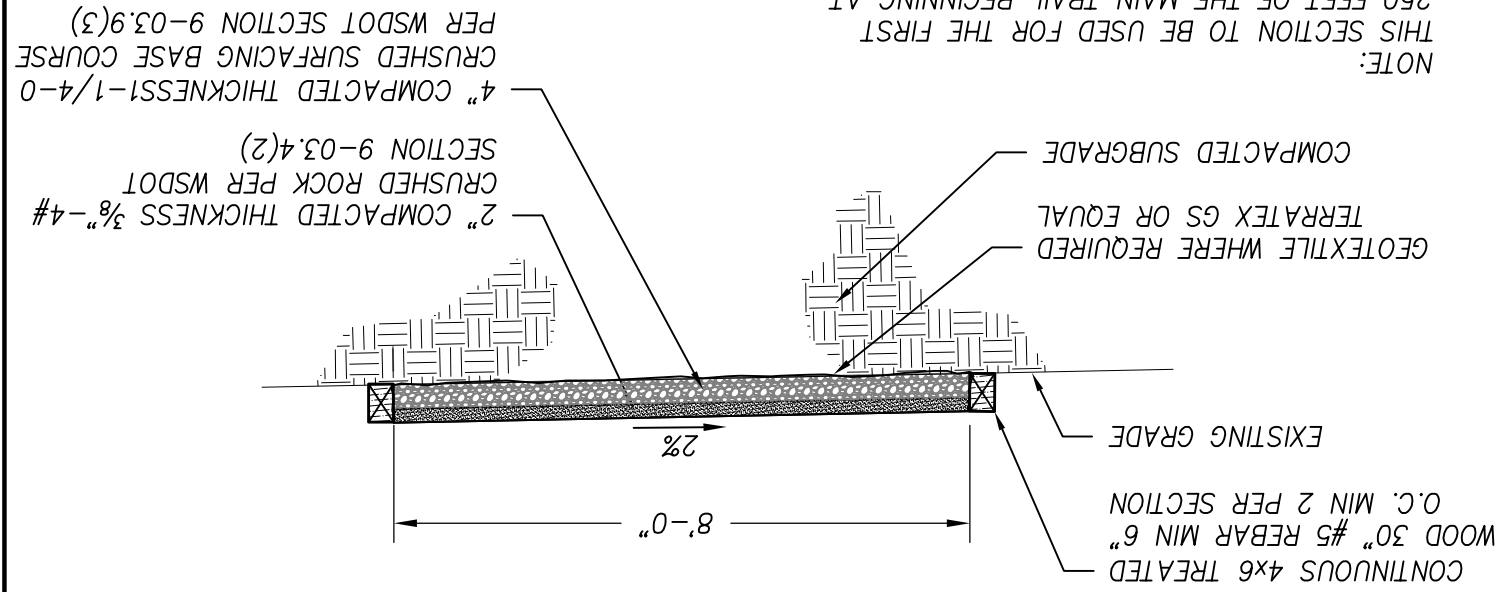
WOOD CHIP TRAIL SECTION
N.T.S.

NOTE: THIS SECTION TO BE USED FOR THE FIRST 250 FEET OF THE MAIN TRAIL BEGINNING AT NE EVERETT STREET.

NOTE: THIS SECTION TO BE USED FOR THE LOOP AND SPUR TRAILS.

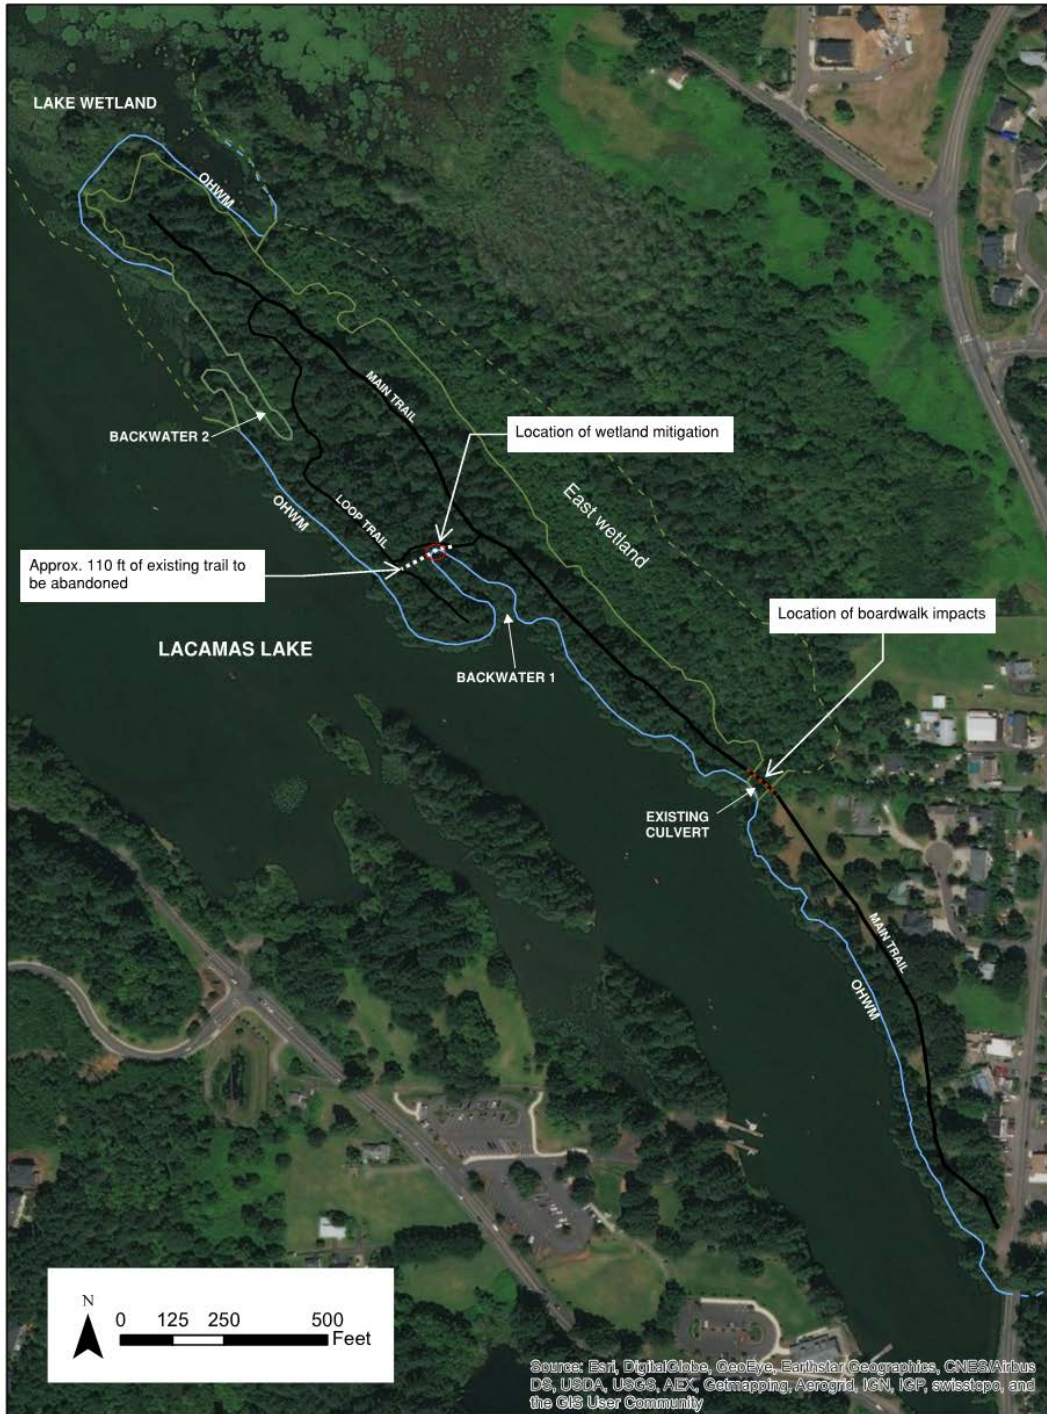
Figure 2. Location of boardwalk impacts and wetland mitigation site.

The East wetland rates as a Category III wetland. The City of Camas Shoreline Master Program (SMP) requires mitigation of Category III wetlands at a 4:1 ratio for wetland rehabilitation. Thus, 24 square feet of wetland rehabilitation is required to mitigate for 6 square feet of boardwalk impacts.
